**International
Aero Engines**

V2500 Propulsion System — Nacelle

NACELLE — POWERPLANT — SEAL, PYLON APRON, AFT — MODIFICATION OF

V2500-NAC-71-0212

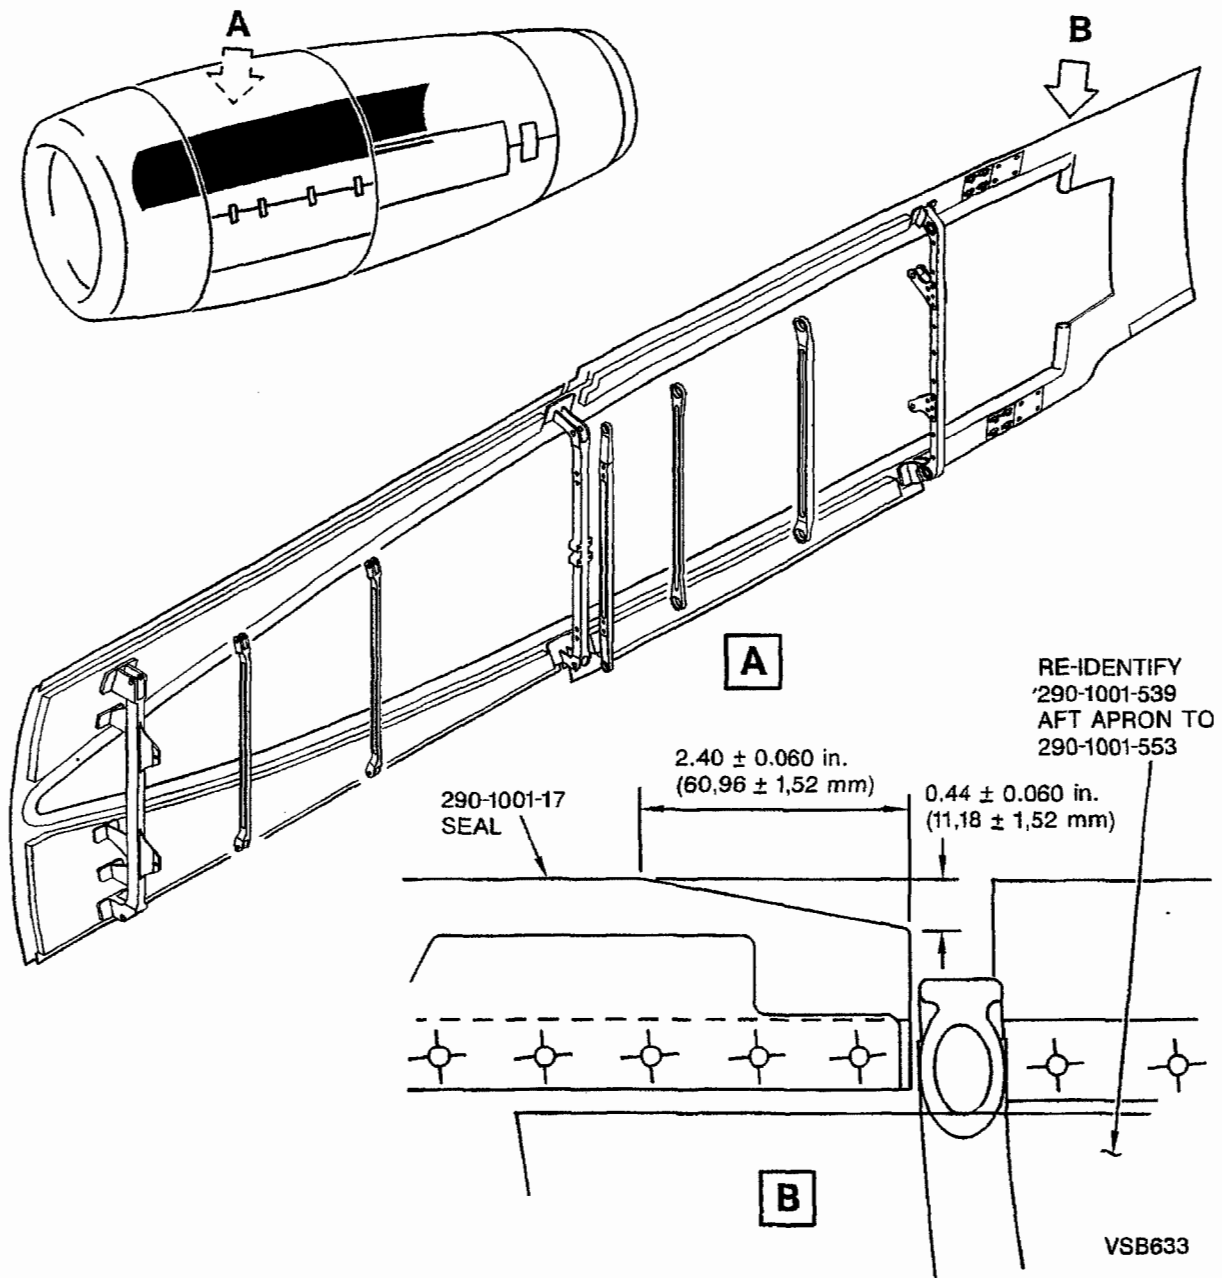
Modify the Left Aft Pylon Apron
Figure 1 (Sheet 1)

The upper forward blade seal on the aft pylon apron can overlap the core compartment fixed structure seal and contribute to disbonding of the translating sleeve at the upper inboard corner.

- (1) Remove material from the upper forward blade seal to the dimensions shown in Figure 1.
