V2500-A1/A5 SERIES PROPULSION SYSTEMS SERVICE BULLETIN

This document transmits Revision 1 to Service Bulletin V2500-NAC-71-0227

NACELLE – POWERPLANT – FAN COWL DOOR LATCH HANDLES – APPLICATION OF FLUORESCENT PAINT

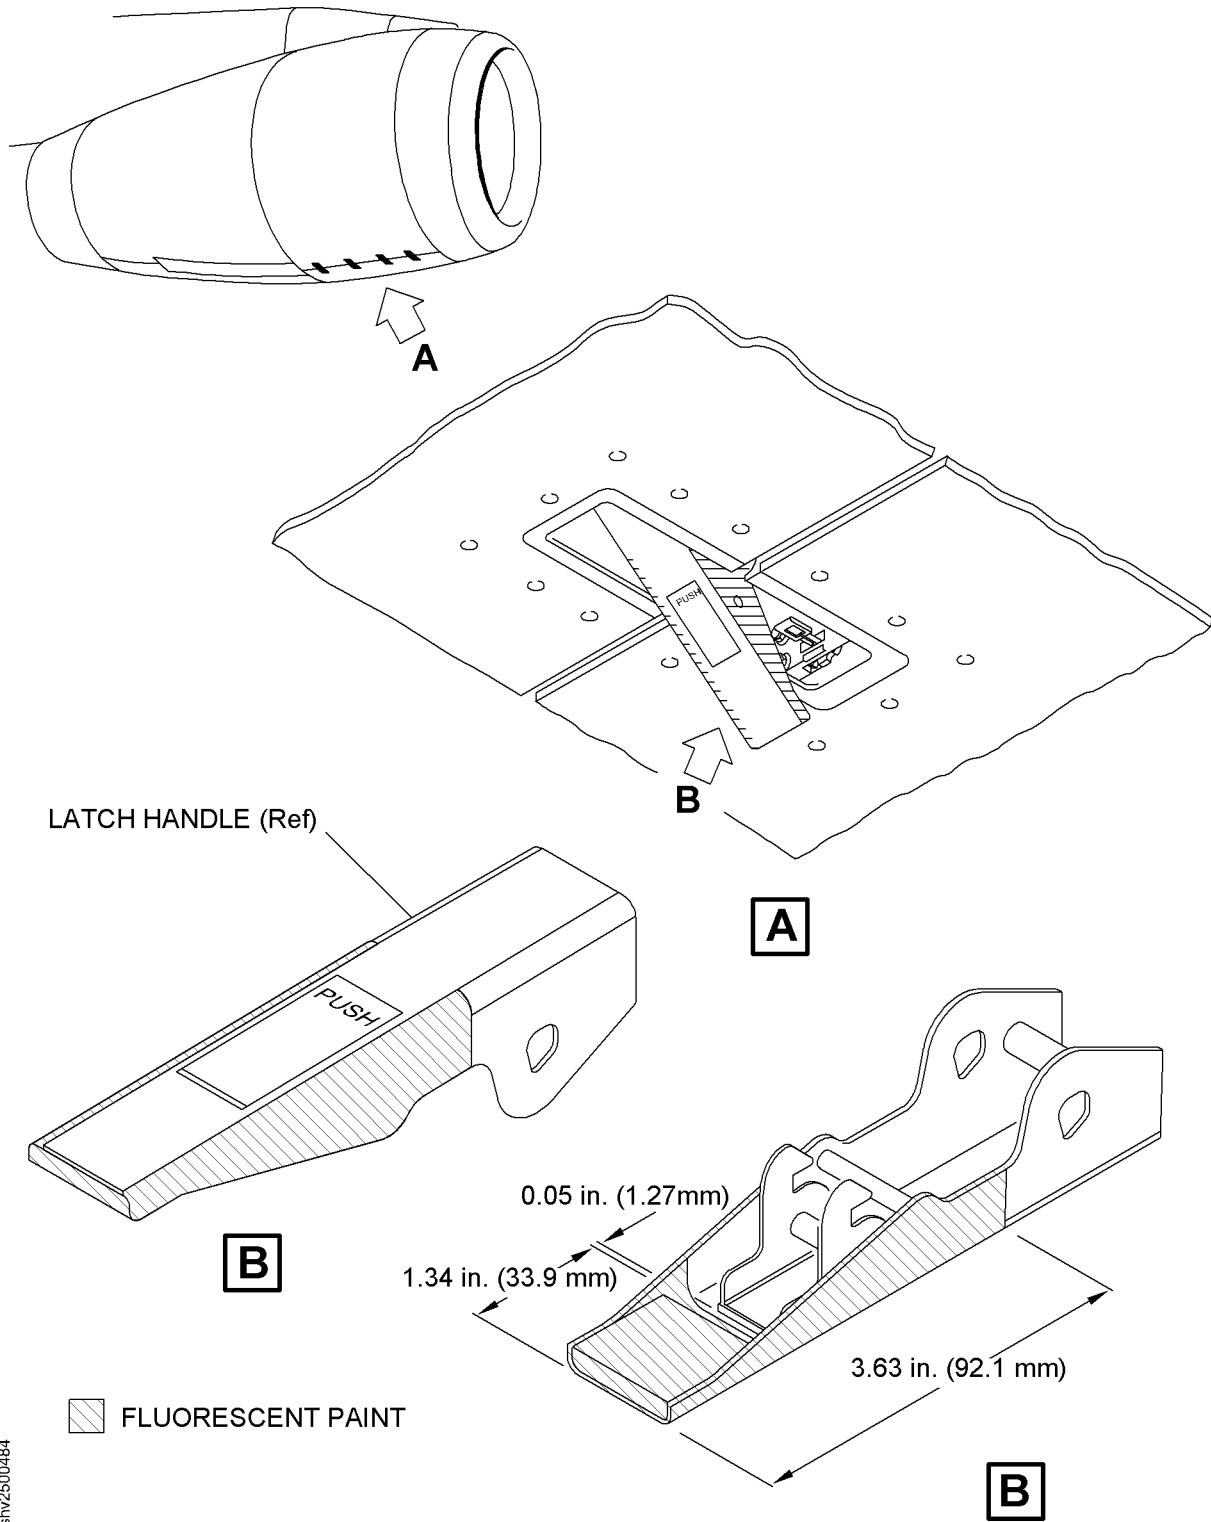
Painting of Fan Cowl Door Latch Handles
Figure 1

Several Operators have reported instances of Fan Cowl Doors Loss due to doors not being properly closed and latched prior to flight.

- (4) Position Latch handles at a suitable angle for rework of paint area as shown (Refer to Figure 1).

- (a) Apply paint with a brush to the latches (shaded area) as shown (Refer to Figure 1).
