**IAE Propulsion System
NON-MODIFICATION
SERVICE BULLETIN**

NACELLE - NOSE COWL - THERMAL ANTI-ICE DUCT INSTALLATION -
INSPECTION OF
(NON-MODIFICATION)

V2500-D5

V2500-NAC-71-0229

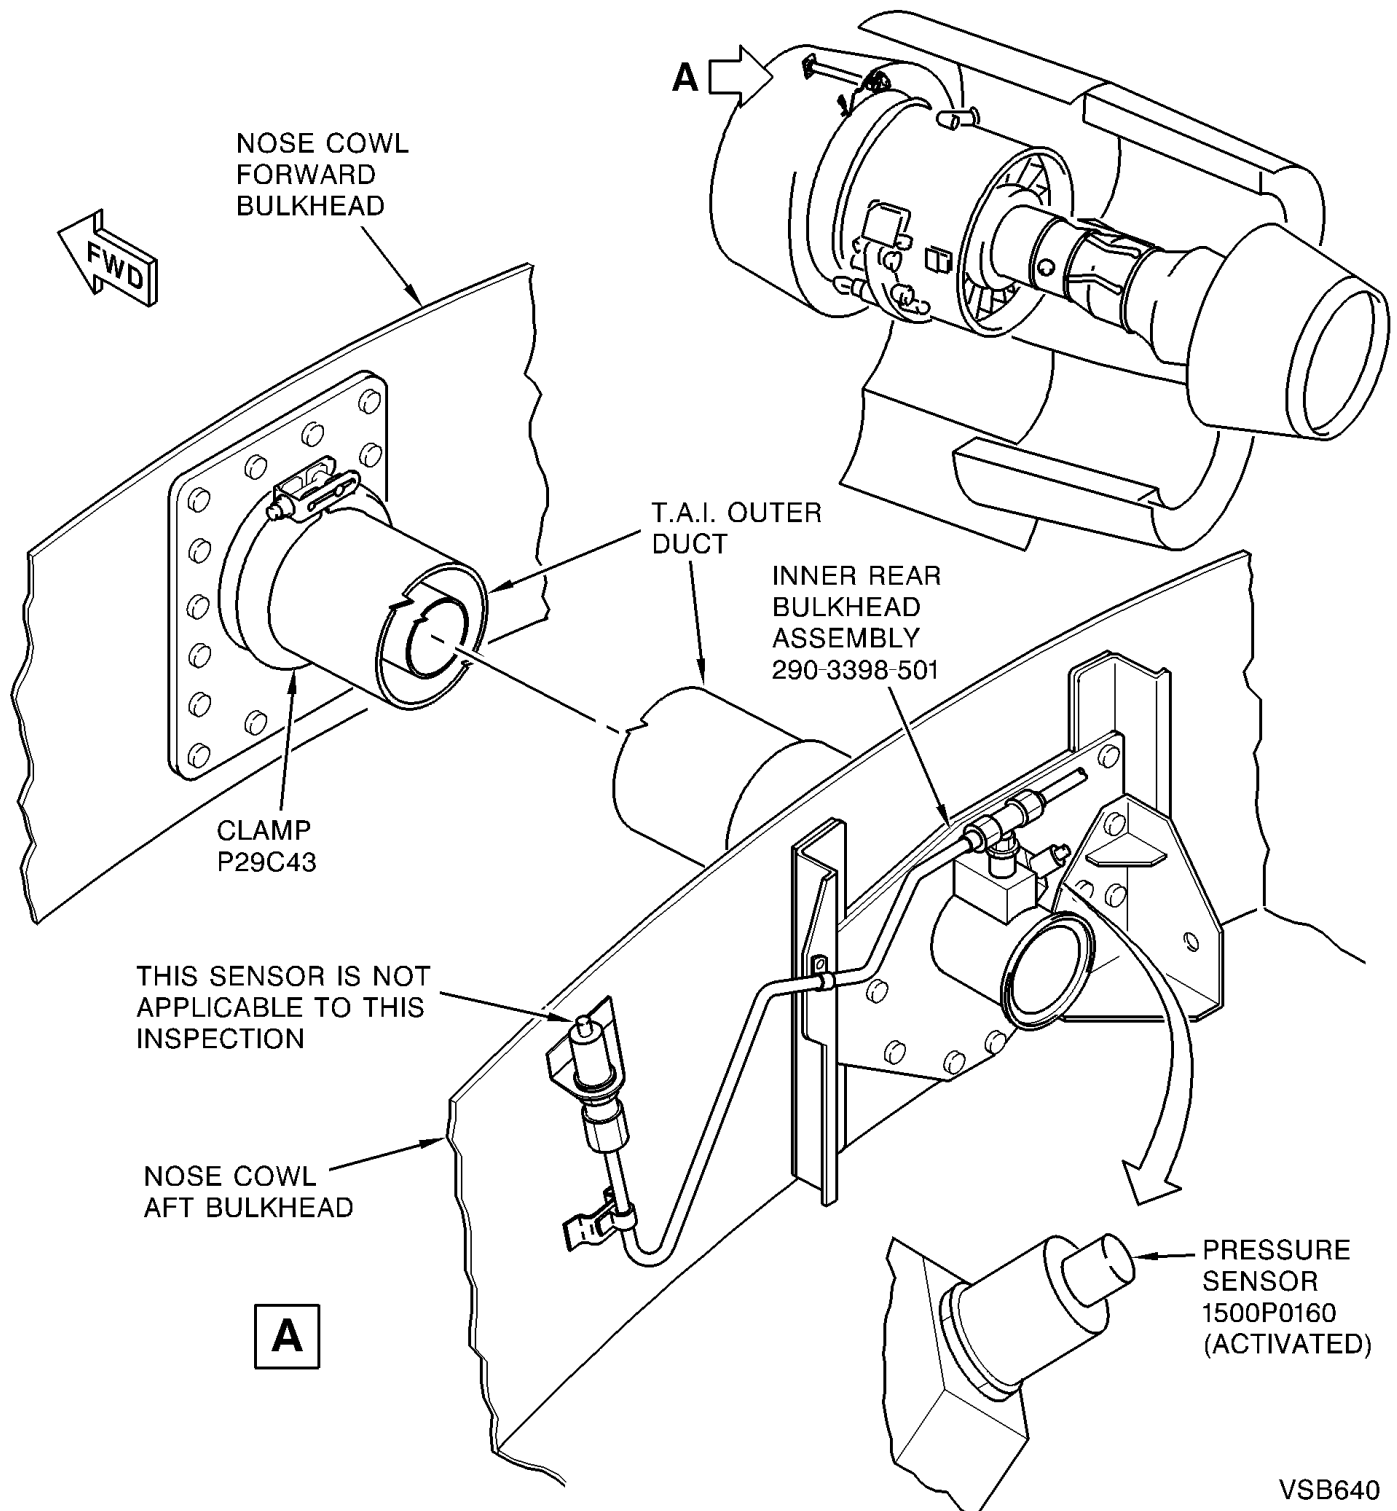
Nose Cowl T.A.I. Installation Inspection
Figure 1

- (1) Open the fan cowl doors. Refer to the MD-90 Aircraft Maintenance Manual, Chapter 71-11-01, page block 201.
- (2) Examine the nose cowl aft bulkhead thermal anti-ice system pressure sensor. Refer to Figure 1. (An activated sensor indicates T.A.I. air is leaking into the outer duct.)

- (a) If the sensor has been activated (red pin is extended) you must do the following:
 - 1 Immediately, push the red pin in to re-set the pressure sensor.

- (b) Examine the outer T.A.I. outer duct forward bulkhead connection. Refer to Figure 1.

- 2 Immediately, examine the T.A.I. outer duct forward bulkhead connection as instructed in Paragraph (3).
 - 3 Within the next 500 flight hours or at the next "A" check, whichever occurs first, incorporate Service Bulletin V2500-NAC-71-0232.

- 1 Make sure the P29C43 clamp at the forward bulkhead is correctly installed and torqued to 35-40 in-lbs (3.95-4.52 Nm) as instructed in service bulletin V2500-NAC-71-0196.
 - (c) Install the T.A.I. access panel and the fifteen NAS7204U5 bolts. Torque the bolts to 20-25 in-lbs (2,26-2,82 Nm).
 - (4) Close the fan cowl doors. Refer to the MD-90 Aircraft Maintenance Manual, Chapter 71-11-01, page block 201.
- H. A record of accomplishment is necessary.
