**International  
Aero Engines**

V2500 Propulsion System — Nacelle

NACELLE — POWERPLANT — UPPER FITTING, THRUST REVERSER OPENING ACTUATOR  
- REPLACEMENT OF

V2500-NAC-71-0231  
Page 1 of 10

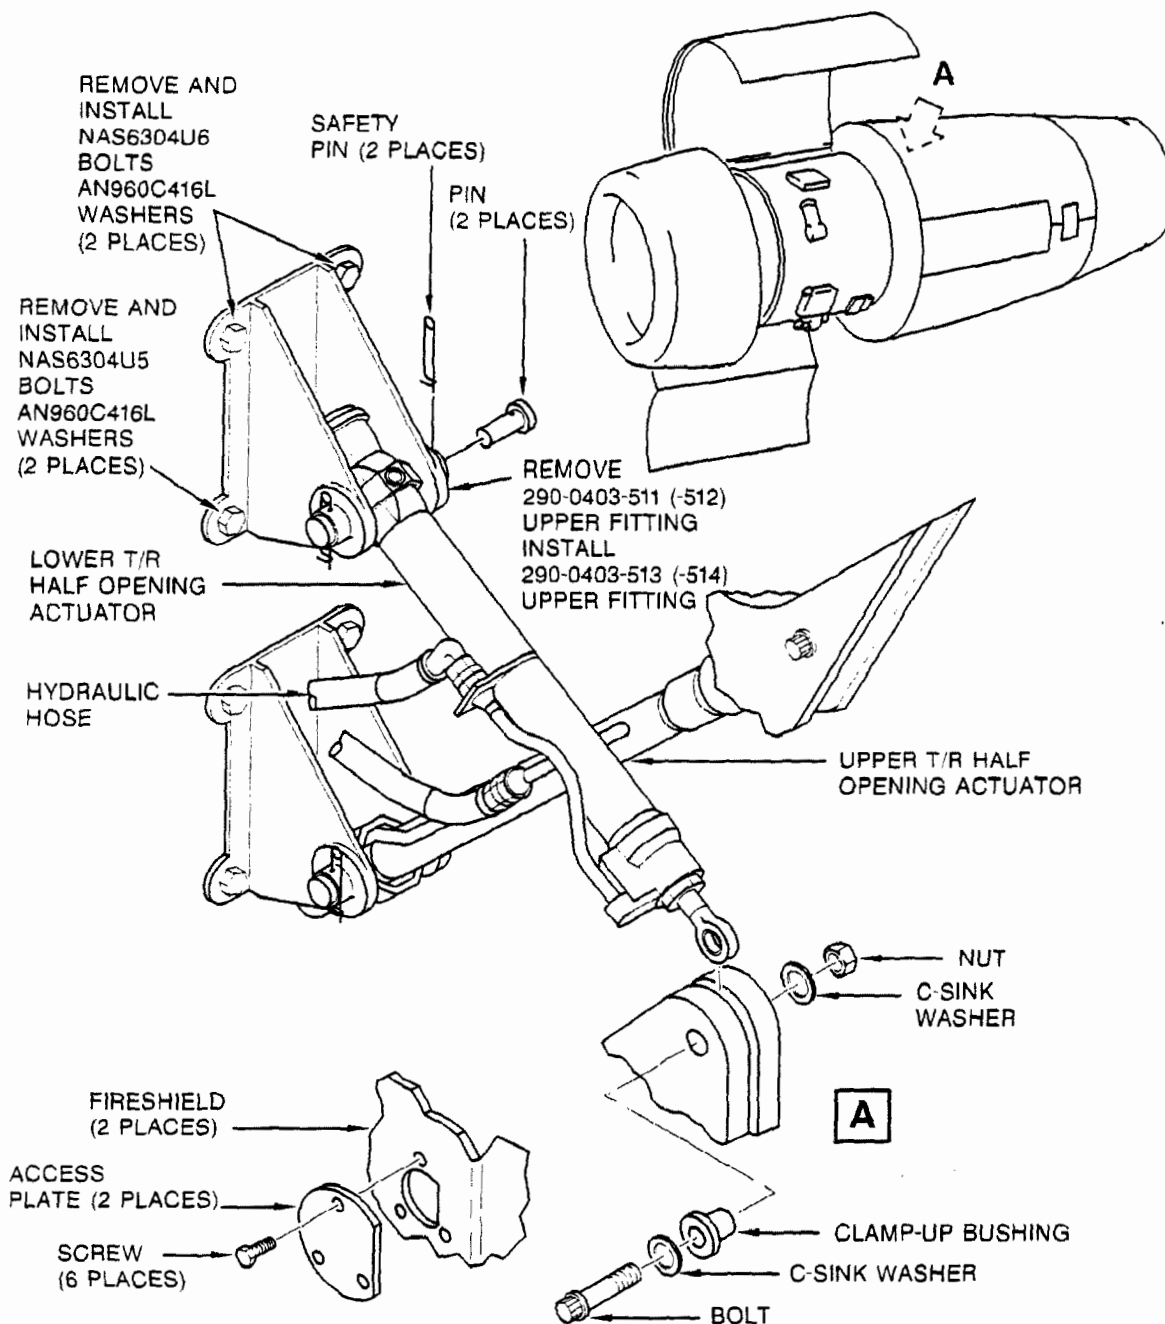
Thrust Reverser Opening Actuator Upper Fitting Assembly Replacement  
Figure 1

The pylon mounted upper fitting for the thrust reverser lower half opening actuator can become wider in service. This can allow the actuator pivot pins to disengage and result in the lower thrust reverser half swinging free when the thrust reverser is opened.

The configuration of the upper fitting does not allow the actuator to move freely through the full range of motion. The gimbal of the actuator interferes with the support bracket and causes it to become wider.

- (1) Remove the NAS6304U6 bolts, NAS6304U5 bolts, AN960C416L washers, and 290-0403-511 (-512) upper fitting from the pylon. Refer to Figure 1.
- (2) Install the 290-0403-513 (-514) upper fitting on the pylon with the AN960C416L washers, NAS6304U5 bolts, and NAS6304U6 bolts. Torque the bolts to 63-70 inlbs (7-8 Nm).
