V2500-D5 SERIES PROPULSION SYSTEM SERVICE BULLETIN

This document transmits Revision 2 to Service Bulletin NV2500-71-0232 and the Initial Issue of the Supplement

V2500-NAC-71-0232
Transmittal - Page 1 of 3

NACELLE – NOSE COWL – FORWARD BULKHEAD FITTING, THERMAL ANTI-ICE DUCT –
MODIFICATION OF

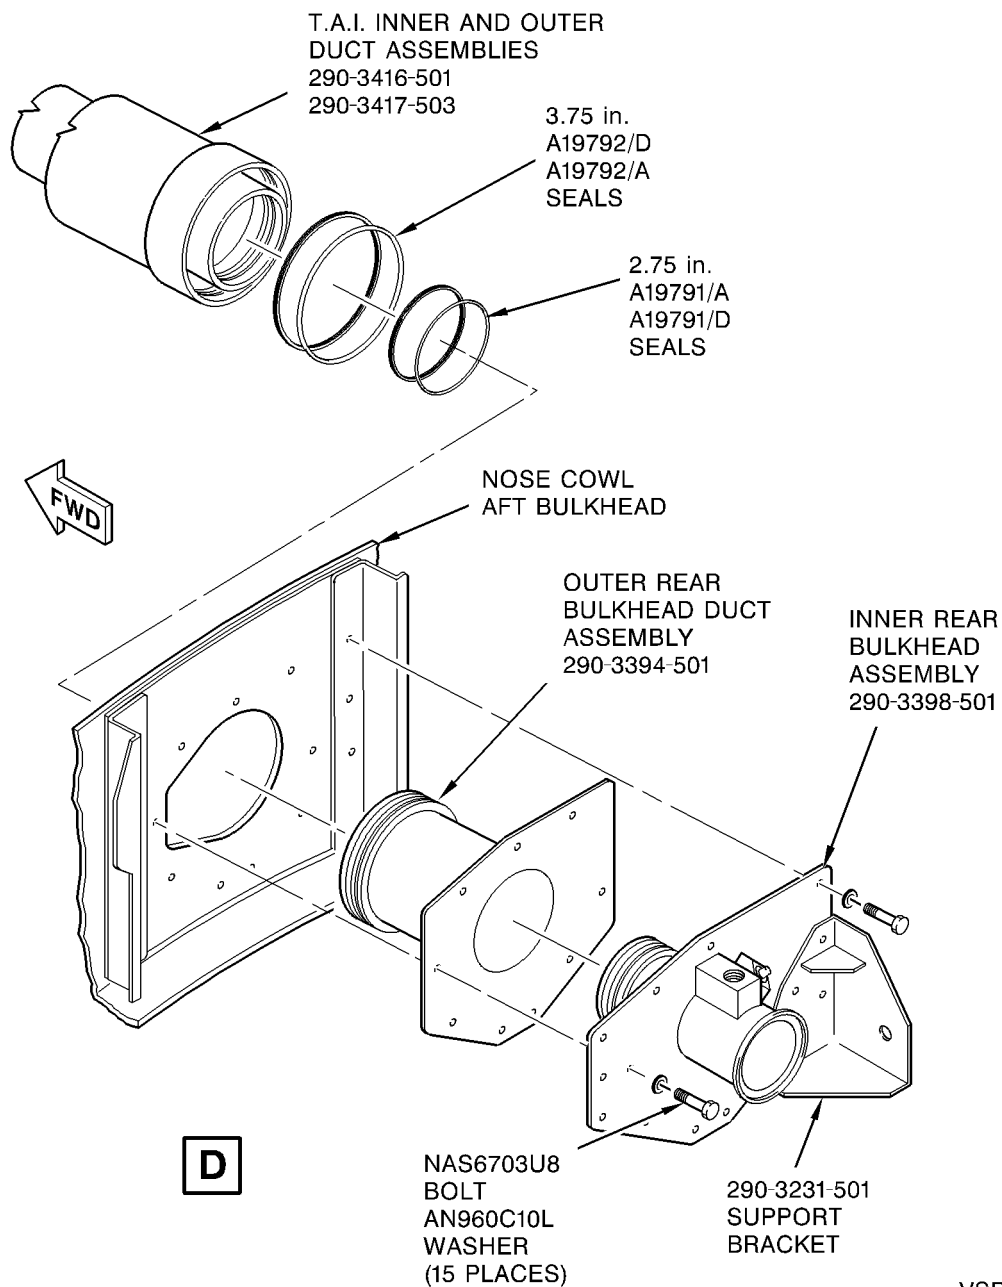
T.A.I. Duct Fitting Modification
Figure 3

Nose cowl T.A.I. duct installations have been found with wear to the forward bulkhead fitting anti-rotation pin and inner duct.

The nose cowl T.A.I forward bulkhead fitting anti-rotation pin and inner duct can become worn in service. Wear of the pin allows air to accumulate in the space between the inner and outer duct.

- (1) Remove the anti-rotation pin from the 290-3395-503 bulkhead fitting.
- (2) Fill the anti-rotation pin hole in the forward bulkhead fitting with stainless steel 410 filler wire (CoMat 03-392).
 - (a) Heat the fitting to 400-500 degrees F (205-260 degrees C) in an oven.
 - (b) Do the weld procedure within 10 minutes and do not allow the fitting to cool below 400 degrees F (205 degrees C). Use stainless steel 410 filler wire (CoMat 03-092). Cover the fitting with a heat blanket, if necessary.
 - (c) Heat the fitting in a furnace at 1300 degrees F (705 degrees C) for one (1) hour.
 - (d) Cool the fitting in a furnace to 1100 degrees F (593 degrees C). Then, air cool fitting to room temperature.
 - (e) Grind both sides of the weld flush to within 0.025 inch (0.64 mm).

(f) Do a high sensitivity fluorescent dye penetrant inspection of all welds on the fitting. No cracks are allowed. Refer to the Standard Practices Manual Task 70-23-05-501.

- (3) Re-identify the 290-3395-503 bulkhead fitting as 290-3004-1AE. Use a rubber stamp and black ink (CoMat 06-073). Refer to the IAE Standard Practices/Processes Manual, Chapter 70-09-00.
