V2500 Propulsion System — Nacelle

SERVICE BULLETIN

NACELLE - POWERPLANT – RIGHT HAND FAN COWL DOOR – MODIFICATION TO LATCH
ASSEMBLY

V2500-NAC-71-0256

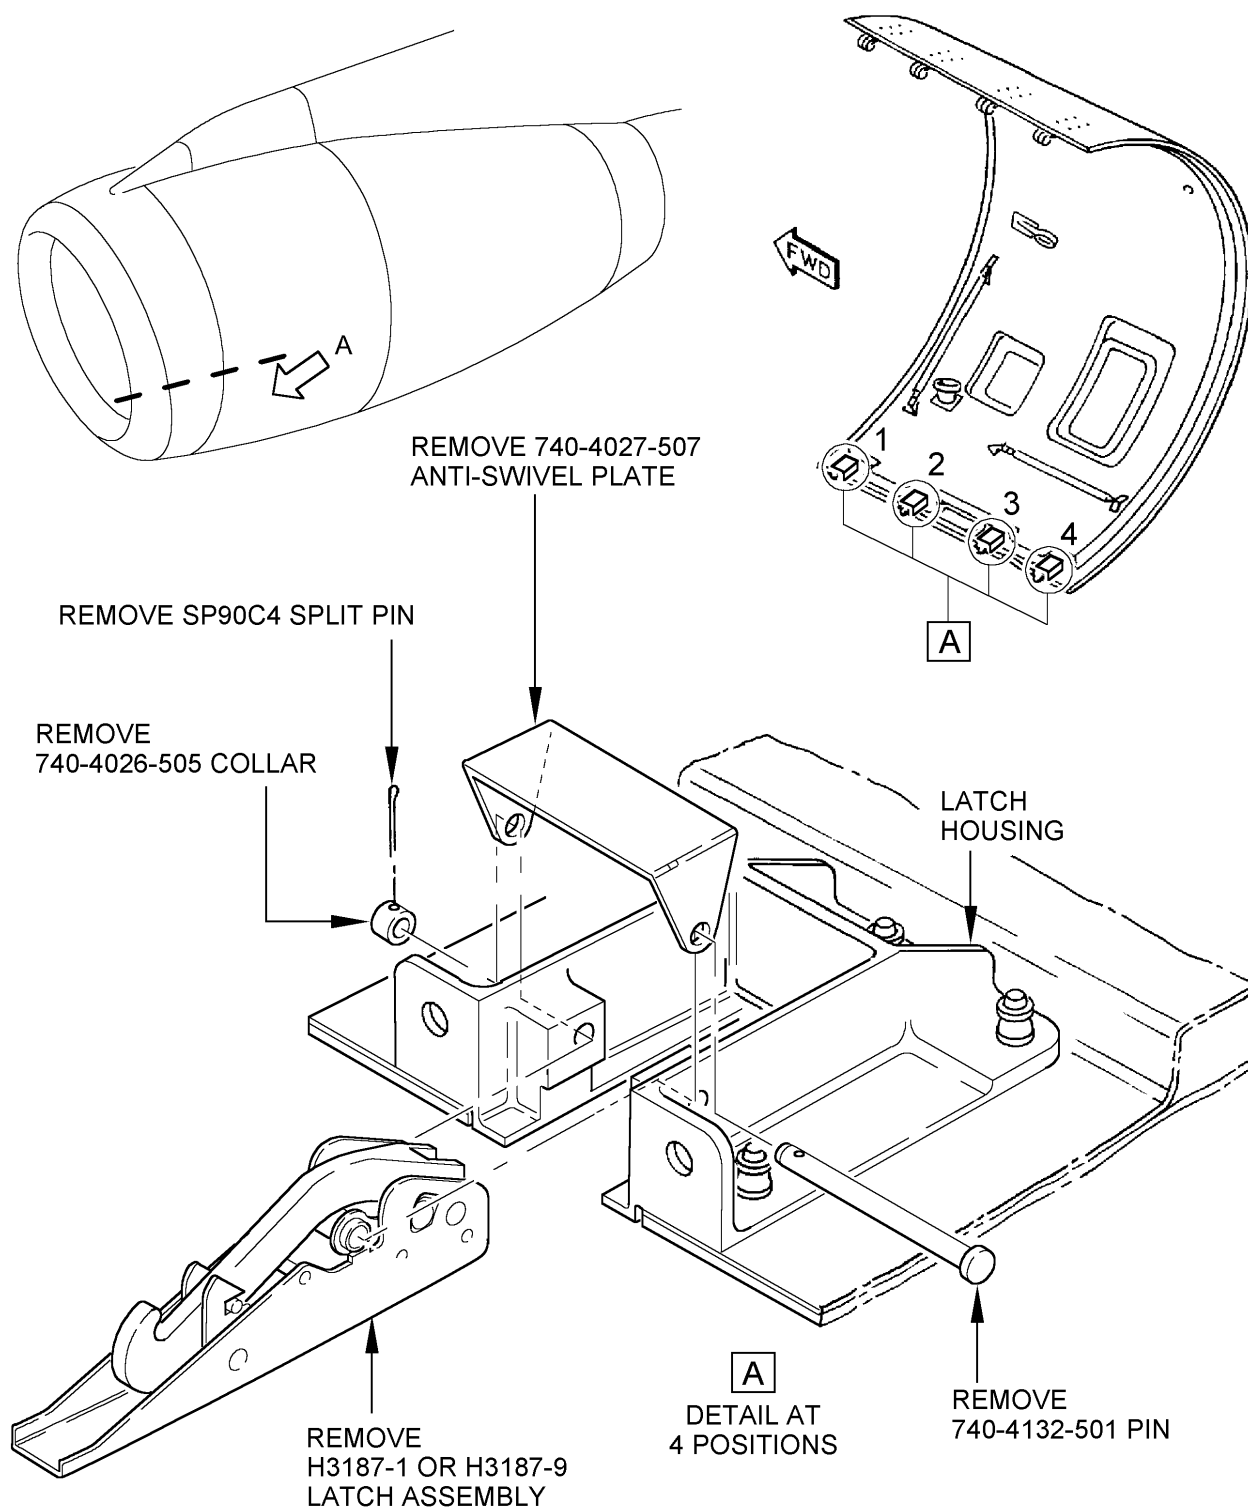
Removal of Anti-swivel Plate – Fan Cowl Door Latches 1,2,3 and 4
Figure 1 Sheet 1 of 1

Several instances have been reported of Fan Cowl Doors not being fully latched (as per manual requirements) prior to flight. This may result in actual Door loss in flight.

- (1) Remove and discard the SP90C4 Split Pin as shown at latch 1. Remove the 740-4026-505 collar. Refer to Figure 1 sheet 1.
- (2) Remove the 740-4132-501 Pin which holds the H3187-1 or H3187-9 Latch Assembly and the 740-4027-507 Anti-swivel Plate.

- (3) Remove the 740-4027-507 Anti-swivel Plate and the H3187-1 or H3187-9 latch Assembly as shown. Discard the Anti-swivel Plate.
- (4) Put the 745-4083-501 Latch Weight in position on the H3187-1 or H3187-9 Latch Assembly as shown. Hold the Latch Weight and drill a hole 0.128" (3.25mm) dia. from the Latch Weight through the Latch Assembly.

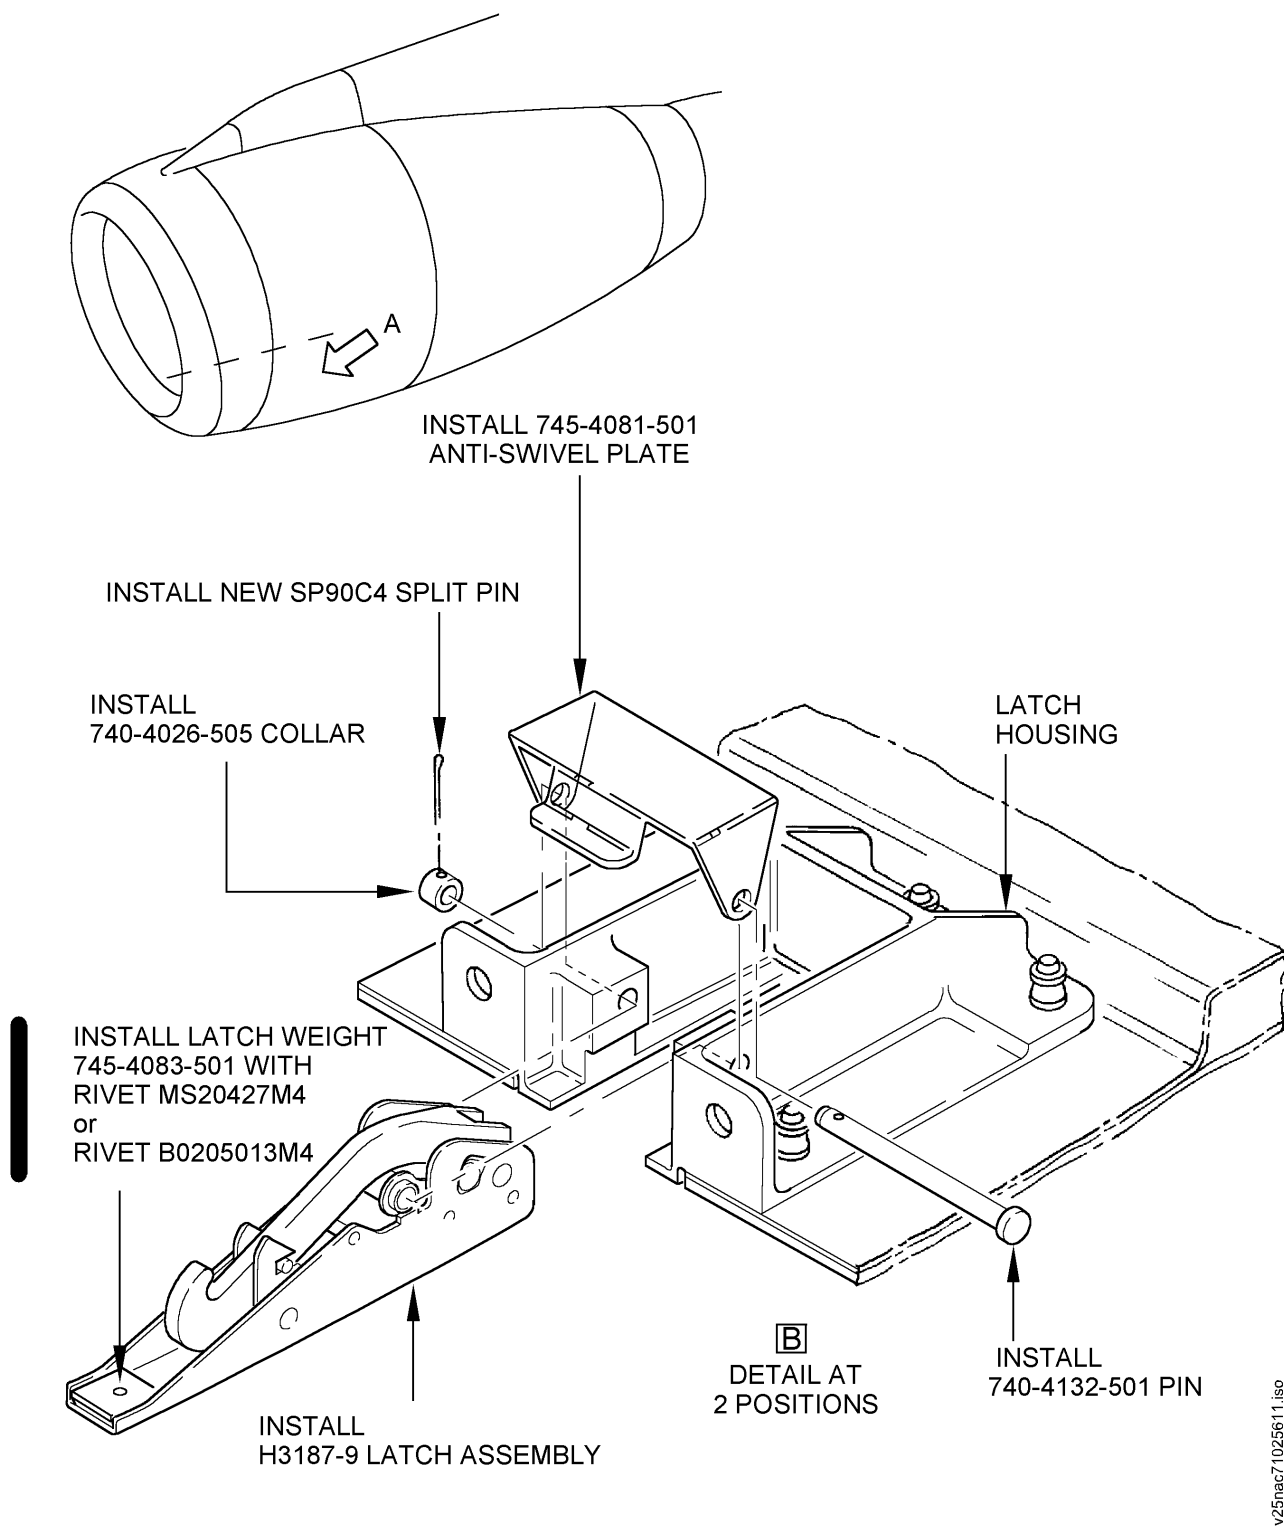
Installation of Anti-swivel Plate and Latch Weight – Fan Cowl Door Latches 3 and 4
Figure 2 Sheet 2 of 2

CAUTION: MAKE SURE YOU INSTALL THE ANTI-SWIVEL PLATES AT THEIR CORRECT LOCATION AS DETAILED ON FIGURE 2, DETAIL 'A' AND 'B'. THE ANTI-SWIVEL PLATES MAY CONTACT AND DAMAGE ADJACENT COMPONENTS ON CLOSING OF THE FAN COWL DOORS IF INCORRECTLY INSTALLED

- (14) Install the H3187-9 Latch assembly to the Latch Housing as shown with the new 745-4082-501 Anti-swivel Plate, the 740-4132-501 Pin, and 740-4026-505 Collar. Make the Pin safe with a new SP90C4 Split Pin.
- (15) Make sure that the H3187-9 Latch Assembly has unrestricted movement through its limit of travel and is not impeded by its clearance with the Latch Housing.
- (16) Do steps (1) thru (15) to install a new 745-4082-501 Anti-swivel plate at latch 2.
- (17) Do steps (1) thru (15) except install a new 745-4081-501 Anti-swivel plate in place of the 740-4027-507 Anti-swivel Plate at latch 3. Refer to Figure 2 sheet 2.
- (18) Do steps (1) thru (15) except install a new 745-4081-501 Anti-swivel plate in place of the 740-4027-507 Anti-swivel Plate at latch 4. Refer to Figure 2 sheet 2.
