## V2500-A1 SERIES PROPULSION SYSTEMS SERVICE BULLETIN

**V2500-NAC-71-0257**  
Transmittal - Page 1 of 1

NACELLE – AIR INLET COWL – INSTALLATION OF A5 TAI OUTER DUCT AND ACCESS PANEL ON A1  
AIR INLET COWLS

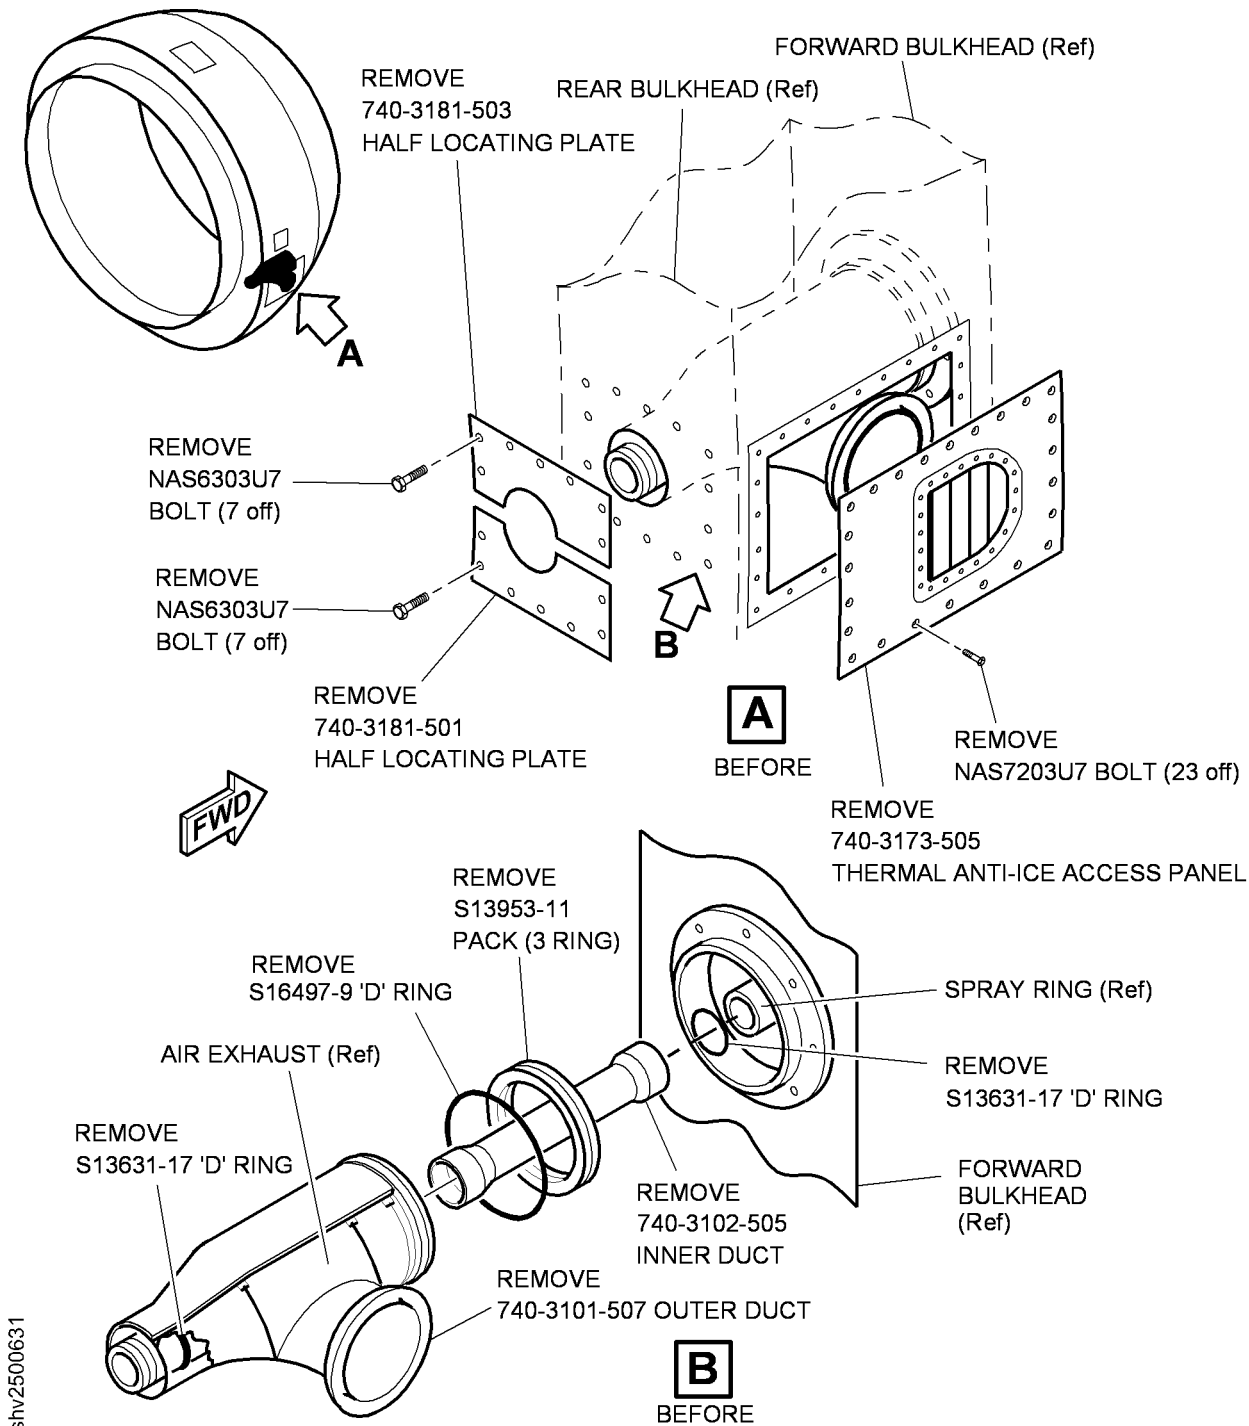
Replacement of TAI Access Panel and Outer Duct  
Figure 1, Sheet 1 of 3

Production of the V2500-A1 standard of TAI (Thermal Anti-Ice) Access Panel and Outer Duct has stopped. To facilitate spares requirements, the V2500-A5 standard of TAI Access Panel and Outer Duct has been validated for use on the V2500-A1 Nacelle.

- (a) The TAI Access Panel is removed.
- (b) The TAI Inner/Outer Duct Assembly is removed from the Air Inlet Cowl and the Outer Duct is removed and replaced with a new Outer Duct.
- (c) The TAI Inner/Outer Duct Assembly is then installed to the Air Inlet Cowl.
- (d) A new TAI Access Panel is fitted.

- (1) Remove the 23 NAS7203U7 Bolts to release the 740-3173-505 TAI Access Panel. Remove the Access Panel. Refer to Figure 1.
- (2) Remove seven NAS6303U7 Bolts to release the 740-3181-503 Half Locating Plate. Remove the Half Locating Plate.
- (3) Remove seven NAS6303U7 Bolts from the 740-3181-501 Half Locating Plate. Remove the Half Locating Plate.
- (4) Put your hand into the Air Inlet Cowl Aperture and hold the 740-3102-505 Inner Duct. Pull the Inner/Outer Duct Assembly away from the Spray Ring and remove from the Air Inlet Cowl. Discard the S13631-17 'D' Ring and put a Blanking Cap on the Spray Ring.
