V2500 Propulsion System — Nacelle

# SERVICE BULLETIN

NACELLE - POWERPLANT – AIR INLET COWL – INSTALLATION OF A FAN COWL DOOR  
HOLD OPEN DEVICE

# V2500-NAC-71-0259

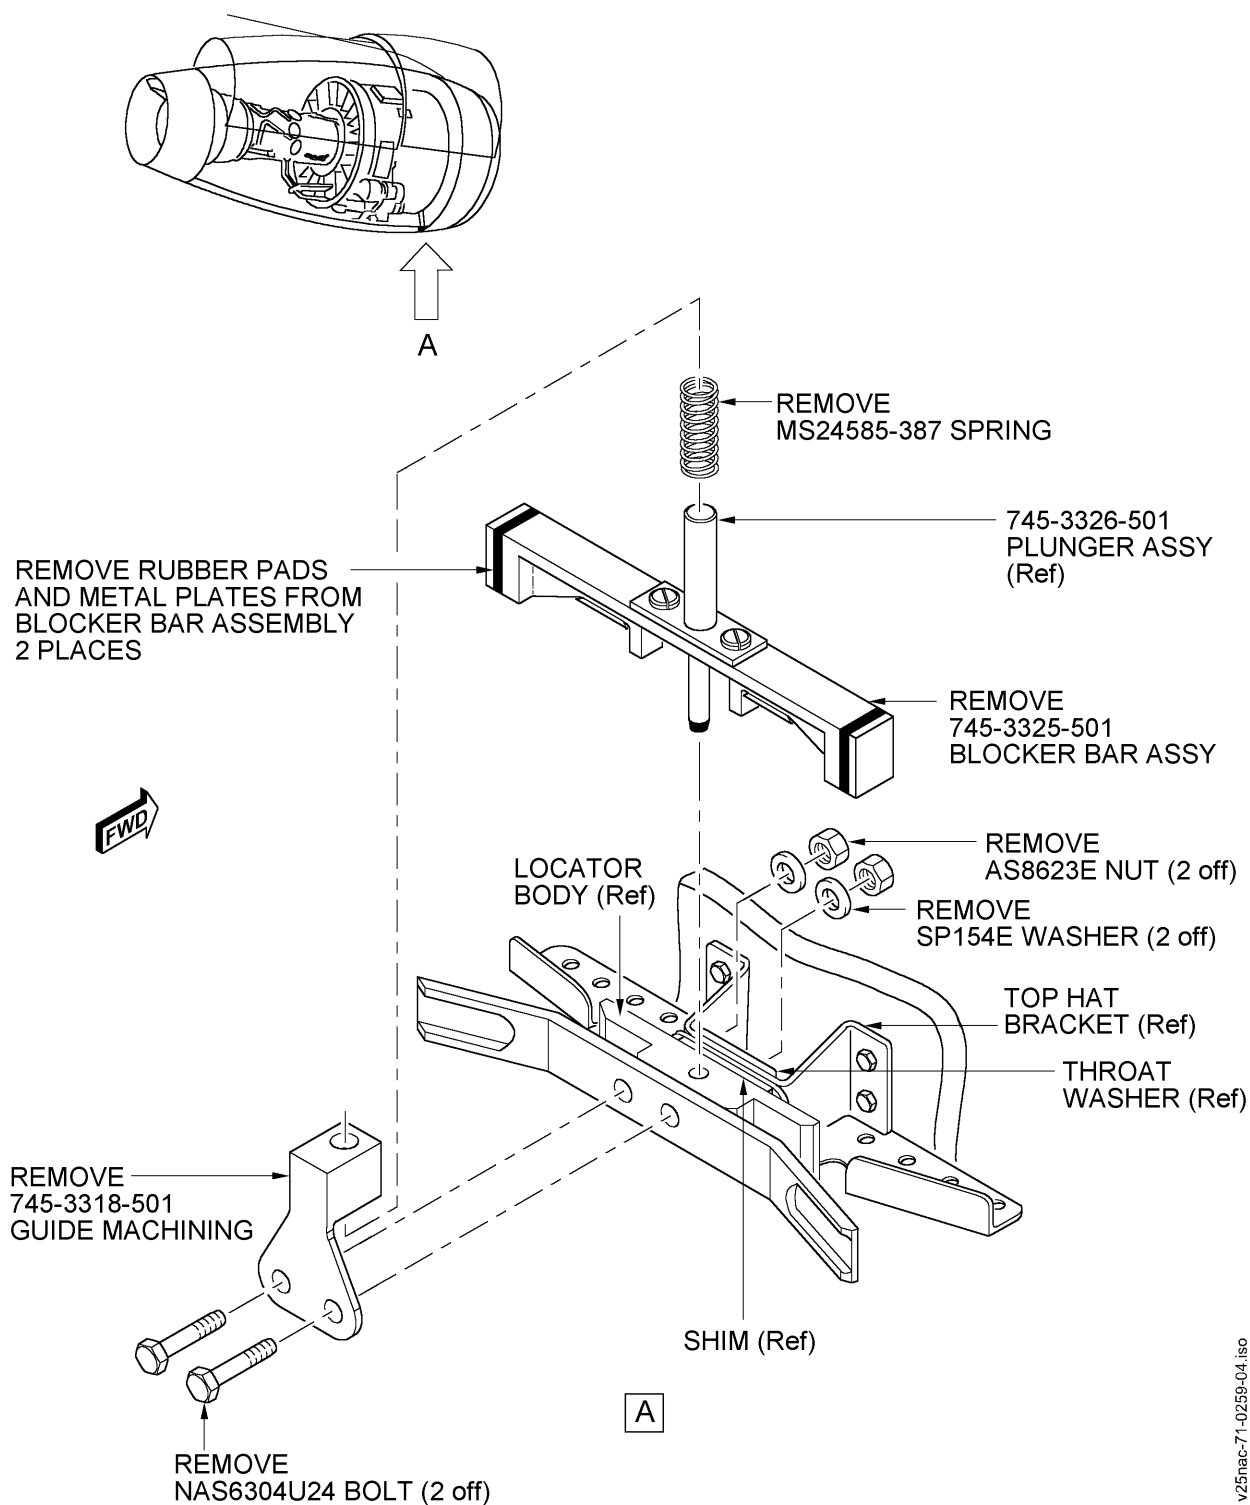
Removal and rework of Hold Open Device  
Figure 3, sheet 1

Several instances have been reported of the rubber block at each end of the Hold Open Device degrading or falling off.

The Hold Open Device was introduced to enhance visibility of unlatched doors. However, the rubber Pads on the Hold Open Device have, in some instances, degraded or fallen off.

- (1) Remove the two AS8623E Nuts, the two SP154E Washers and the NAS6304U24 Bolts from the Door Locator. Refer to Figure 3, sheet 1.
- NOTE: When you remove the two AS8623E Nuts, SP154E Washers and NAS6304U24 Bolts from the Door Locator, you must hold the Throat Washer, the Shim, the Locator Body and the Guide Bar in position.
- (2) Remove the 745-3318-501 Guide Machining and MS24585-387 Spring from the Air Inlet Cowl.
- (3) Remove the 745-3325-501 Blocker Bar Assembly from the Air Inlet Cowl.
- (4) Remove the Rubber Blocks and Metal Plates from the ends of the Blocker Bar Assembly.
