## V2500 Nacelle Systems Modification SERVICE BULLETIN

Subject: Service Bulletin V2500-NAC-71-0266  
Revision 2 , Dated September 30, 2009

### NACELLE – INLET COWL – T.A.I. EXHAUST ACCESS PANEL – REPLACEMENT OF

V2500-NAC-71-0266

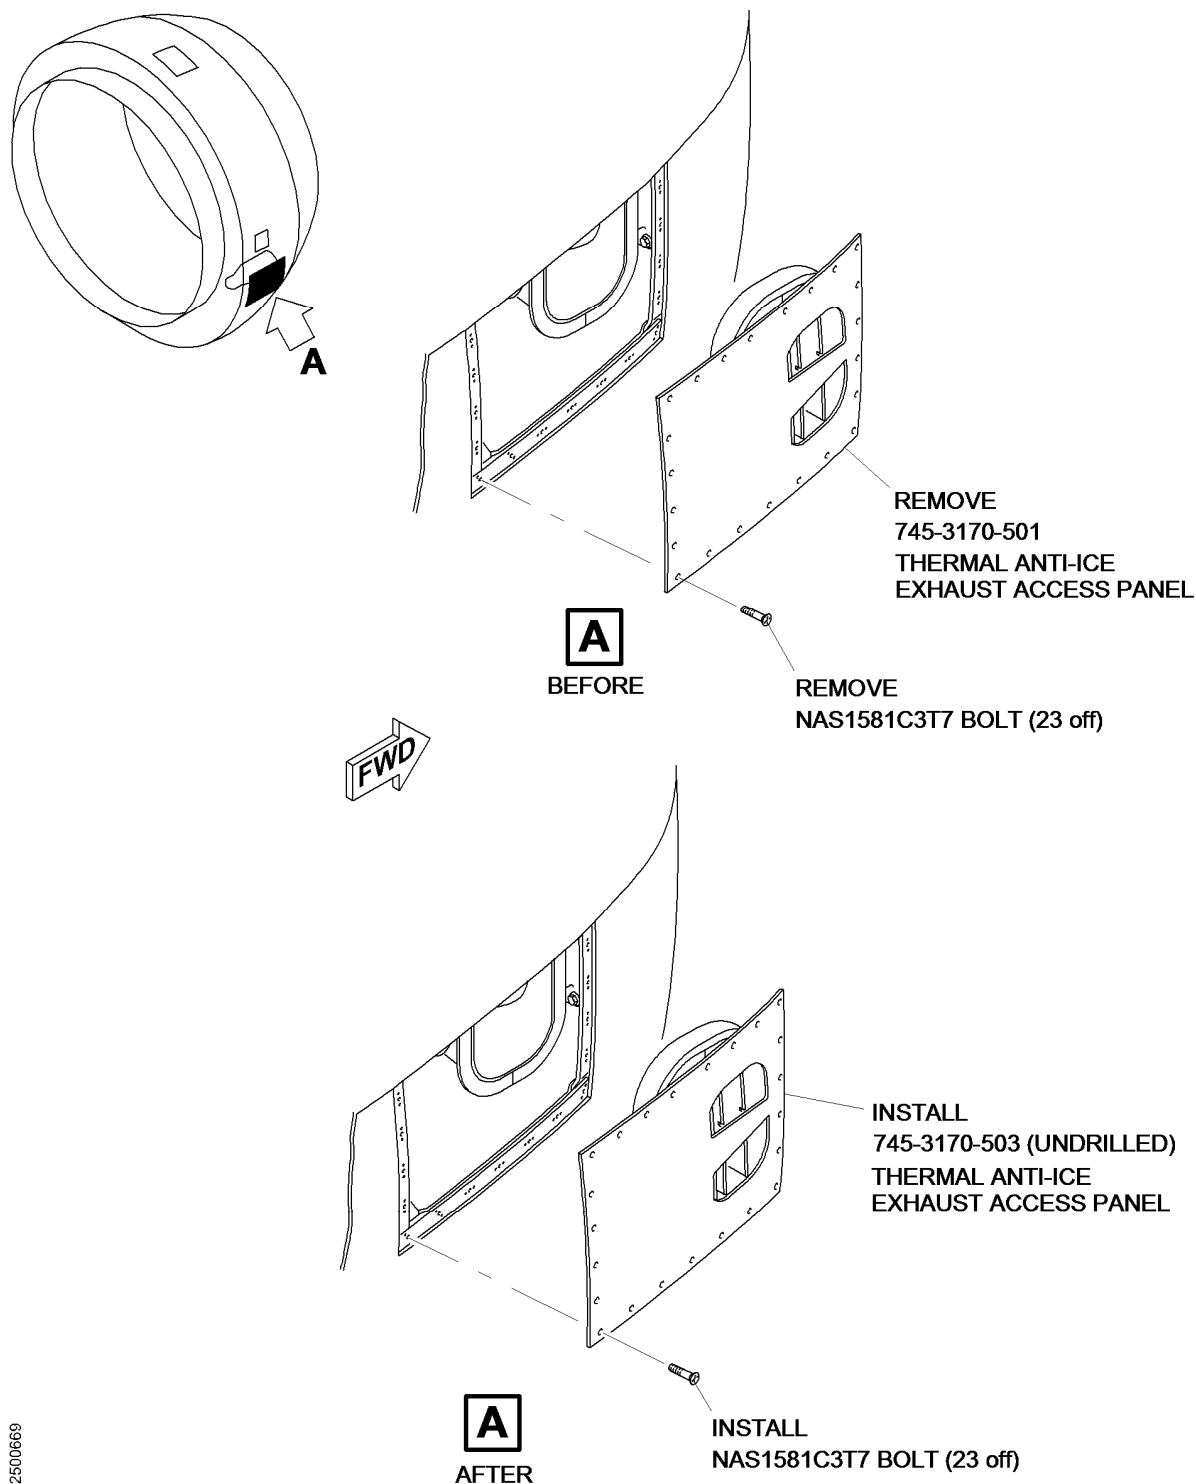
**Removal and Installation of the T.A.I Exhaust Access Panel.  
Figure 1 (Sheet 1 of 1)**

- (1) Condition: Air exhausting from the T.A.I. Outlet Grille may cause a “whistling” noise that is audible in the Aircraft Cabin.
- (2) Problem: The T.A.I. Outlet Grille may cause a “whistling” noise audible in the Aircraft Cabin, and the Duct Vanes may crack at the welded joints where the Vanes meet the Plenum Duct Sides.
- (3) Cause: Investigation has identified this noise as emanating from the T.A.I. Outlet Grille.
- (4) Background: Several operators have reported “whistling” noises that are audible in the Aircraft Cabin and cracking of the welded joints at the Duct Vanes.
- (5) Objectives: To remove the “whistling” noise emanating from the T.A.I. Outlet Grill by the introduction of a new T.A.I. Exhaust Access Panel with revised welded vane edges.
- (6) Substantiation: The new T.A.I. Exhaust Access Panel has demonstrated acceptable noise levels during flight test trials.

- (1) Remove 23 off NAS1581C3T7 Bolts to release the 745-3170-501 T.A.I. Exhaust Access Panel. Remove the T.A.I. Exhaust Access Panel from the Nose Cowl. Refer to Figure 1.
- (2) Make a mark of the hole pattern on the new 745-3170-503 (undrilled) T.A.I. Exhaust Access Panel identical to the hole pattern of the attaching locations on the Inlet Cowl (use the removed T.A.I. Exhaust Access Panel as a template).
- (3) Drill 23 off pilot holes 3/32" (2.4 mm) diameter through the 745-3170-503 T.A.I. Exhaust Access Panel.
- (4) Enlarge the pilot holes to 0.2047" +0.003" / -0.000" (5.20 mm +0.0762mm / -0.000mm) diameter on the T.A.I. Exhaust Access Panel.
- (5) Countersink the 23 off holes on the outer surface of the T.A.I. Exhaust Access Panel to suit NAS1581C3T7 Bolts. Remove all burrs from holes.

- (15) Wipe the area with a clean piece of lint free cloth before the solvent dries.
- (16) Remove any unwanted jointing compound.
- (17) Install the 745-3170-503 T.A.I. Exhaust Access Panel with 23-off NAS1581C3T7 Bolts. Torque the bolts to 26 lbin (3.0 Nm).
