V2500-A1 SERIES PROPULSION SYSTEMS SERVICE BULLETIN

V2500-NAC-71-0272
Transmittal - Page 1 of 1

NACELLE – ENGINE BUILD UNIT (EBU) – REPLACEMENT AND REROUTING OF SEVERAL EBU SYSTEMS
TO ACCOMMODATE THE REROUTING OF THE OIL SCAVENGE TUBES

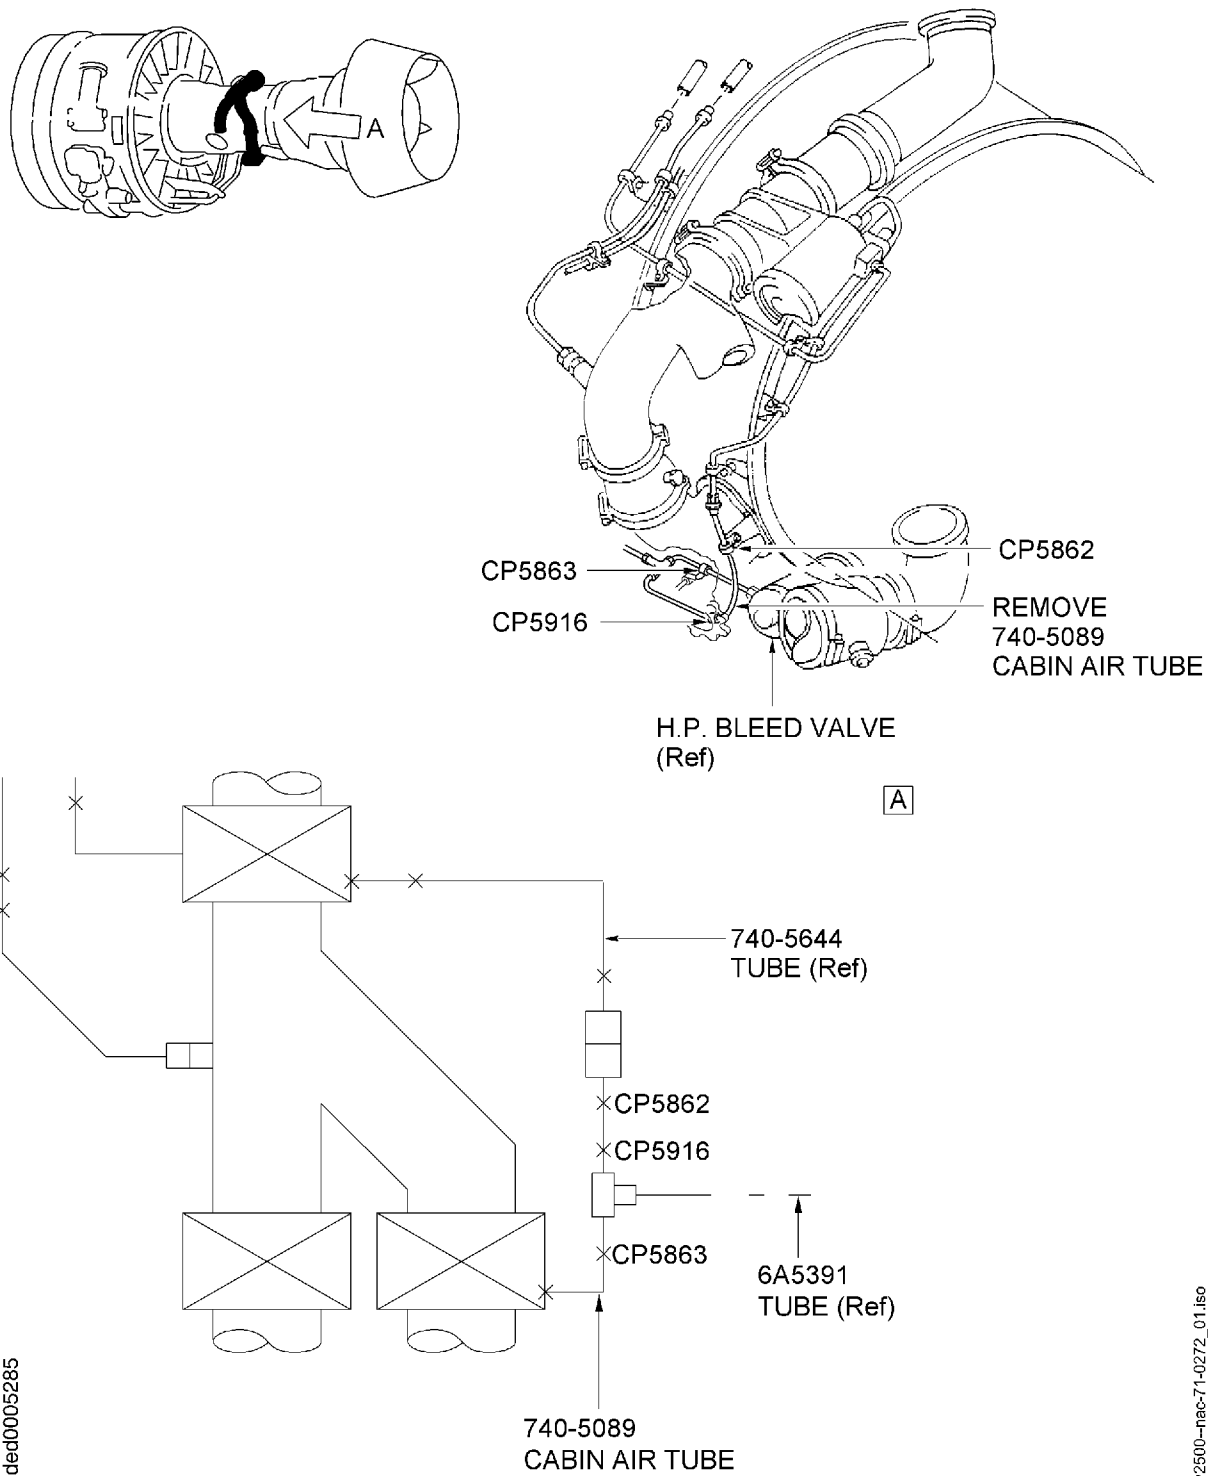
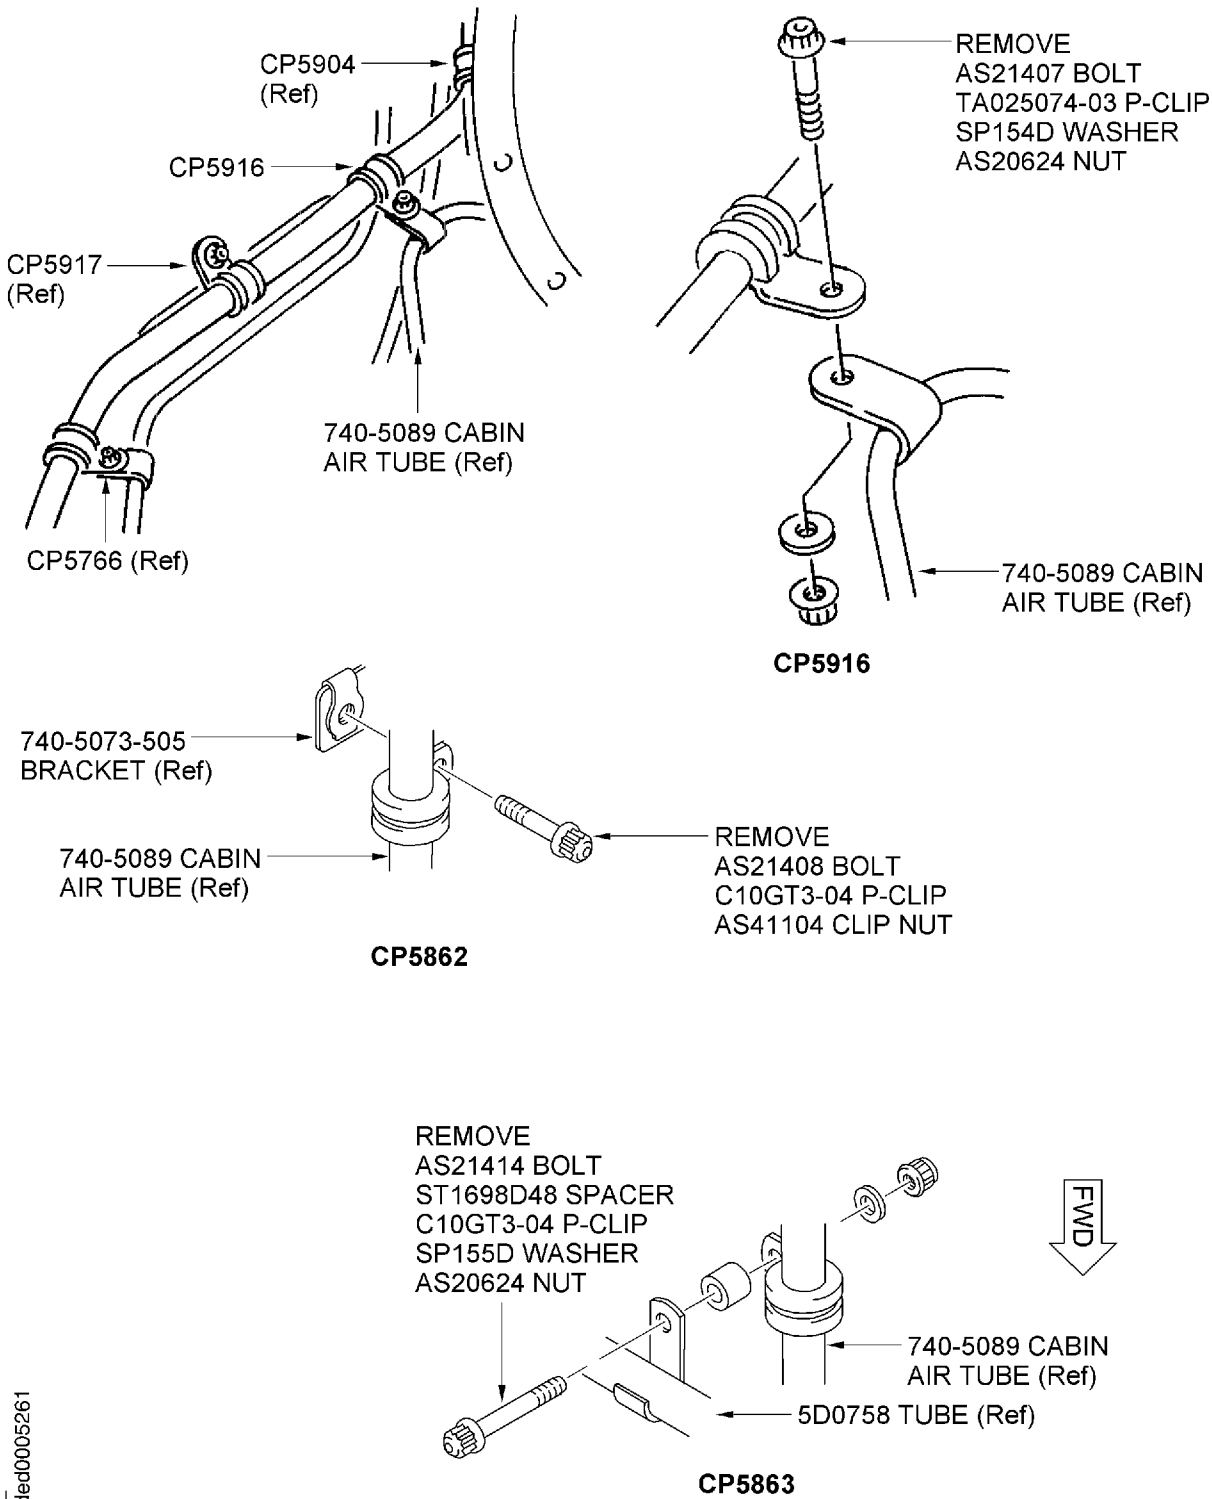
Removal of the Cabin Air Tube
Figure 1 Sheet 1 of 2

(3) Remove the 740-5089 Cabin Air Tube

- (a) Clipping Point CP5916 – Remove the AS20624 Nut, the SP154D Washer, the AS21407 Bolt and the TA025074-03 P-Clip
 - (b) Clipping Point CP5862 – Remove the AS21408 Bolt, the AS41104 Clip Nut and the C10GT3-04 P-Clip
 - (c) Clipping Point CP5863 – Remove the AS20624 Nut, the SP155D Washer, the ST1698D48 Spacer, the AS21414 Bolt and the C10GT3-04 P-Clip.
 - (d) Cut and safety the Lockwire which safeties the Tube Connections.
 - (e) Disconnect the 6A5391 Tube from the 740-5089 Cabin Air Tube.
 - (f) Disconnect the 740-5089 Cabin Air Tube from the 740-5644 Tube.
 - (g) Disconnect the 740-5089 Cabin Air Tube from the High Pressure Bleed Valve.
 - (h) Remove the 740-5089 Cabin Air Tube from the Nacelle.
- (4) Remove the 7702-01 or 7702-02 Fire Detector

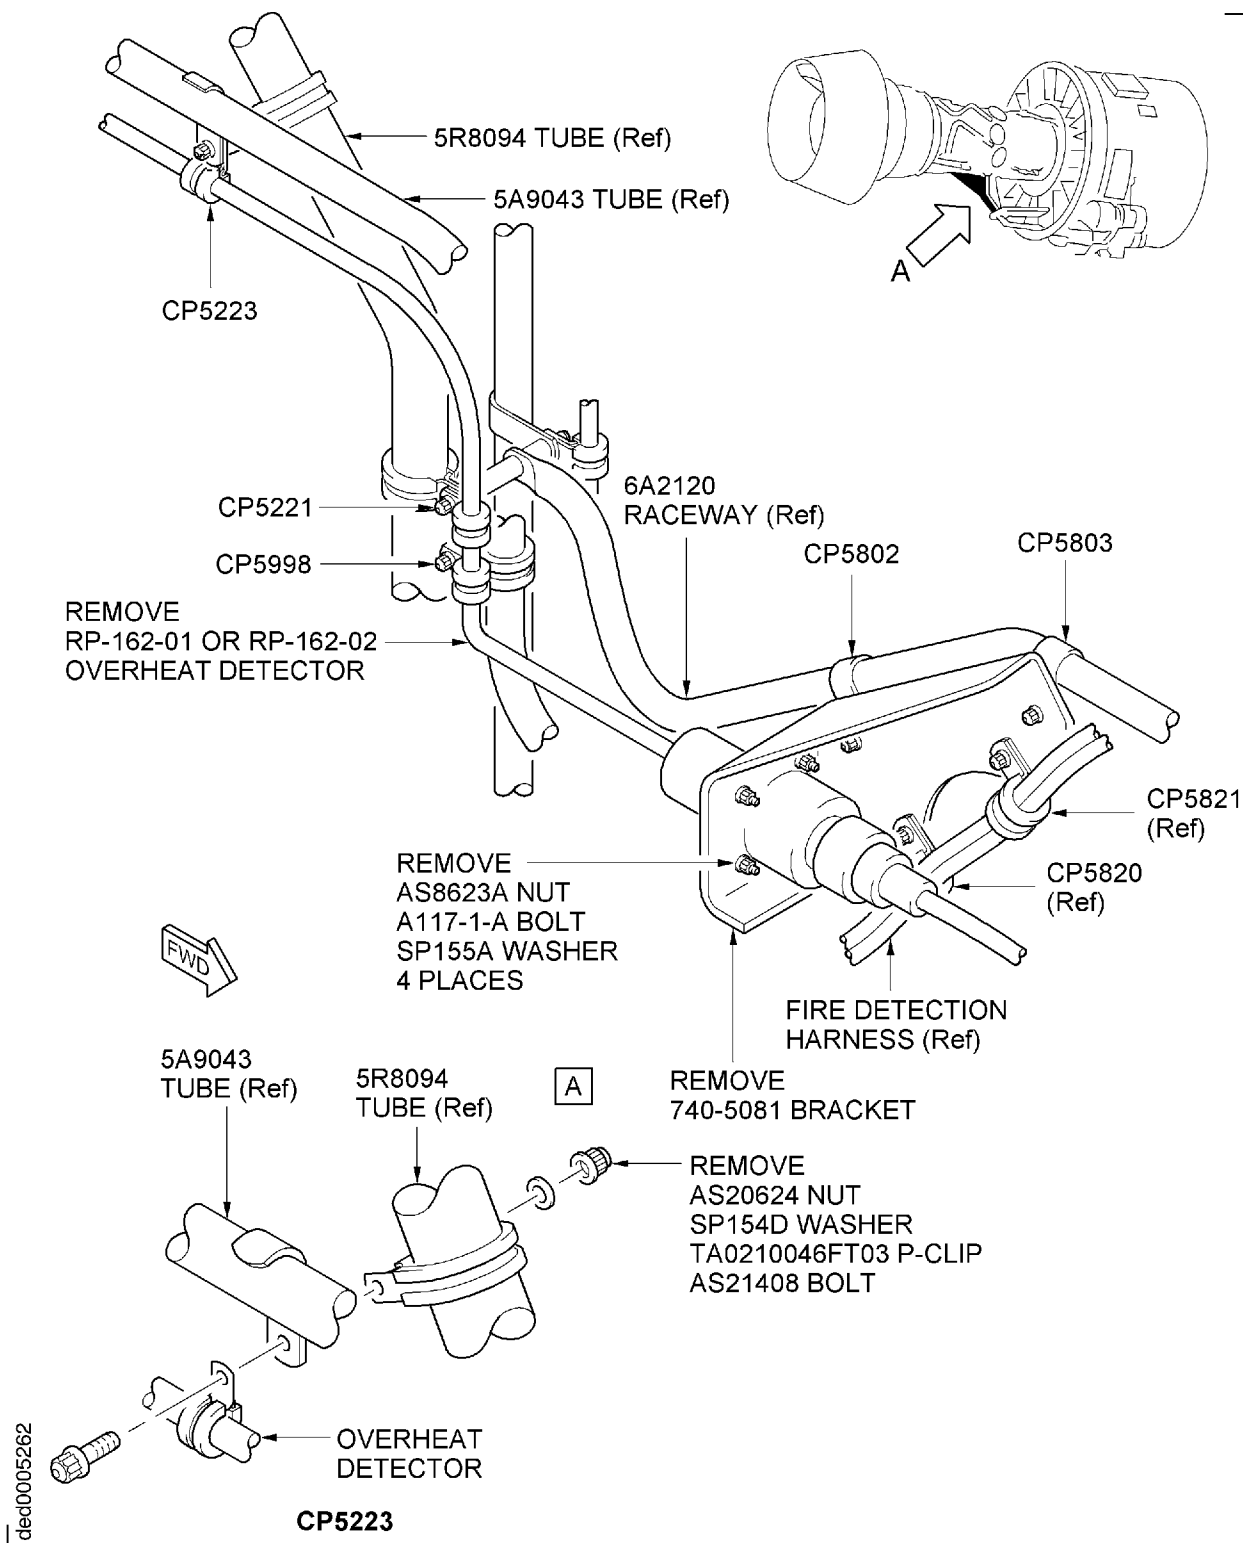
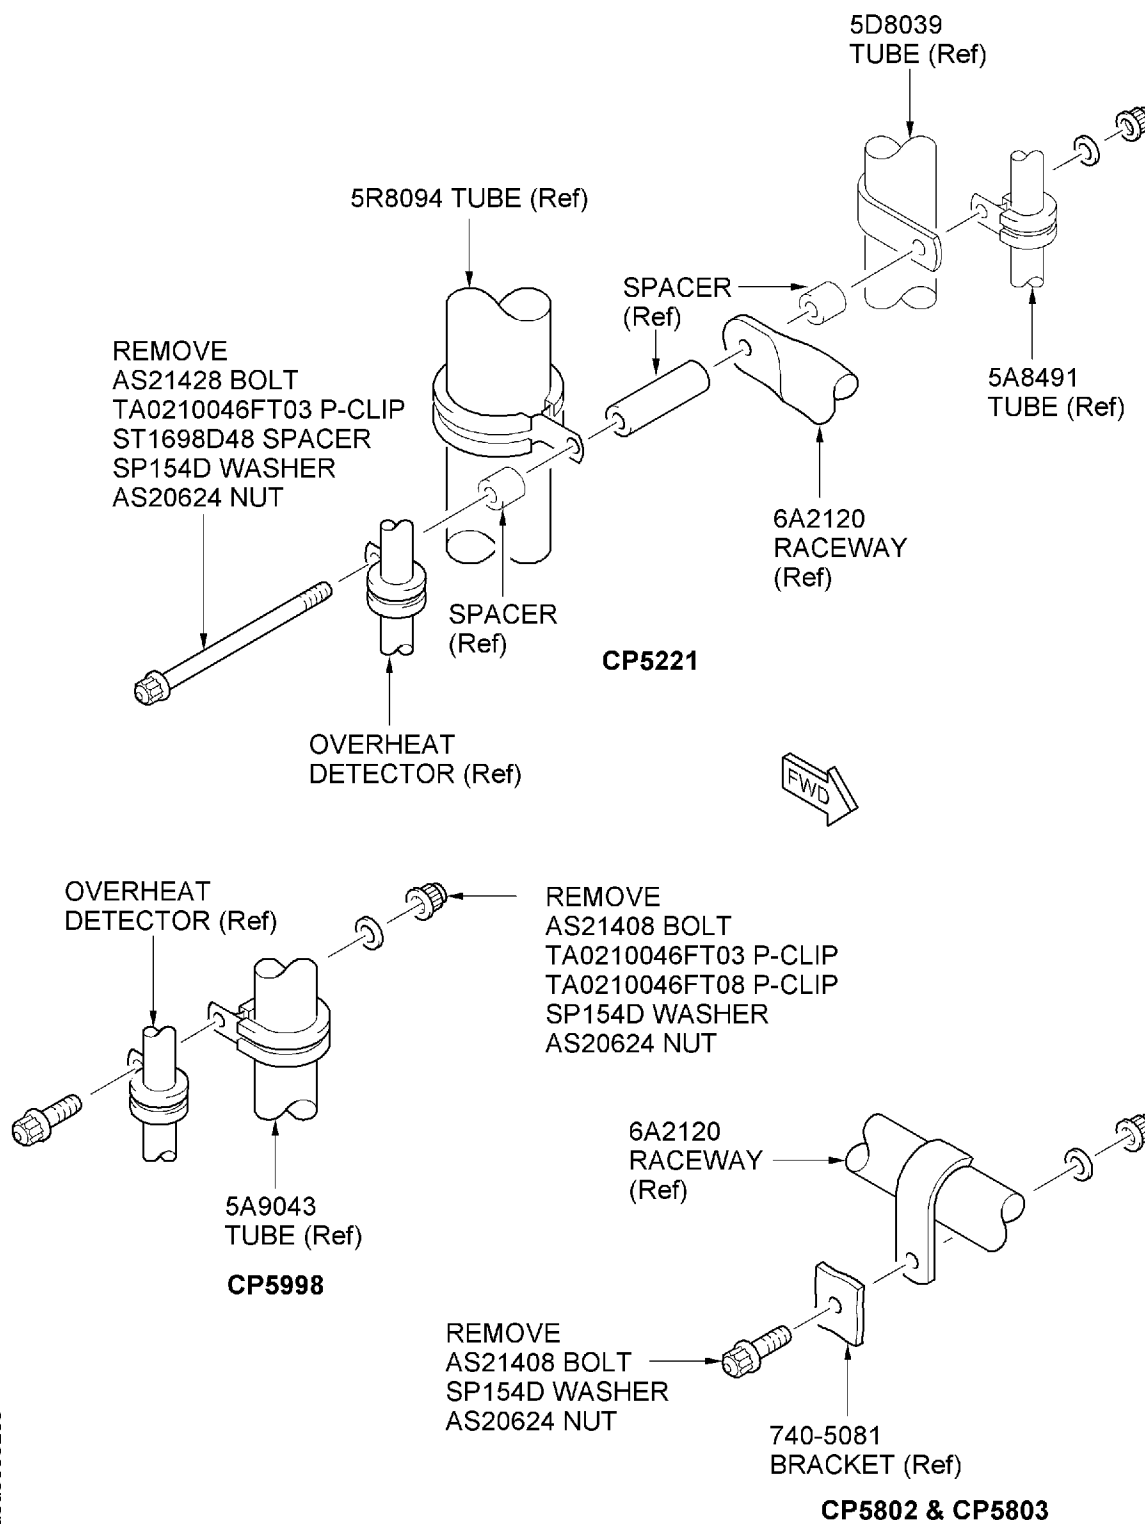
Removal of the Overheat Detector and Bracket
Figure 2 Sheet 1 of 2

PROCEDURE	RELATED DATA
(a) Clipping Point CP5223 - Remove the AS20624 Nut, the SP154D Washer, the AS21408 Bolt and the TA0210046FT03 P-Clip	Refer to Figure 2.
(b) Clipping Point CP5221 - Remove the AS20624 Nut, the SP154D Washer, the ST1698D48 Spacer, the AS21428 Bolt and the TA0210046FT03 P-Clip.	
(c) Remove the four AS8623A Nuts, the four SP155A Washers and the four A117-1-A Bolts to release the RP162-01 Overheat Detector from the 740-5081 Bracket.	
(d) Remove the RP162-01 Overheat Detector from the Nacelle.

- (a) Clipping Points CP5802 and CP5803 – Remove the AS20624 Nut, the SP154D Washer and the AS21408 Bolt to release the 740-5081 Bracket from the 6A2120 Raceway. Refer to Figure 2.
- (b) Remove the 740-5081 Overheat Detector Bracket from the Nacelle.
- (9) Partial removal of the 7827-02 Core Fire Detector

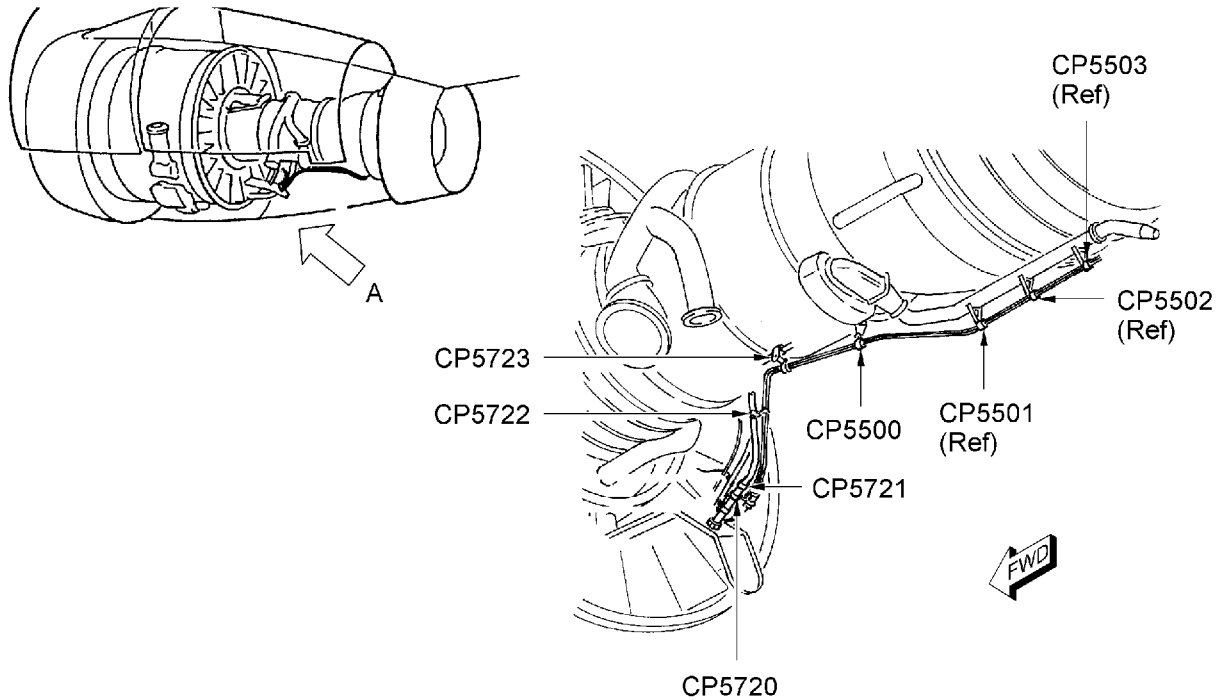
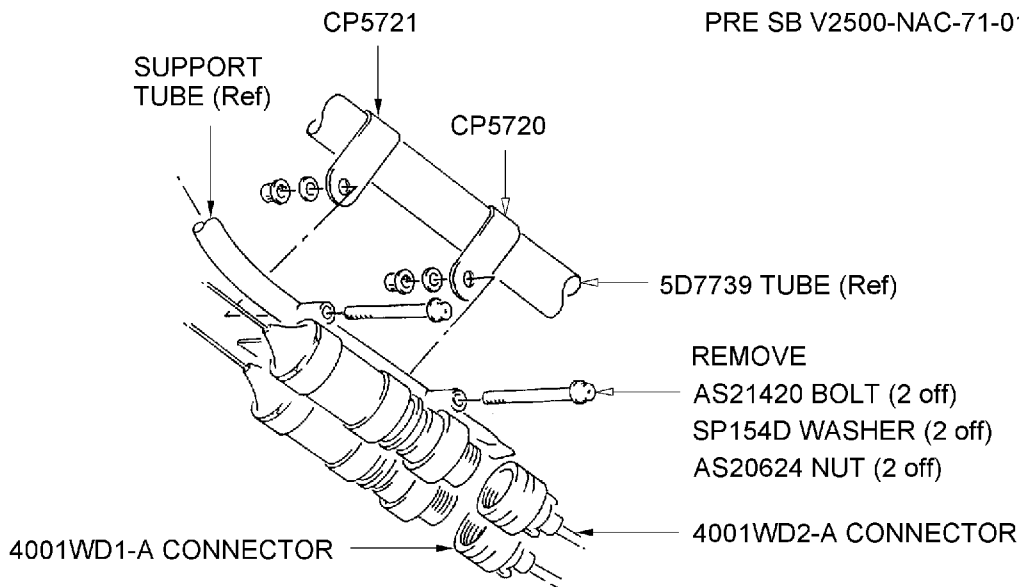
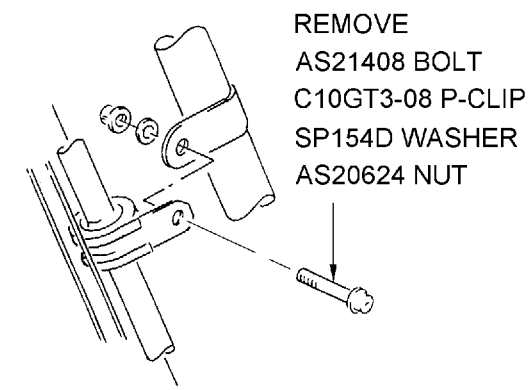
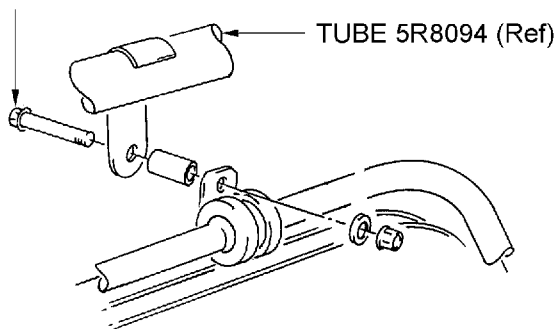
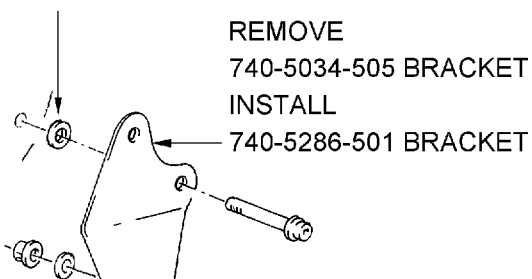
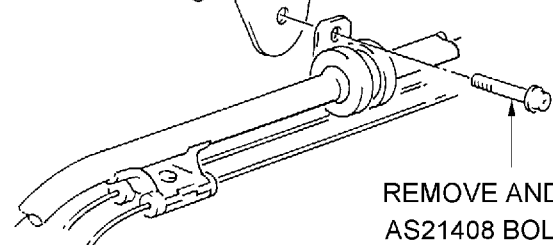
Removal of the Core Fire Detector
Figure 3 Sheet 1 of 2

- (a) CP5720 and CP5721 – Remove the AS20624 Nut, the SP154D Washer and the AS21420 Bolt Refer to Figure 3.
- (b) CP5722 – Remove the AS20624 Nut, the SP154D Washer, the AS21408 Bolt and the C10GT3-08 P-Clip
- (c) CP5723 – Remove the AS20624 Nut, the SP154D Washer, the ST1698D50 Spacer, the AS21408 Bolt and the C10GT3-08 P-Clip

(d) CP5500 – Remove the AS20624 Nut, the SP154D Washer and the AS21408 Bolt

(e) CP5501, CP5502 and CP5503 – Loosen the AS21408 Bolts to allow the Fire Detector to move freely.

(f) Remove the two 4W0167 Bolts and the two SP123E Washers to release the 740-5034-505 Bracket from the Engine. Retain the Bolts and Washers

(g) Install the 740-5286-501 Bracket to the Engine with the two SP123E Washers and the two 4W0167 Bolts

(h) CP5500 – Install the Fire Detector to the 740-5286-501 Bracket with the AS21408 Bolt, the SP154D Washer and the AS20624 Nut.

(i) Torque the 4W0167 Bolts to 75 – 85 lbfin (8,5 – 9,5 Nm)

(j) CP5500, CP5501, CP5502 and CP5503 – Torque the AS20624 Nuts to 36 – 45 lbfin (4 – 5 Nm)

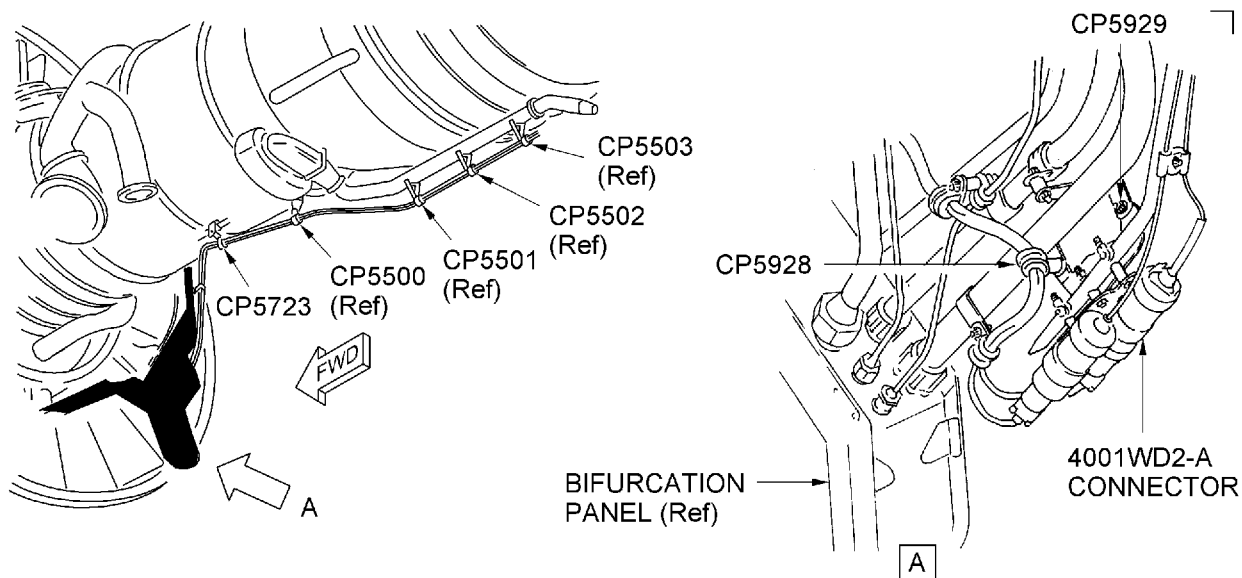
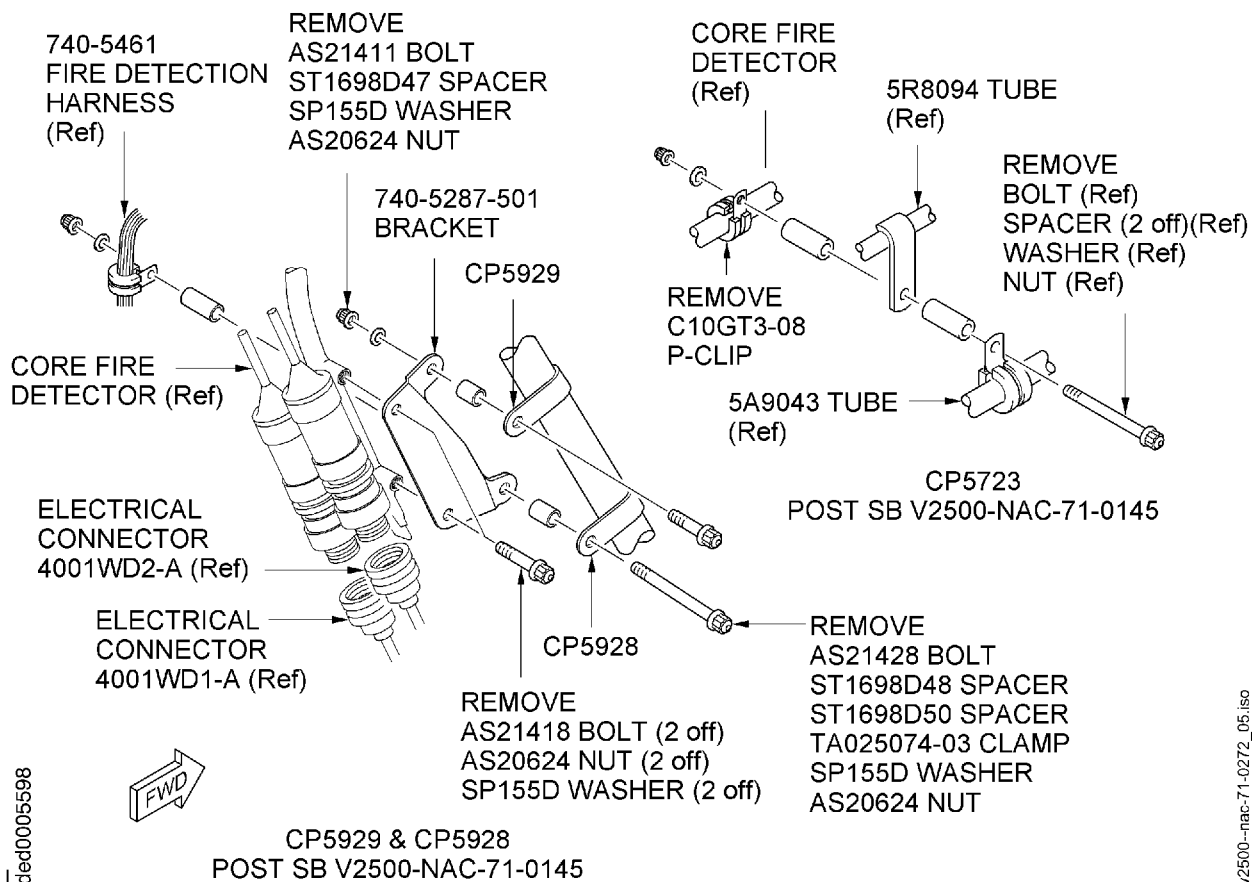
Removal of the Core Fire Detector
Figure 4

(a) Remove the two AS20624 Nuts, the two SP155D Washers and the two AS21418 Bolts to release the Fire Detector Responders from the 740-5287-501 Fire Detector Bracket. Retain the Bolts and Washers.

- (b) Clipping Point CP5928 – Remove the AS20624 Nut, the SP155D Washer, the ST1698D48 Spacer, the ST1698D50 Spacer, the AS21428 Bolt and the TA025074-03 P-Clip.
 - (c) Clipping Point CP5929 – Remove the AS20624 Nut, the SP155D Washer, the ST1698D47 Spacer and the AS21411 Bolt to release the 740-5287-501 Fire Detector Bracket from the 6A5367 Pipe.
 - (d) Remove the 740-5287-501 Fire Detector Bracket from the Nacelle.
 - (e) At Clipping Point CP5723 remove the C10GT3-08 P-Clip.
- (11) Install the 740-5089-507 Cabin Air Tube
