V2500-A1/A5 SERIES NACELLE SERVICE BULLETIN

V2500-NAC-71-0277

NACELLE – POWERPLANT – NOSECOWL – REPLACEMENT OF THE HOIST POINT BLANKING PLUGS

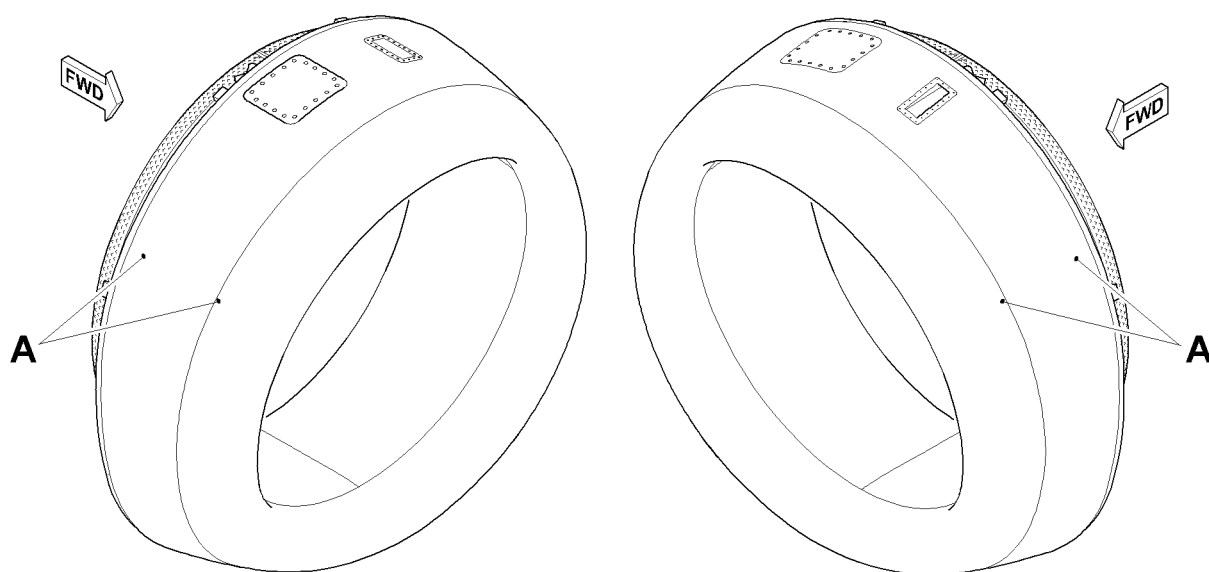
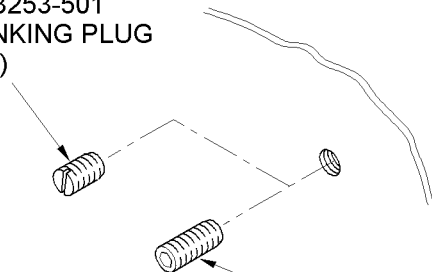
Removal of the Nosecowl – Hoist Point Blanking Plugs
Figure 1

| <p>(a) Identify the four old 740-3253-501 Blanking Plugs in their respective locations on the Nosecowl.</p> | <p>The Blanking Plugs are located on the Nosecowl looking Aft in the 2 o'clock and 10 o'clock positions. Refer to Figure 1.</p> |

REMOVE
740-3253-501
BLANKING PLUG
(4 off)

(e) Install four new AN565AC624H16 Blanking Plugs in place of the four old 740-3253-501 Blanking Plugs on the Nosecowl.

INSTALL
AN565AC624H16
BLANKING PLUG
(4 off)
