## V2500-A1/A5 SERIES PROPULSION SYSTEMS SERVICE BULLETIN

# V2500-NAC-71-0280

NACELLE – POWER PLANT – BEARING ASSEMBLY, FORWARD ENGINE MOUNT – REPLACEMENT OF SNOOT  
BEARING BALL

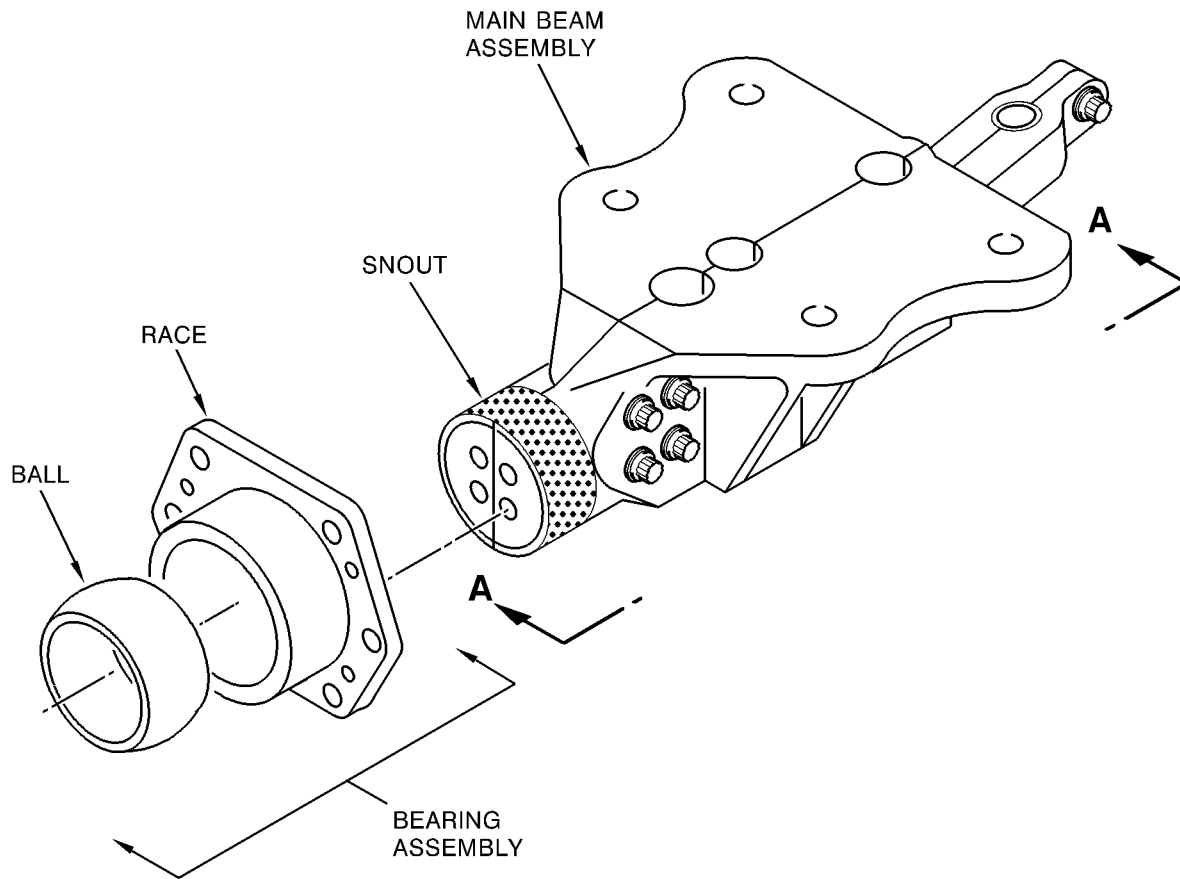
Forward Engine Mount Assembly Re-work  
Figure 1 (sheet 1)

Operators have found galling between the forward engine mount snout and the inner surface of the bearing assembly ball.

Galling can occur between the forward engine mount snout and the inner surface of the bearing assembly ball.

- (7) Measure the minimum diameter of the main beam assembly snout. Refer to Figure 1.
- (a) If the minimum snout diameter, dimension "X", is 2.119-2.1245 inch (53,82-53,96 mm) do Parts 3, 4, and 5 of this Service Bulletin.

- (3) Machine the main beam assembly snout to a diameter, dimension "X", of 2.0985–2.0995 inch (53,30–53,33 mm). Refer to Figure 1.
- (4) Blend mismatch of machine cuts to a 10:1 ratio without making the cuts deeper. – Finish the surface to 32/RMS.
- (5) Measure the minimum diameter of the main beam assembly snout. The diameter, dimension "X", must be 2.0985–2.0995 inch (53,30–53,33 mm). If the minimum diameter is less than 2.0985 inch (53,30 mm), you must replace the main beam assembly with a new 740–2011–505 main beam assembly.
