International Aero Engines

V2500 Propulsion System - Nacelle

SERVICE BULLETIN

SUBJECT: NOSE COWL - REPLACEMENT OF LIPSKIN ATTACH RIVETS

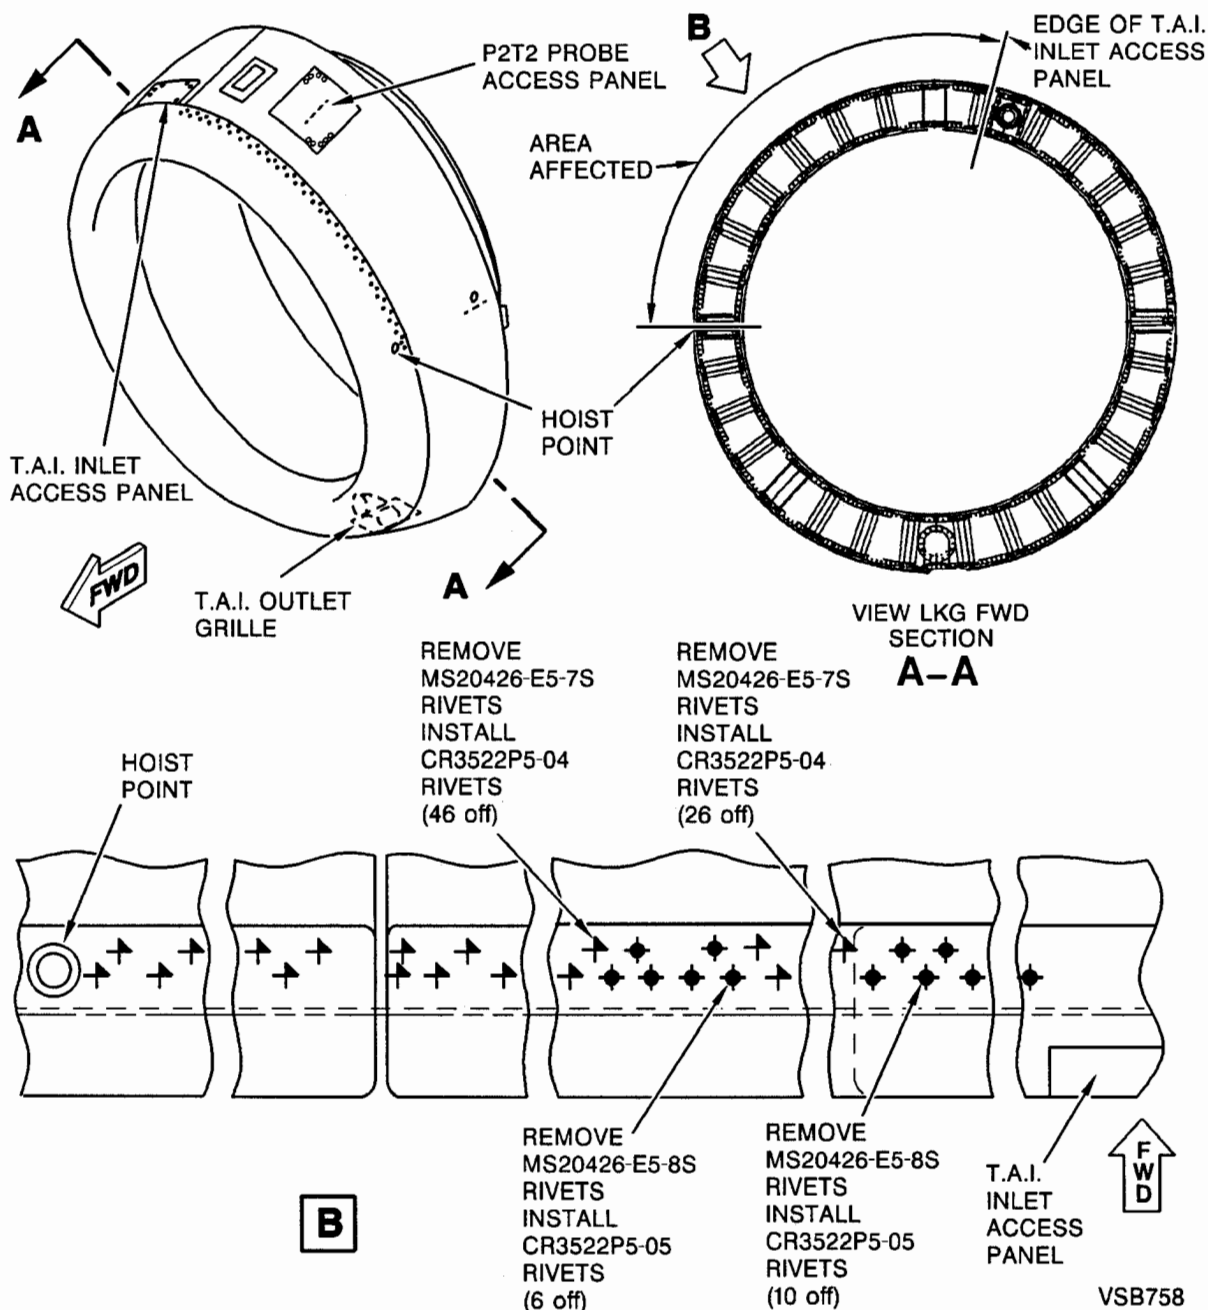
Nose Cowl Rivet Replacement
Figure 1

B. Replace the nose cowl lipskin attach rivets. Refer to Figure 1.

- (1) Remove the 88 existing lip skin attach rivets between the edge of the T.A.I inlet access panel and the first hoist point. Do not remove all of the rivets at the same time. Refer to Figure 1. Do not damage the rivet holes.
- (2) Examine the rivet holes. Make any damaged holes larger. Refer to Figure 2 for oversize limits. Countersink the holes that you make larger 100 degrees.
- (3) Remove the rivet and drilling pieces from the nose cowl. Remove and install access panels as necessary.

(7) Wet install the rivets with primer mix. Refer to Figure 1.
