V2500-A1 SERIES PROPULSION SYSTEM SERVICE BULLETIN

V2500-NAC-71-0292
Transmittal - Page 1 of 2

NACELLE – POWERPLANT – COWL, AIR INTAKE – REPLACEMENT OF THE P2T2 MOUNTING BRACKET
ASSEMBLY AND SEALING BLOCK

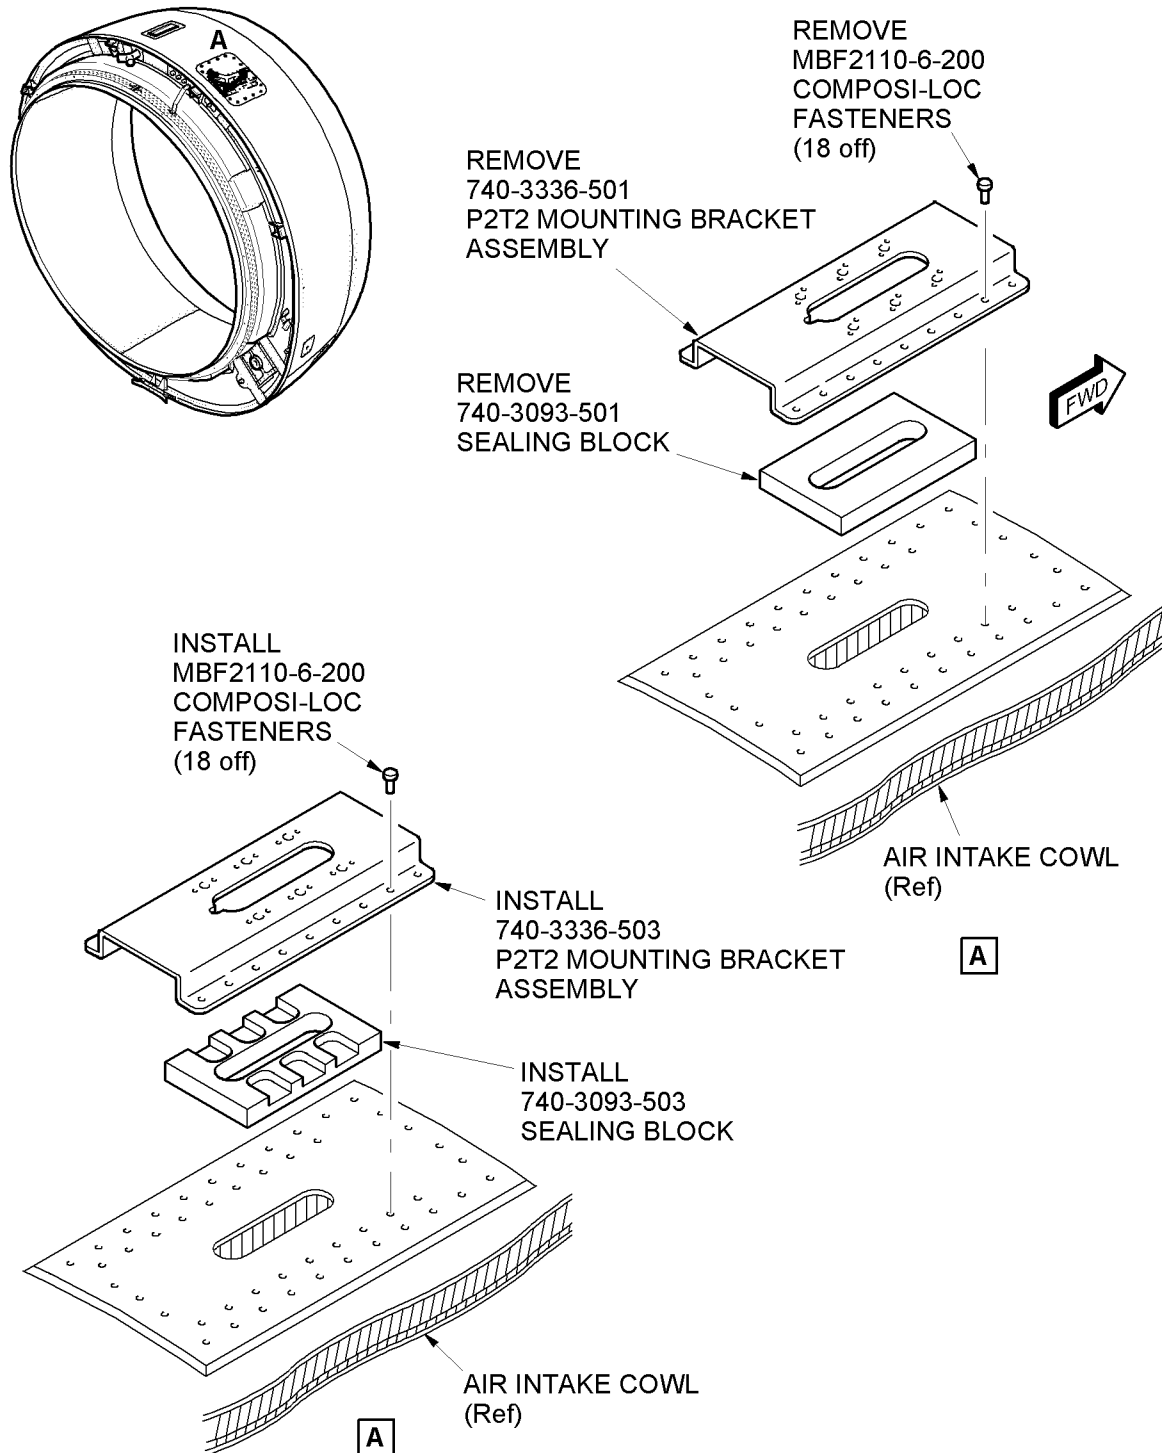
Replacement of the P2T2 Mounting Bracket Assembly and Sealing Block
Figure 1

Several 'hybrid' Air Intake Cowls, used by Indian Airlines, have shown signs of wear and cracking of the P2T2 Mounting Bracket Assemblies.

- (a) Carefully remove the 18 MBF2110-6-200 Composi-loc fasteners to release the 740-3336-501 P2T2 Mounting Bracket Assembly and the 740-3093-501 Sealing Block from the Air Intake Cowl. Refer to Figure 1.
- (b) Remove the 740-3336-501 P2T2 Mounting Bracket Assembly and the 740-3093-501 Sealing Block from the Air Intake Cowl.

- (c) Remove the inboard flange from the old 740-3336-501 P2T2 Mounting Bracket Assembly and firmly secure to the inboard flange of the new 740-3336-503 P2T2 Mounting Bracket Assembly. Make sure that the flange edges are flush.

- (d) Remove the outboard flange from the old 740-3336-501 P2T2 Mounting Bracket Assembly and firmly secure to the outboard flange of the new 740-3336-503 P2T2 Mounting Bracket Assembly. Make sure that the flange edges are flush.

- (e) Drill 18 3/32 in. (2,40 mm) pilot sized holes from the old flanges into the 740-3336-503 P2T2 Mounting Bracket Assembly.
- (f) Progressively increase the size of the 18 holes to 0.193 0.197 in. (4,90 5,00 mm).

- (l) Use CoMat 04-005 Jointing Compound as a faying surface between the Mounting Bracket Assembly, the Sealing Block and the Air Intake Cowl and install the 740-3093-503 Sealing Block and the 740-3336-503 P2T2 Mounting Bracket Assembly to the Air Intake Cowl with the 18 MBF2110-6-200 Composi-loc fasteners. Refer to IAE/V2500 Standard Practices/Processes Manual, Chapter 70-36-02.
