V2500-A1/A5 SERIES PROPULSION SYSTEMS SERVICE BULLETIN

V2500-NAC-71-0293

NACELLE – POWERPLANT – FAN COWL DOOR – REWORK OF THE UPPER LOCATOR

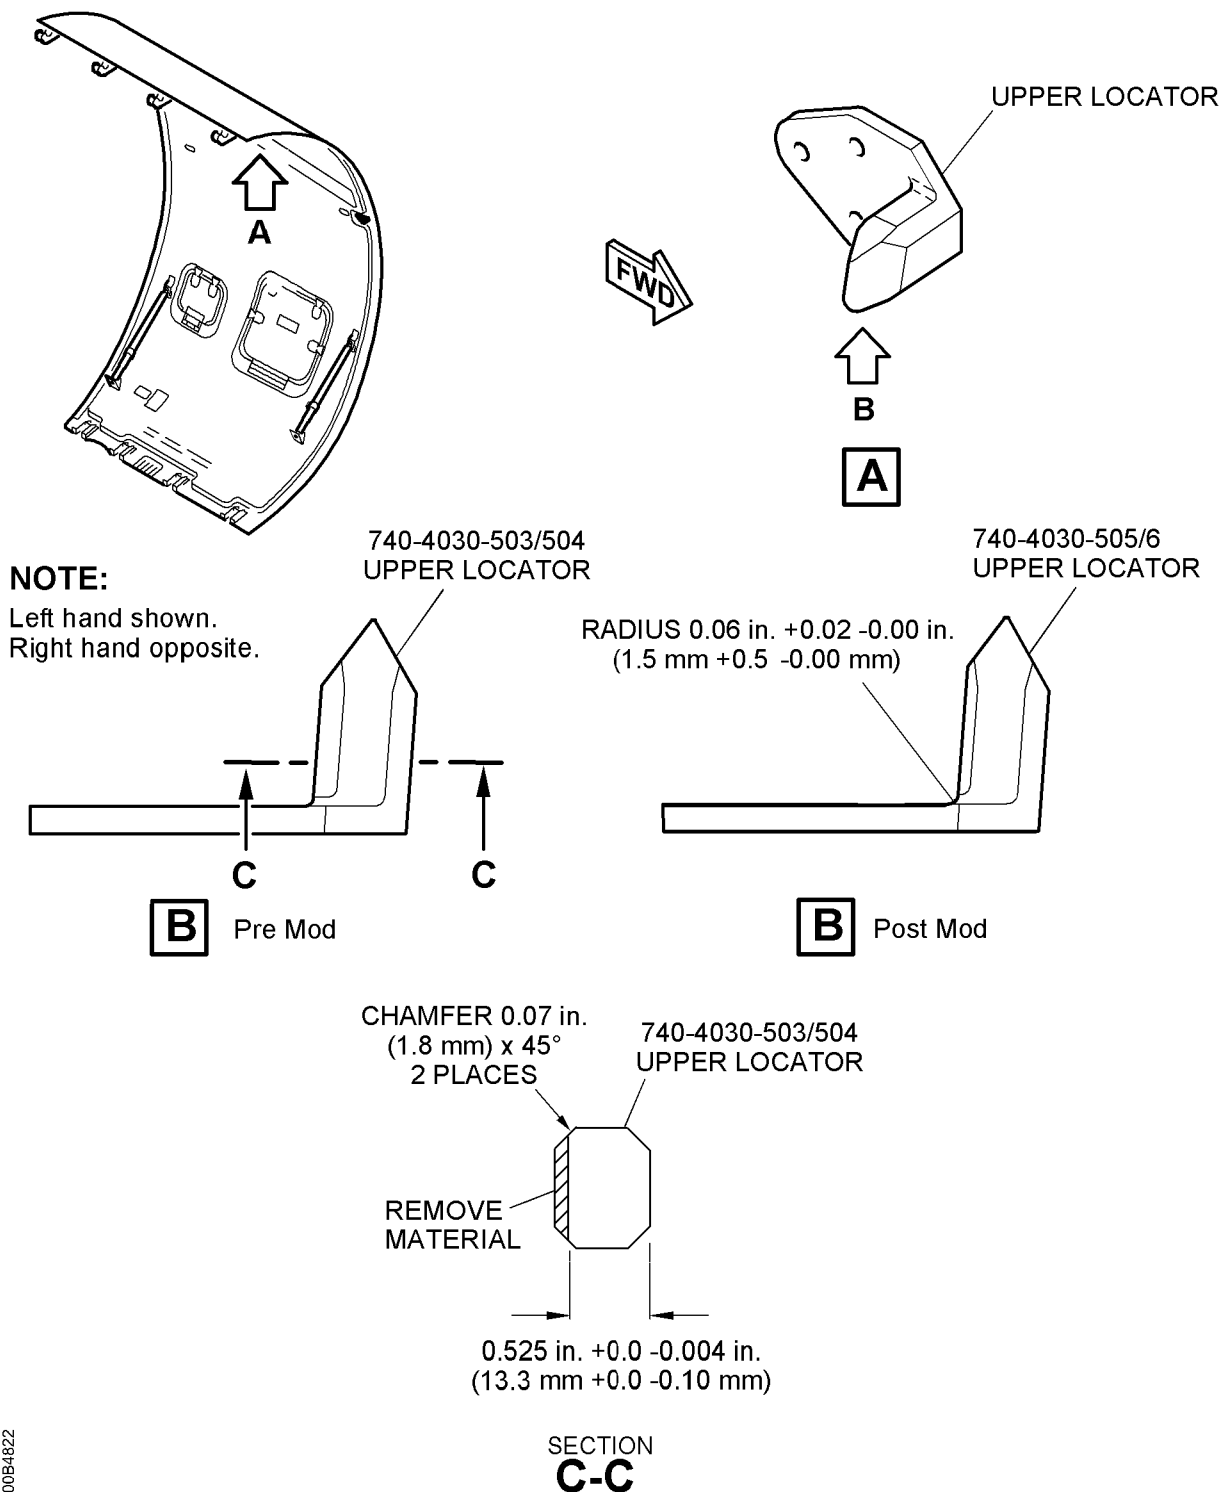
Rework of the Fan Cowl Door Upper Locator
Figure 1

On some Nacelles the 'into-wind' step between the Nose Cowl and the Fan Cowl Doors may not be within the design specification.

This modification has been successfully carried out under concessionary cover. Additionally, stress substantiation demonstrates that the removal of material from the aft face of the upper-locator is acceptable to alleviate the condition.

- (1) Find the 740-4030-503/504 upper Locator on the Fan Cowl Door. Refer to Figure 1.

- A line of the new aft edge 0.525 in. +0.0 -0.004 in. (13,3 mm +0 -0.1 mm) from the forward edge.

- Two new corner chamfers 0.07 in. (0,18 mm) x 45 Deg.

- (3) Carefully remove the material from the Locator to suit new spigot profile. Make sure that you blend the new spigot profile at the base of the locator with radius 0.06 in. +0.02 -0.00 in. (1,5 mm +0,5 -0,0 mm). Refer to Figure 1, view B 'Post Mod'.
- (4) Deburr the cut metal edges.
