## V2500-A1/A5 SERIES PROPULSION SYSTEM NON-MODIFICATION SERVICE BULLETIN

This document transmits the Revision 1 of Non-Modification Service Bulletin V2500-NAC-71-0298

NON-MODIFICATION SERVICE BULLETIN – NACELLE – FORWARD AND AFT ENGINE MOUNT ASSEMBLIES  
– BOLT IDENTIFICATION

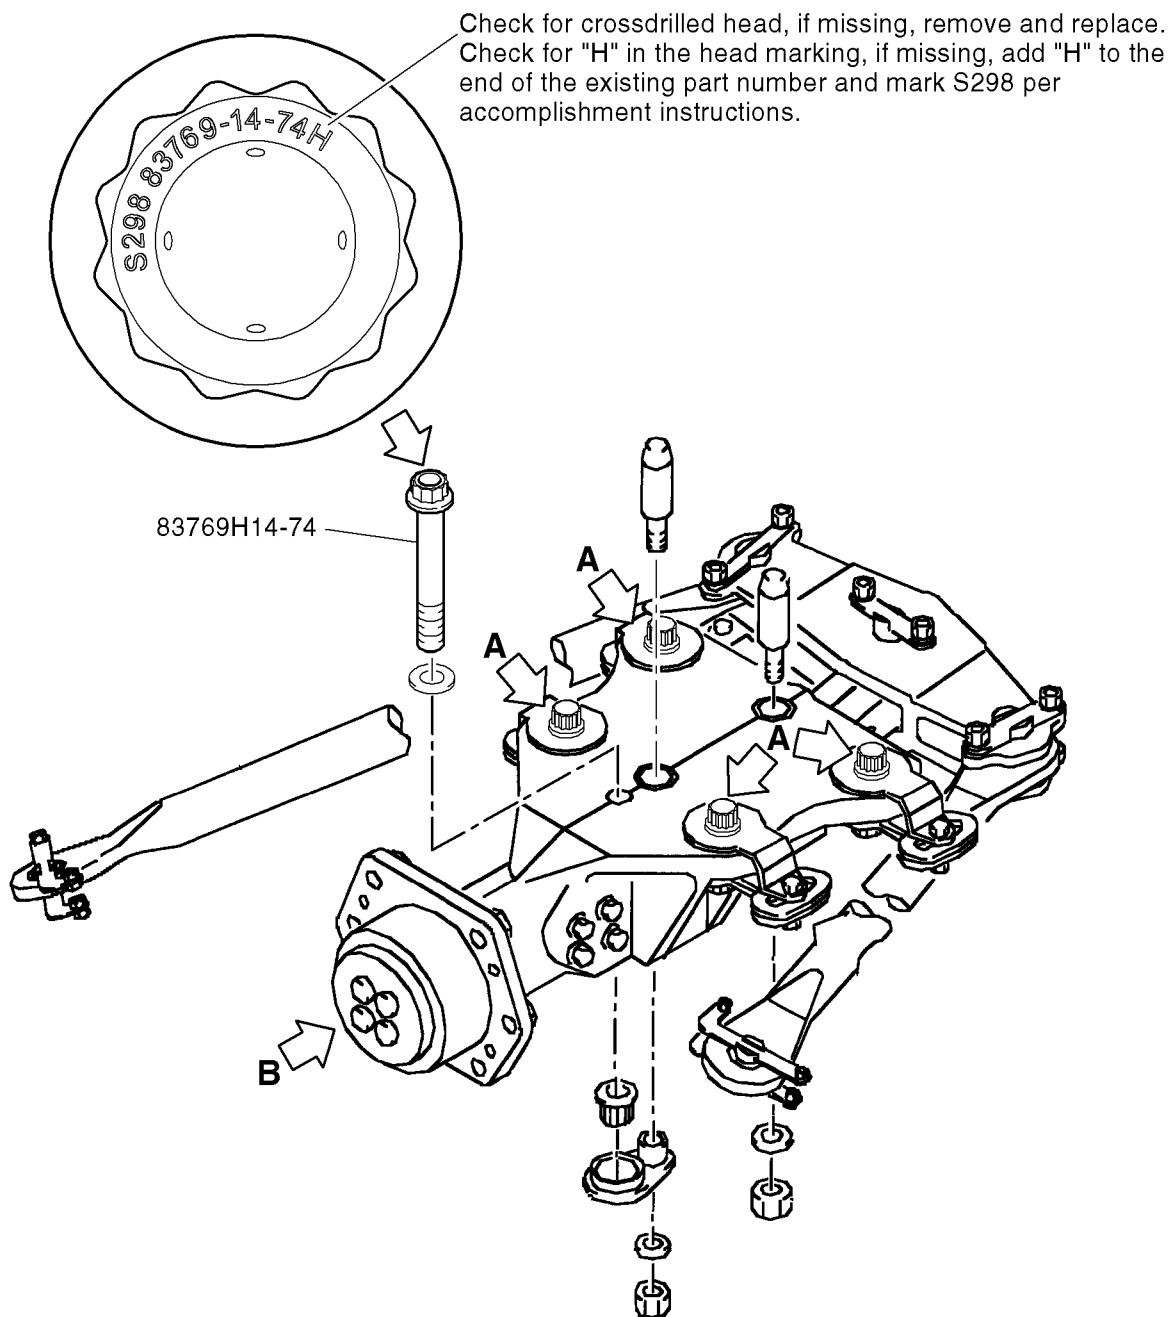
Forward Mount Assembly  
Figure 1 (Sheet 1 of 2)

- C. To be completed at next engine shop visit.
- (1) Refer to Table 1 and Figures 1 and 2 to locate affected bolts.
  - (2) Inspect the bolts per CMM 71-21-12-200-001 item 12.

- (4) If part number is incomplete, verify that the head is crossdrilled, if missing, remove and replace the bolt. If the head is crossdrilled, remove bolt and electroetch the required part number on the bolt head at a depth of 0.010 in max. Refer to the IAE V2500 Standard Practices/Processes Manual, Chapter 70-09-00.

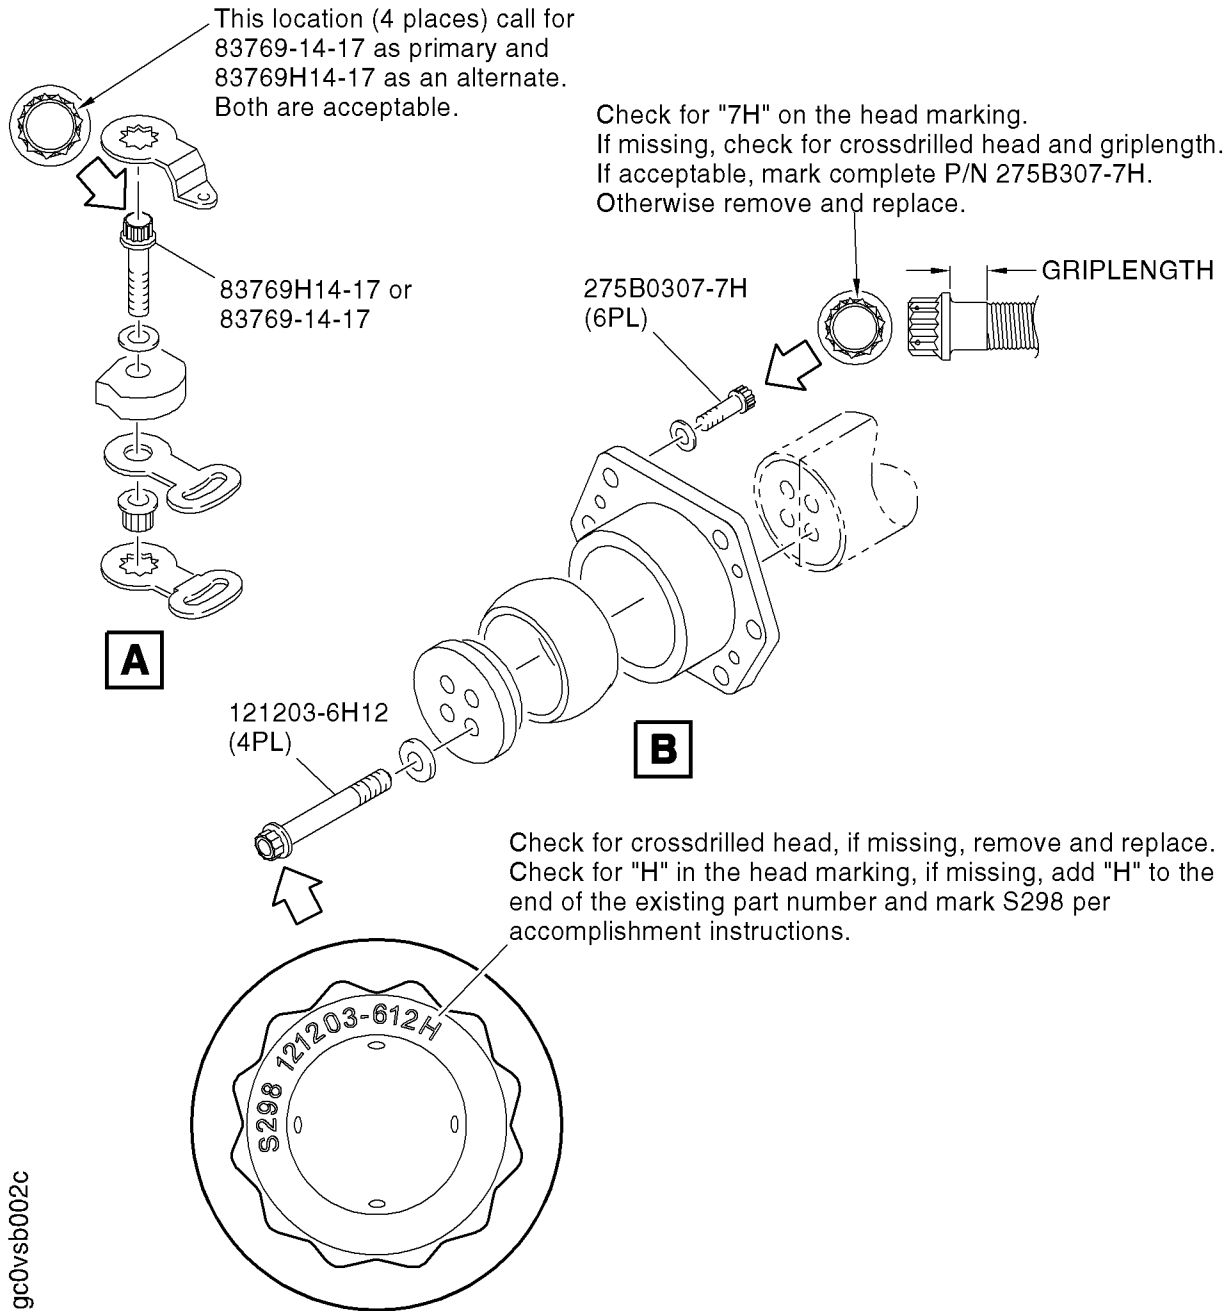
Forward Mont Assembly  
Figure 1 (Sheet 2 of 2)

If the '7' in the suffix is not stamped on the bolt head, remove bolt and measure grip length to ensure it is 0.4375 in +/- 0.010 in or 11.1 mm +/- 0.3 mm. Refer to Figure 1 Sheet 2 to measure griplength. If the length does not meet the requirements, replace bolts per AMM 71-21-12-410-064.
