V2500-A1/A5 SERIES PROPULSION SYSTEM NON-MODIFICATION SERVICE BULLETIN

This document transmits the Initial Issue of Non-Modification Service Bulletin
V2500-NAC-71-0305

NON-MODIFICATION SERVICE BULLETIN – NACELLE – FORWARD ENGINE MOUNT – BOLT PART
NUMBER, INSPECTION OF

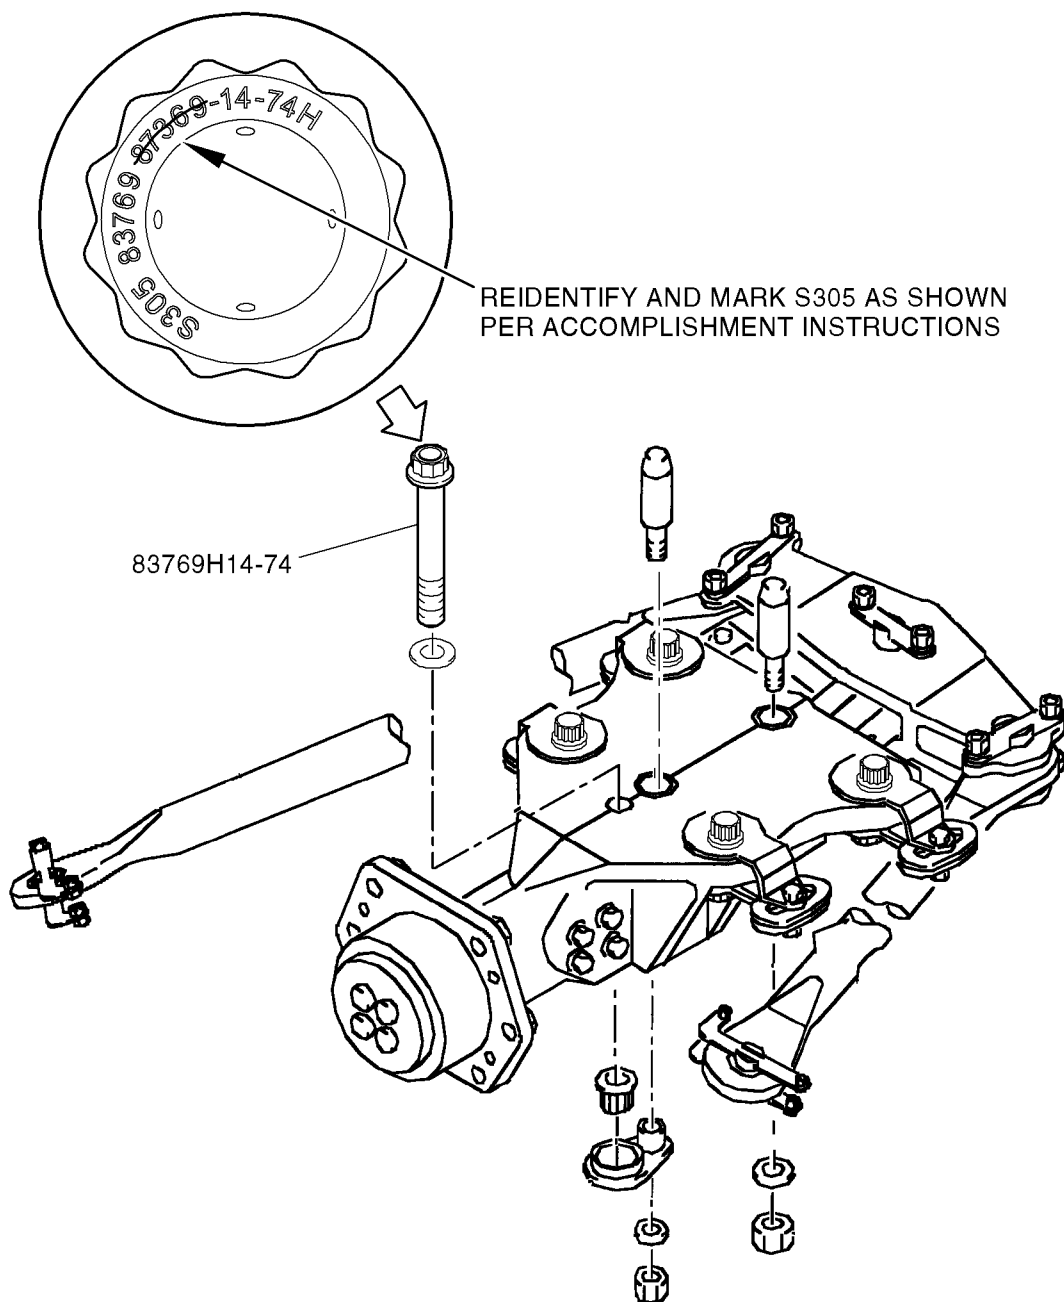
Forward Engine Mount Assembly
Figure 1

The supplier for the engine mount bolt in question inadvertently transposed two digits of the part number. The error is limited to a lot of 27 bolts and is the only deviation from the part specification.

- (1) Refer to Figure 1 to locate affected bolts.
 - (2) Inspect the bolts per CMM 71-21-12-200-001 item 12.
 - (3) Refer to Table 1 to confirm any action required based on the part number stamped on the bolt head.

- (4) To correct a bolt with transposed numbers, electroetch the correct basic part number "83769-" immediately preceding the existing incorrect "87369" number. Use the electroetch to cross out the existing "87369" on the bolt head. Mark bolt head at a depth of 0.010 in max. Refer to IAE V2500 Standard Practices/Processes Manual, Chapter 70-09-00. See Figure 1 for clarification.

- (5) Add the "H" designator immediately subsequent to the existing part number. Mark bolt head at a depth of 0.010 in max. Refer to the IAE V2500 Standard Practices/Processes Manual, Chapter 70-09-00. See Figure 1 for clarification.

- (6) To mark that Service Bulletin 71-0305 has been accomplished, electroetch "S305" on the bolt head. Mark bolt head at a depth of 0.010 in max. Refer to the IAE V2500 Standard Practices/Processes Manual, Chapter 70-09-00.

CAUTION: DO NOT USE METAL STAMP OR VIBROETCH ON ENGINE MOUNT BOLTS.
