## V2500-A1/A5 SERIES PROPULSION SYSTEMS SERVICE BULLETIN

# V2500-NAC-71-0306

NACELLE – POWER PLANT – REPLACEMENT OF THE FAN COWL DOOR CORNER PIECES**1. Planning Information****A. Effectivity****(1) Airplane:**

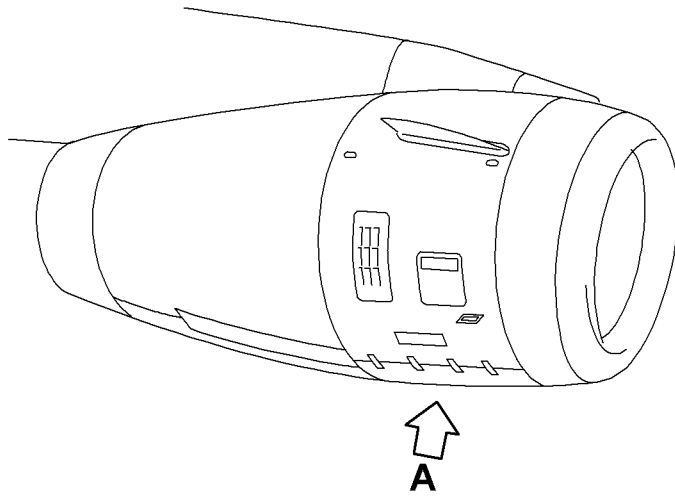
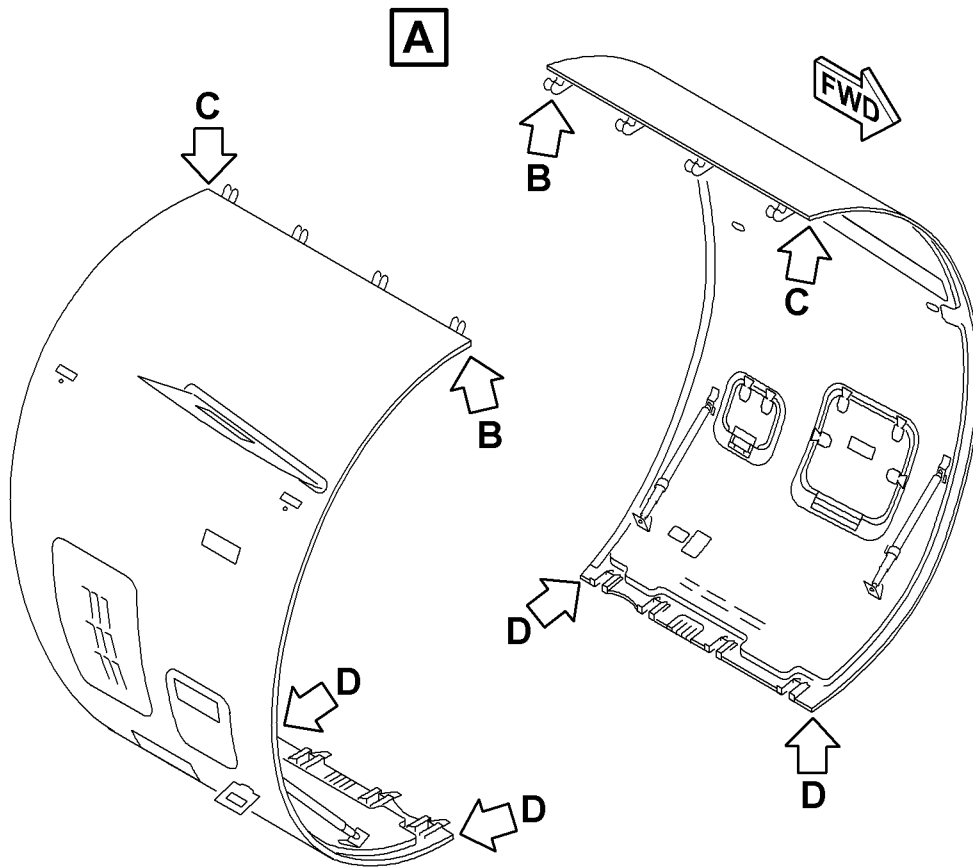
Replacement of the Fan Cowl Door Corner Pieces  
Figure 1 sheet 1

The Fan Cowl Door Corner Pieces are attached to the Fan Cowl Door by way of titanium rivets. The titanium rivet heads may make contact with the aluminium Capping Straps on the Inlet Cowl and cause excessive wear.

Airlines have experienced excessive wear of the Inlet Cowl Capping Straps in way of the upper and lower Fan Cowl Door Corner Pieces.

- (1) At four locations, carefully drill out the five rivets, P/N CSR904B4-5 to release the Corner Piece, P/N 740-4019 from the left hand Fan Cowl Door. Refer to Figure 1.
- (2) Remove the four Corner Pieces, P/N 740-4019 from the Fan Cowl Door.
- (3) At four locations, carefully drill out the five rivets, P/N CSR904B4-5 to release the Corner Piece, P/N 740-4019 from the right hand Fan Cowl Door.
- (4) Remove the four Corner Pieces, P/N 740-4019 from the Fan Cowl Door.
- (5) On the left hand Fan Cowl Door do the steps that follow.
