V2500-A1/A5 SERIES PROPULSION SYSTEMS NON-MODIFICATION SERVICE BULLETIN

This document transmits Revision 2 to Non-Modification Service Bulletin
V2500-NAC-71-0308

NON-MODIFICATION SERVICE BULLETIN – NACELLE – FAN COWL – INSPECTION FOR FAN COWL
DISBOND (FOR CONTROLLED SERVICE USE)

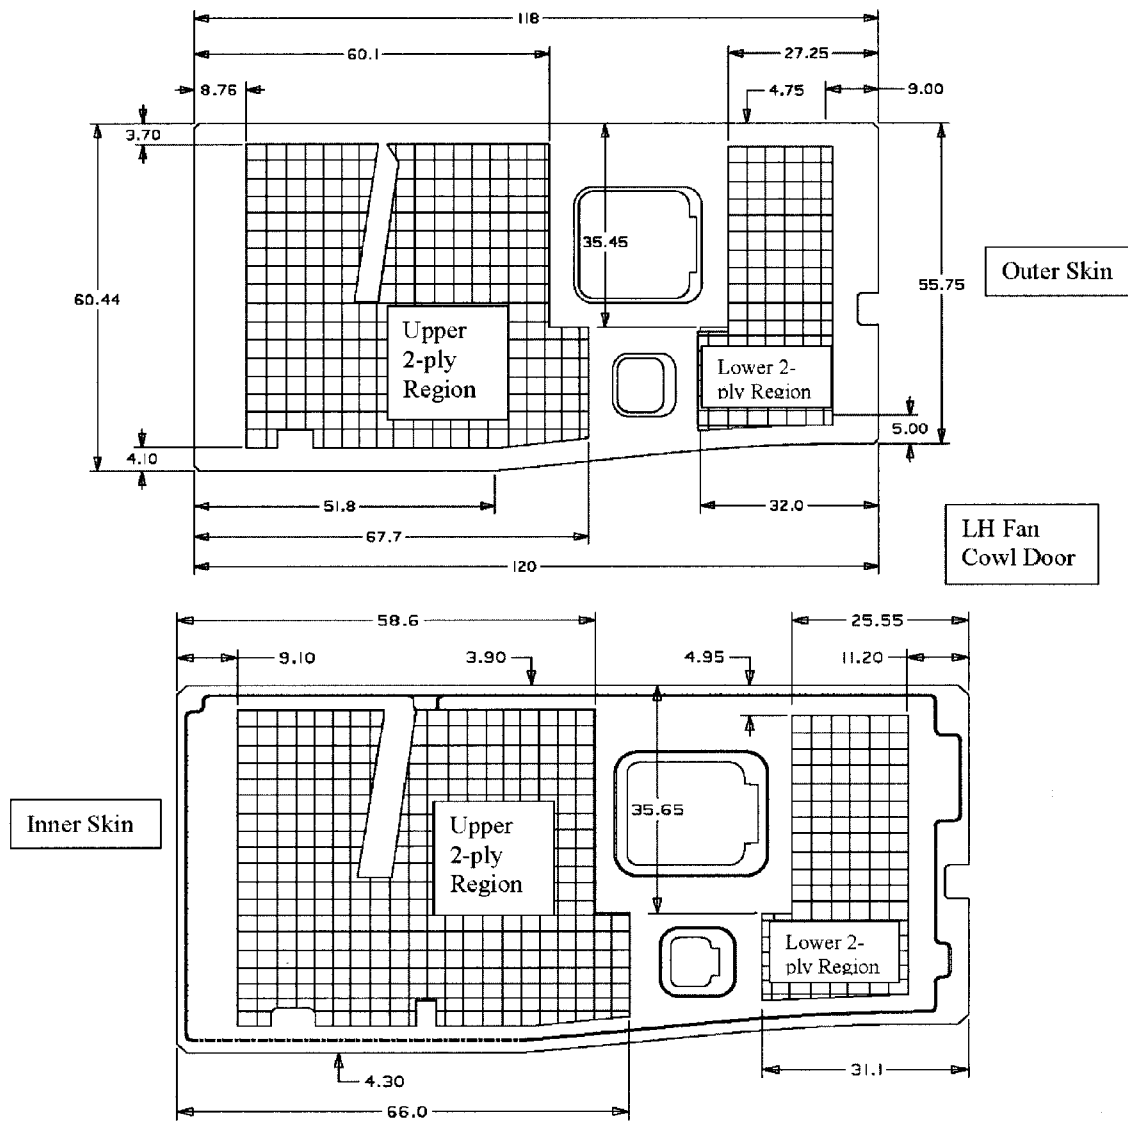
Left Hand Door
Figure 1

- (1) Conduct a general visual inspection of the fan cowl (Refer to the AMM 05-24-30-200-003).
- (2) Conduct a tap test on the fan cowl door (Refer to the NTM 51-10-03 for tap test instructions and Figure 1 and Figure 2 for inspection areas).
- (3) If a disbond is discovered, determine the affected area
 - (a) If a disbonded area in the upper region is less than or equal to 576 sq. in. (3716 sq. cm) or in the lower region less than or equal to 186 sq in. (1200 sq cm), refer to step 3.A.(3)(b)(i) and (ii). If the disbonded area is greater than the limit or there is disbond in both the upper and the lower region, skip to 3.A.(3)(b)(iii). Refer to Figures 1 and 2 for area definition.
 - (b) Any disbond must be within the main panel body as indicated in Figures 1 and 2.

- (i) If the disbond area is less than or equal to the limit, complete the form in Appendix 1 and submit the appropriate figure with an approximation of the disbond area drawn directly onto the figure to Goodrich. See step 3.A.(4) for contact information.

- (ii) Any fan cowl which meets the limits in Step 3(b)(i) above may continue to fly for 6000 flight hours (FH) with re-inspection every subsequent 600 FH (an A-check interval). Each subsequent inspection requires the submission of an additional inspection report prior to next inspection. Once the aircraft arrives at 6000 FH (a C-check interval), it is recommended that the disbonded fan cowl be removed and repaired.

- (iii) If the disbond is greater than the limits posted in Step (3)(a) above, but less than 1000 sq. in. (6452 sq. cm) in the upper 2-ply region and/or 400 sq. in. (2581 sq. cm) in the lower 2-ply region, complete the form in Appendix 1 and submit the appropriate figure with an approximation of the disbond area drawn directly onto the figure to Goodrich. See step 3.A.(4) for contact information.

(iv) Any fan cowl which meets the limits in Step 3(b)(iii) above, may continue to fly for 600 flight hours (FH) with re-inspection every subsequent 100 FH. Each subsequent inspection requires the submission of an additional inspection report prior to next inspection. Once the aircraft arrives at 600 FH (an A-check interval), it is recommended that the disbonded fan cowl be removed and repaired.

(v) A disbond greater than the indicated limit and less than or equal to 1680 sq. in. (10838 sq. cm) in the upper 2-ply region and/or less than or equal to 544 sq. in. (3510 sq. cm) in the lower 2-ply region requires a One Time Concession (OTC) request from the Goodrich Repair group to enable fly-on. Duration of fly-on and interval of inspection will be assessed on a case-by-case basis. Complete a Nacelle Damage Description (NDD) form and submit the document to your regional Goodrich Airline Support Manager (ASM). For any damage strictly above 1680 sq. in. (10838 sq. cm) in the upper region and/or 544 sq. in. (3510 sq. cm) in the lower region, the part must be removed and repaired.
