## V2500-A5 SERIES PROPULSION SYSTEMS SERVICE BULLETIN

# V2500-NAC-71-0312

NACELLE - POWERPLANT - DRAIN SYSTEM - REROUTING OF THE HYDRAULIC PUMP DRAIN TUBES1. Planning InformationA. Effectivity

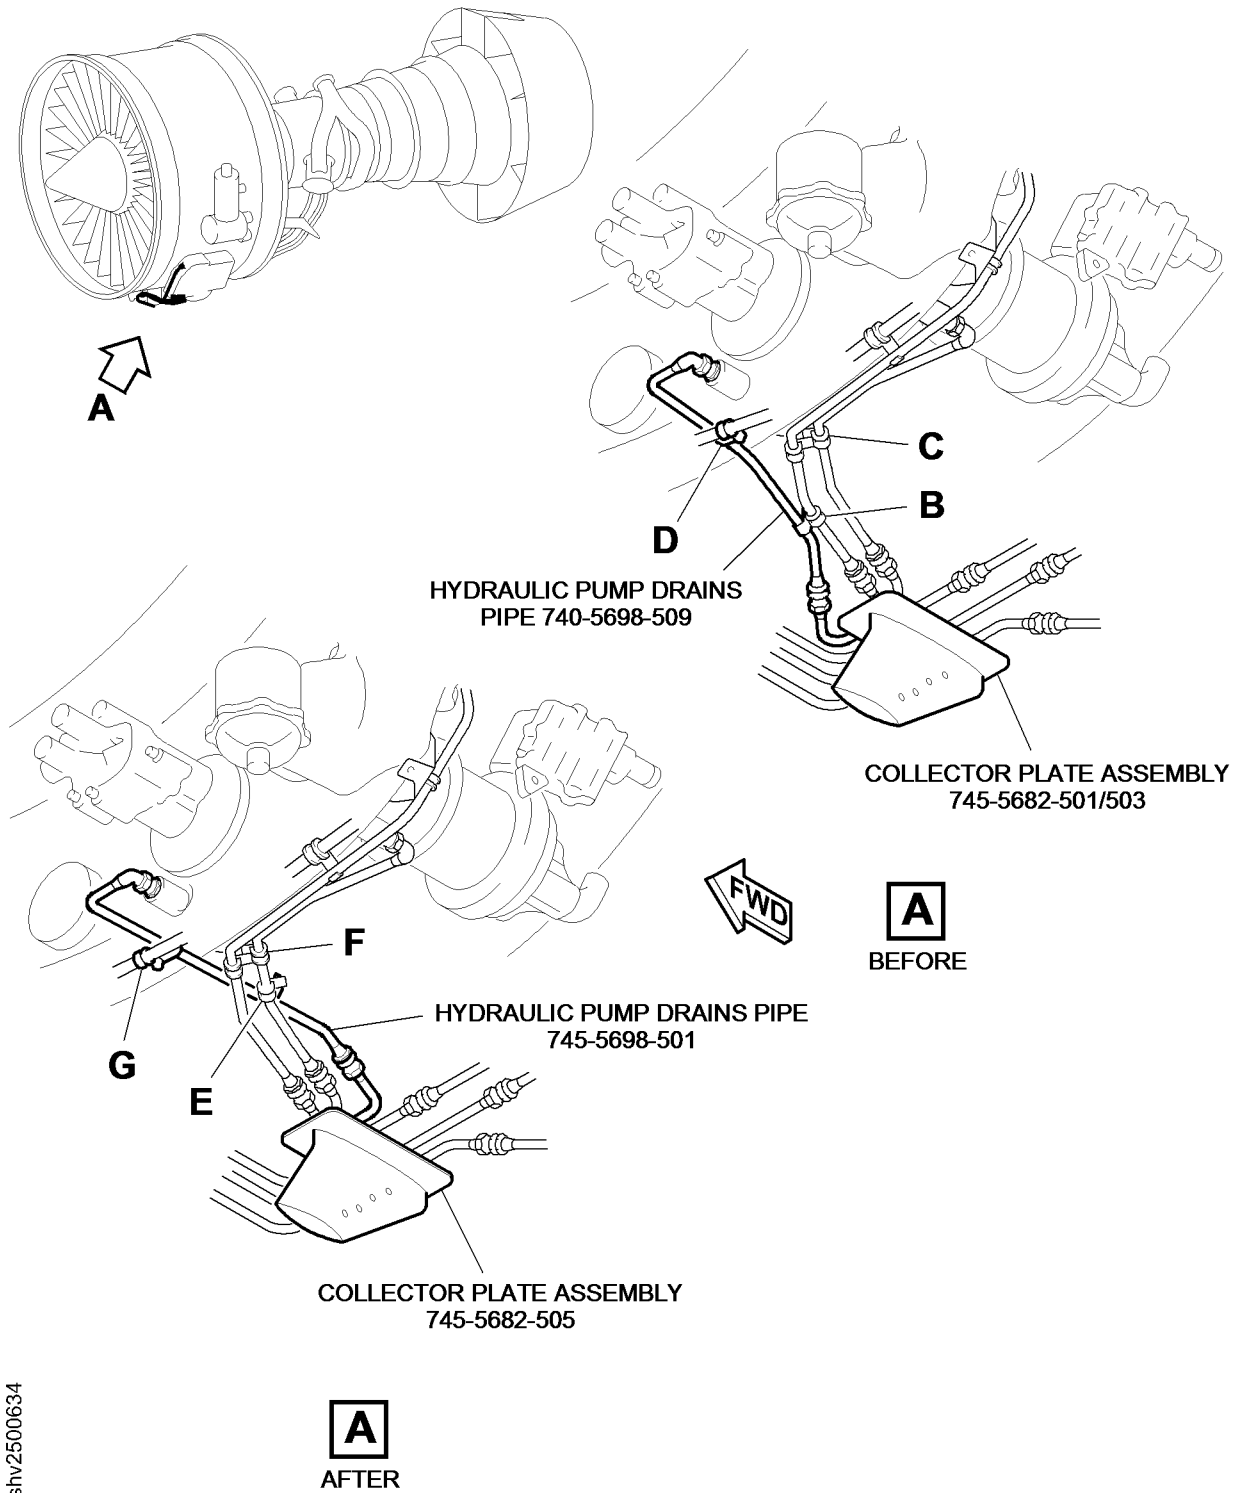
Rerouting of the Hydraulic Drains Tube Assembly  
Figure 1 (Sheet 1 of 3)

The anti-swivel plate on the right hand fan cowl door no. 3 latch may chafe with the hydraulic pump drains pipe.

An operator has reported damage to the hydraulic pump drains pipe. Upon investigation, it was discovered that there may be less than minimum clearance between the no. 3 latch anti-swivel plate on the right hand fan cowl door and the hydraulic pump drains pipe.

- (1) At clipping point CP0943, remove the nut AS20624, the washer SP154D and the bolt AS21408 to release the p-clip 400WSS6 from the tube assembly the 740-5673-503 (Refer to Figure 1, view B).

- (2) At clipping point CP0943, remove the p-clip 400WSS6 from the 740-5673-503 tube assembly.
- (3) At clipping point CP0942, remove the bolt AS21411 or AS21415 and the spacer ST1698D47 or ST1698D48 to release the tube assembly 740-5702-509 and tube assembly 740-5673-503 from the bracket 740-5640-503 (Refer to Figure 1, view C).

- (4) At clipping point CP0942, remove the p-clip 400WSS4 from the tube assembly 740-5702-509 and the p-clip 400WSS6 from the tube assembly 740-5640-503.

- (5) At clipping point CP0959, remove the nut AS20624, the washer SP154D and the bolt AS21408 to release the p-clip 400WSS8 from the fan case fire detector (Refer to Figure 1, view D).

- (6) At clipping point CP0959, remove the p-clip 400WSS8 from the fan case fire detector.
- (7) Remove the collector plate 745-5682-501 or 745-5682-503 from the aircraft as instructed in the Aircraft Maintenance Manual, Chapter 71-71-42-000-010 (Refer to Figure 1, sheet 1).

- (8) Disconnect the hydraulic drain tube 740-5698-509 from the hydraulic pump union (Refer to Figure 1).
