ENGINE - FUEL AND CONTROL - NACELLE - POWERPLANT - PIPE ASSEMBLY, P2T2 - REPLACEMENT OF
- CATEGORY CODE 7 - MOD.NAC-73-0118

V2500-NAC-73-0118

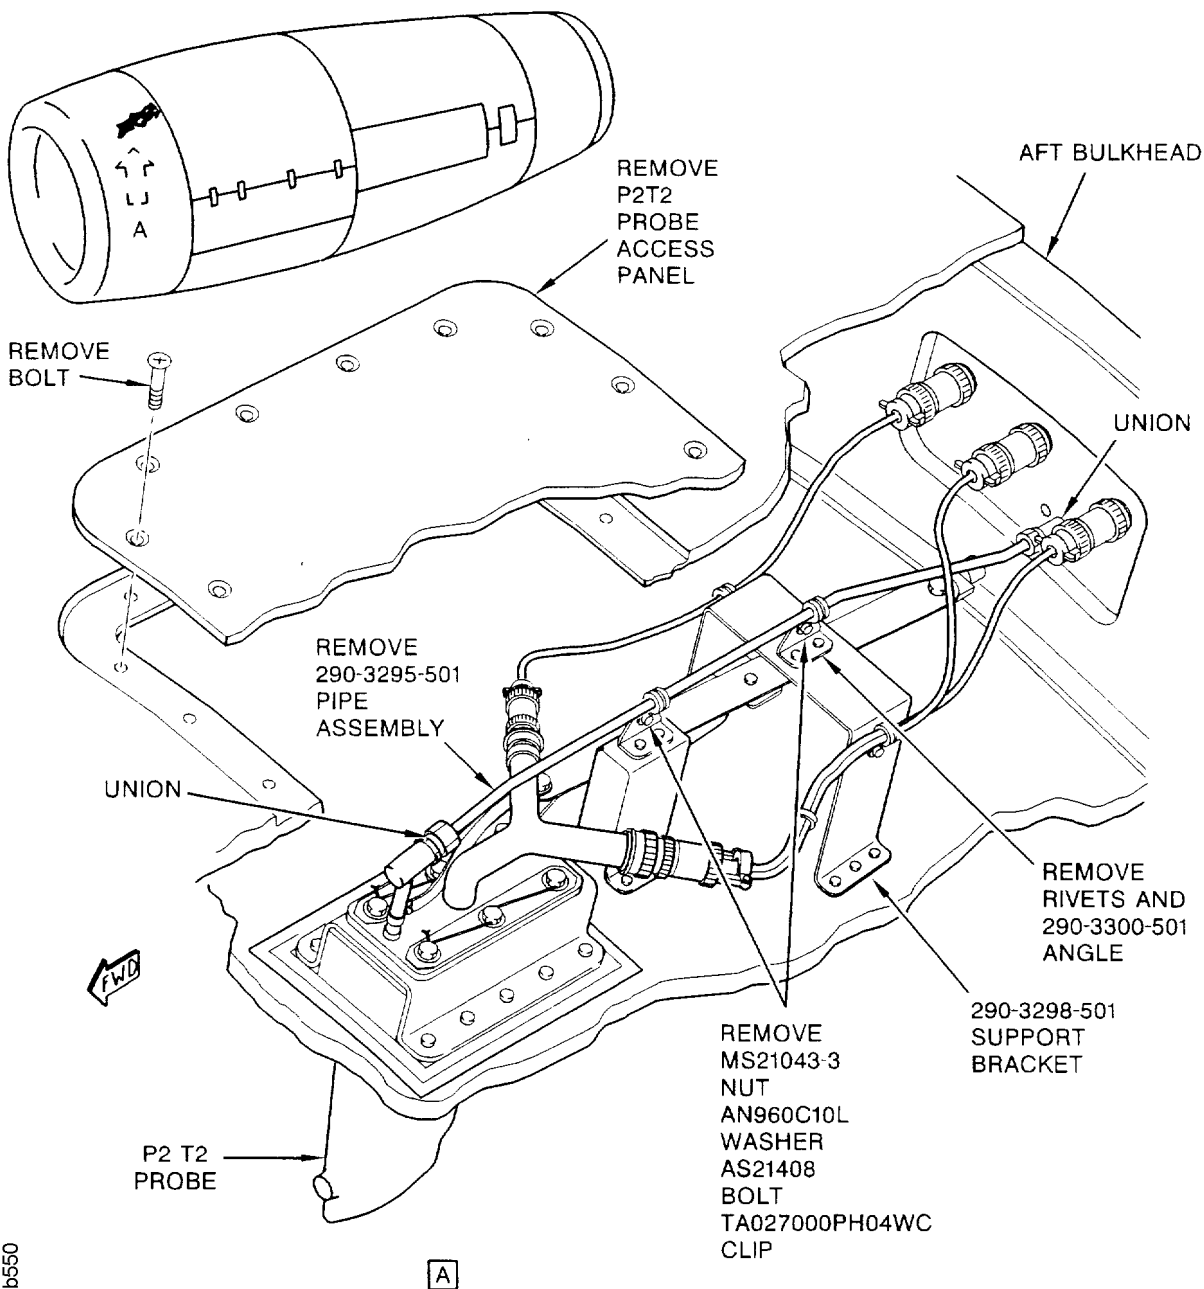
P2T2 Pipe Assembly Replacement
Fig.1

The nose cowl rigid P2T2 pipe assembly may be difficult to install.

Operators have experienced difficulty installing the rigid P2T2 pipe assembly.

- (1) Remove the bolts and the probe access panel. Refer to Figure 1.

- (1) Remove the nuts MS21043-3, bolts AS21408, washers AN960C10L, and clips TA027000PH04WC. Discard one nut, one bolt, one washer, and one clip. Refer to Figure 1.
- (2) Remove the pipe assembly 290-3295-501. Refer to Figure 1.
- (3) Remove the two rivets and the 290-3300-501 angle from the 290-3298-501 support bracket.
- (4) Install the pipe assembly AE709614-2 on the aft bulkhead union and the P2T2 sensor union. Torque the coupling nuts to 135-145 lbfin (15.25-16.38 Nm). Refer to Figure 2.
- (5) Attach the pipe assembly to the bracket with the clip TA027000PH04WC, the bolt AS21408, the washer AN960C10L, and the nut MS21043-3. Refer to Figure 2.
