NACELLE - AIR - CLIPS, OVERHEAT DETECTOR - REPLACEMENT OF - CATEGORY CODE 5 -
MOD.NAC-75-0056

V2500-NAC-75-0056

SERVICE BULLETIN

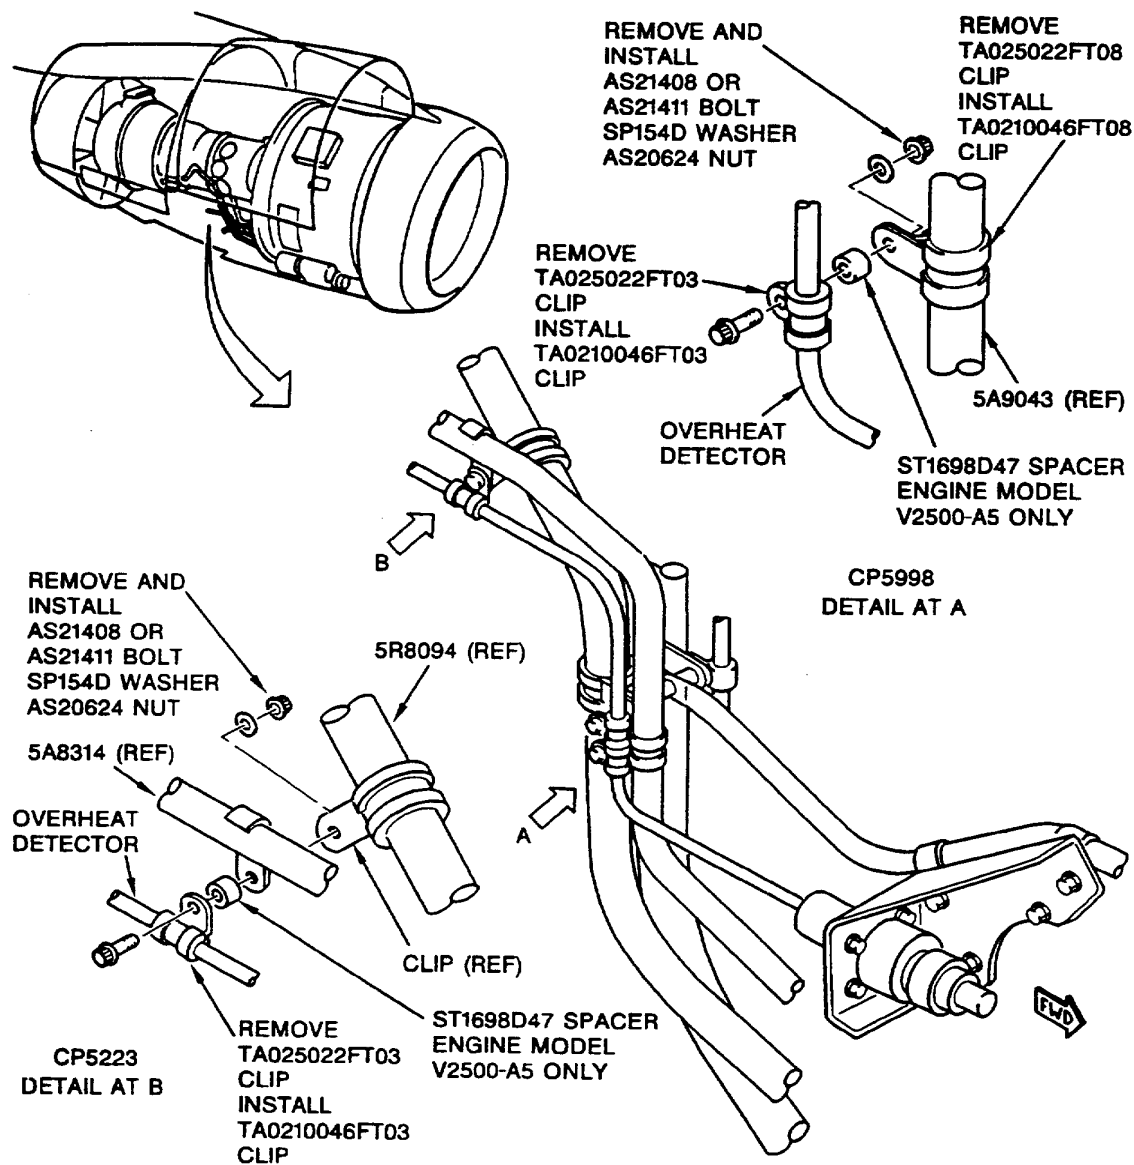
REPLACEMENT OF CLAMPS ON CORE OVERHEAT DETECTOR.
Fig.1

- (1) Condition
- Operators have reported frettage to overheat detector at clipping points.
- (2) Background
- Clip inserts have shown wear and/or are missing from clips.

- (a) The clip that supports the overheat detector at clipping point CP5223 is replaced. Both clips at clipping point CP5998 are also replaced. Refer to Figure 1.

- (1) Remove the TA025022FT03 P-clip from clipping point CP5223. See Figure 1.
- (2) Assemble clipping point CP5223 as shown, with new TA0210046FT03 P-clip, AS21408 bolt, SP154D washer, and AS20624 nut.
- (3) Remove the TA025022FT03 P-clip and TA025022FT08 P-clip from clipping point CP5998.
- (4) Assemble clipping point CP5998 as shown, with new TA0210046FT03 and TA0210046FT08 P-clips, AS21408 bolt, SP154D washer, and AS20624 nut.
- (5) Torque the nuts in steps (2) and (4) to 40 lbf-in (4.6 Nm).
