AIR - NACELLE - EXHAUST - ACAC EXHAUST DUCT - EXIT AREA INCREASE OF - CATEGORY CODE 4
- MOD.NAC-75-0062

V2500-NAC-75-0062

SERVICE BULLETIN

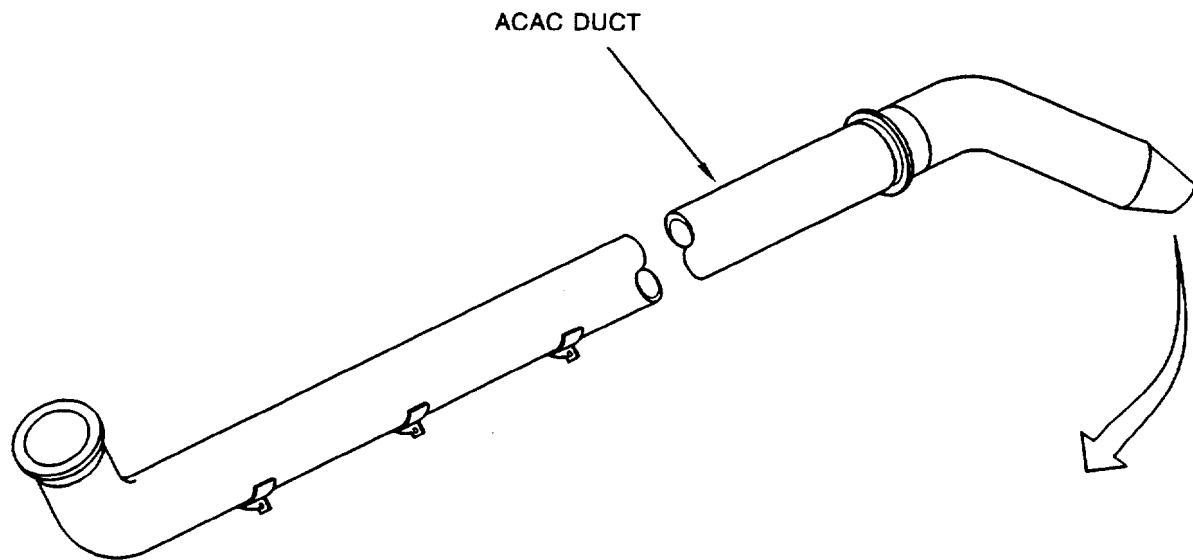
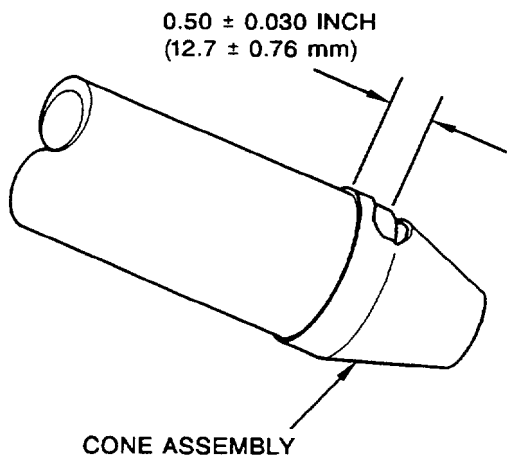
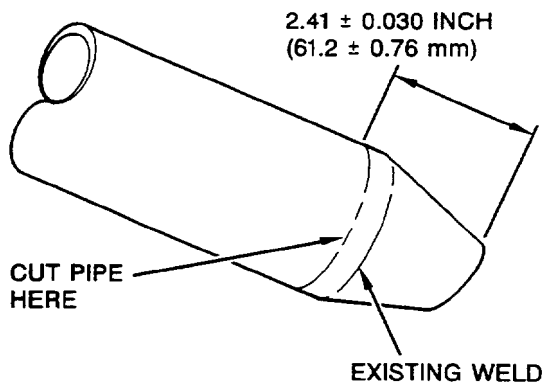
**ACAC Duct Exit Area Modification
Figure 1**

Investigation of the black oil problem on some V2500-A1 and -A5 engines has shown that the oil contained carbon particles which are generated in the No. 4 bearing compartment. This is caused by low ACAC flow and associated high temperature of compartment buffer air. An increase in ACAC airflow is required to provide adequate cooling for the No. 4 bearing compartment buffer air for all models of V2500 engine including the V2533-A5 (33,000 lb thrust) engines.

- (1) Remove the ACAC duct as instructed in the A320/A321 Aircraft Maintenance Manual, TASK 78-11-11-000-010.
- (2) Remove the exit end from the duct as shown in Figure 1. Remove all burrs and sharp edges.
- (3) Size the end of the tube.
- (4) Weld the 740-0364-2D cone assembly on the duct as shown in Figure 1. Refer to the IAE V2500 Standard Practices/Processes Manual, TASK 70-31-13-310-501. (MIL-STD-2219 is an acceptable substitute for TASK 70-31-13-310-501.) Use welding filler wire (CoMat 03-287).
- (5) Penetrant inspect the weld. Refer to the IAE V2500 Standard Practices/Processes Manual, TASK 70-23-00-230-501. (MIL-STD-6866 is an acceptable substitute for TASK 70-23-00-230-501.)

- (6) Identify the modified 740-0361-503 duct as the 740-0361-507 duct with electroetch or vibroetch method. Refer to the IAE V2500 Standard Practices/Processes Manual, Chapter 70-09-00.
- (7) Install the 740-0361-507 ACAC duct as instructed in the A320/A321 Aircraft Maintenance Manual, TASK 78-11-11-400-010.
