SERVICE BULLETIN

NACELLE - EXHAUST - THRUST REVERSER ATTACH HARDWARE AT NO. 4 HINGE LOCATION -
REPLACEMENT OF - CATEGORY CODE 4 - MOD.NAC-78-0016

V2500-NAC-78-0016

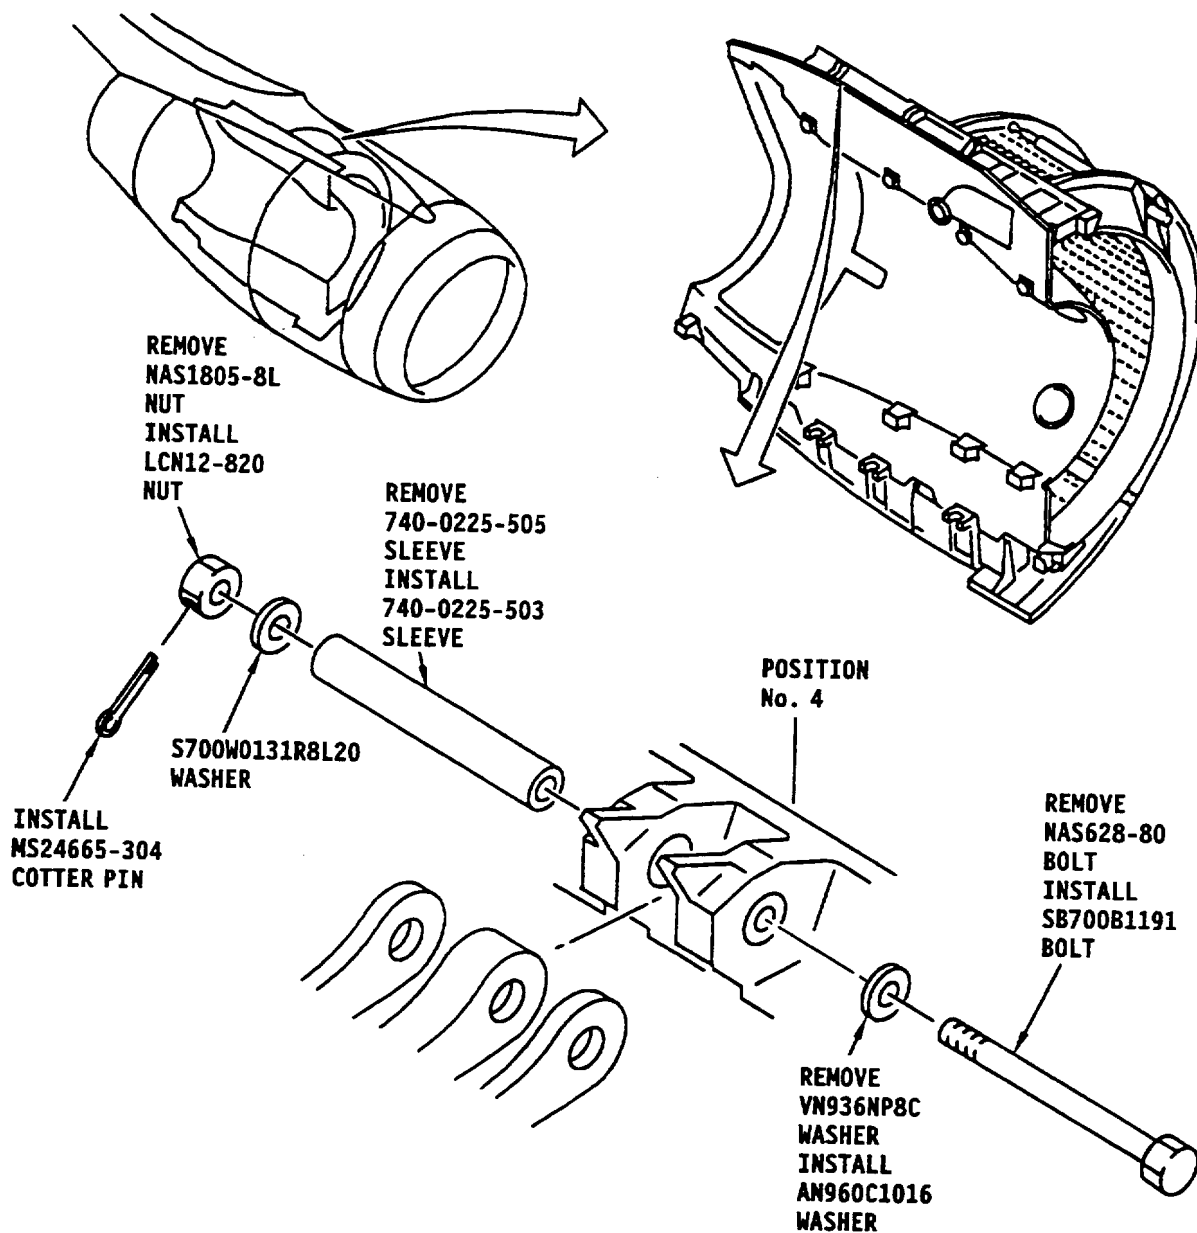
Repacement of No. 4 Hinge Hardware
Fig.1

The existing No. 4 hinge bolt thread protrusion from the nut is not adequate, and there is a possibility that the hinge hardware may clamp up on the hinge lugs

- (1) Remove bolt, washers, sleeve, and nut from No. 4 hinge. discard all hardware. (Refer to Figure 1).
- (2) Lubricate S700B1191 bolt with CoMat 10-058 penetrating oil.
- (3) Install 740-0225-503 sleeve, AN960C1016 washer, S700B1191 bolt, S700W0131R8L20 washer, and LCN12-820 nut.
- (4) Torque nut to 480 -690 lb-in. (54.2 -78.0 N.m).
- (5) Install MS24665-304 cotter pin in bolt.
