NACELLE - EXHAUST - THRUST REVERSER OPENING ACTUATOR, COOLING HOSE - REPLACEMENT OF -
CATEGORY CODE 4 - MOD.NAC-78-0018

V2500-NAC-78-0018

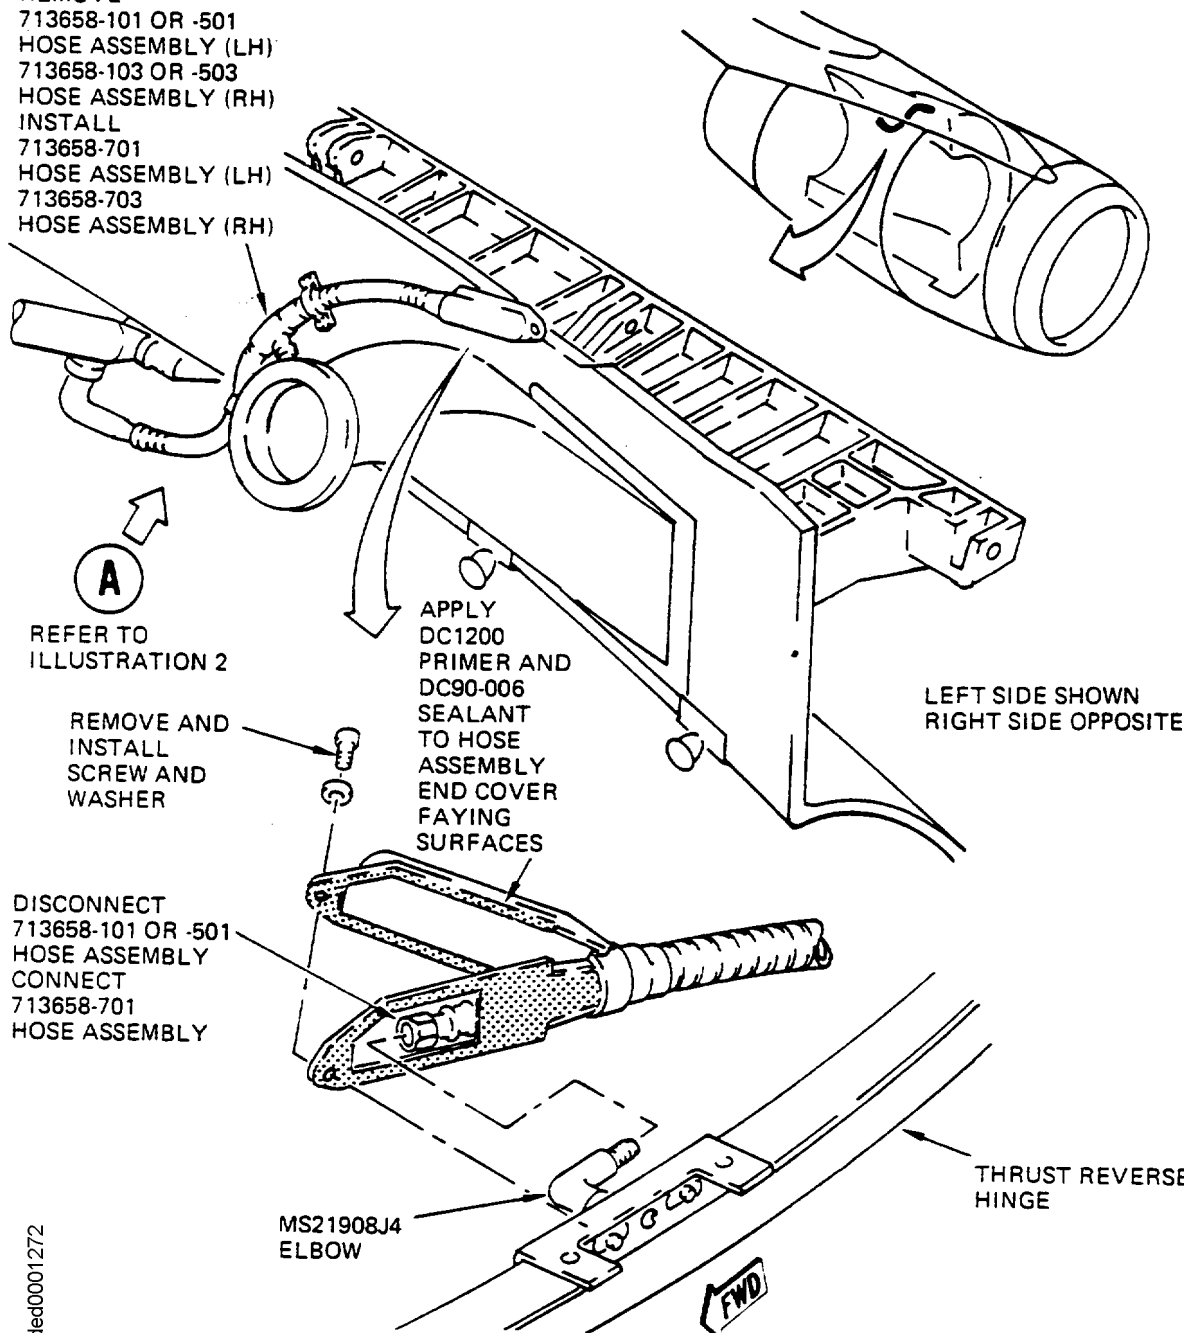
Replacement of Cooling Hose Assembly
Fig.1

Coking of hydraulic fluid in the hose which feeds the thrust reverser door opening actuator may occur.

Remove and replace the existing cooling hoses from the left and right thrust reverser opening actuator with improved airflow cooling hoses.

- (1) Open the thrust reverser halves as specified in the A320 Aircraft Maintenance Manual, Task 78-32-00-010-010.
- (2) Find 713658-101 or -501 hose assembly on the thrust reverser inner barrel (Refer to Figure 1.)

- (1) Remove existing screw and washer that attach 713658-101 or -501 hose assembly end cover to the thrust reverser inner barrel. Keep screw and washer.

- (2) Pull back 713658-101 or -501 hose assembly end cover and disconnect coupling nut from MS21908J4 elbow.

- (15) Clean the hose assembly end cover faying surfaces using a cloth wet with MIBK. Wipe surfaces dry before solvent dries. (Refer to Figure 1.)
