Subject: Transmittal of Revision 1 to Service Bulletin Number V2500-NAC-78-0038

V2500-NAC-78-0038 Transmittal Page 1 of 1 NACELLE - EXHAUST - THRUST REVERSER No. 4 HINGE WASHERS -REPLACEMENT OF

# Aero Engines SERVICE BULLETIN

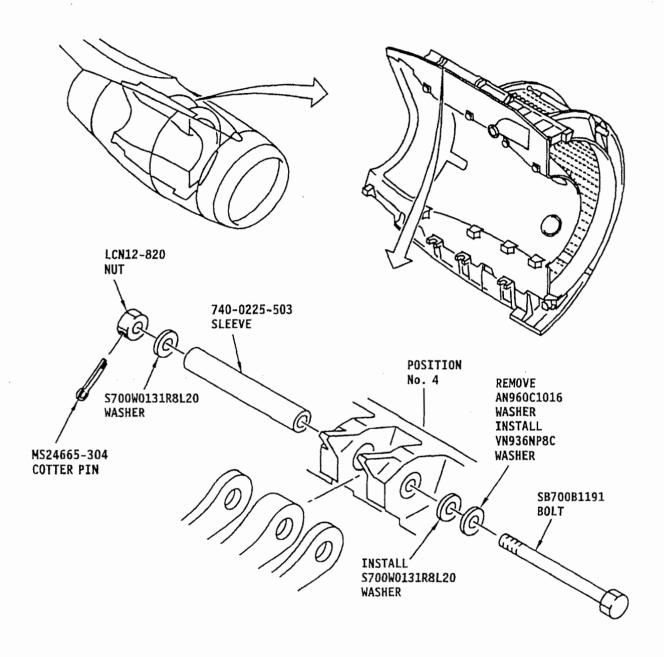
No. 4 Hinge Modification -After Condition Figure 1

The existing No. 4 hinge bolt exposed thread length is too short to allow proper installation.

Replace the AN960C1016 washer under the bolt head with VN936NP8C washer and add anouther S700W0131R8L20 washer under the new VN936NP8C washer.

- B. Rework or Modification Instructions
  - (1) Remove bolt, washers, sleeve, and nut from No. 4 hinge. Discard AN960C1016 washer. (Refer to Figure 1).

- (2) Lubricate S700B1191 bolt with CoMat 10-058 penetrating oil.
  - (3) Install S700B1191 bolt, VN936NP8C washer, two S700W0131R8L20 washers, and LCN12-820 nut.

- (4) Torque nut to 480 -690 lb-in. (54.2 -78.0 N.m).
  - (5) Install MS24665-304 cotter pin in bolt.
- C. Post-requisite Instructions
  - (1) Install the hinge access panels as specified in A320 Aircraft Maintenance Manual, Chapter 78-32-00.
