SERVICE BULLETIN

NACELLE - EXHAUST - THRUST REVERSER, HYDRAULIC HOSE CLAMPING - ADDITION OF - CATEGORY
CODE 6 - MOD.NAC-78-0050

V2500-NAC-78-0050

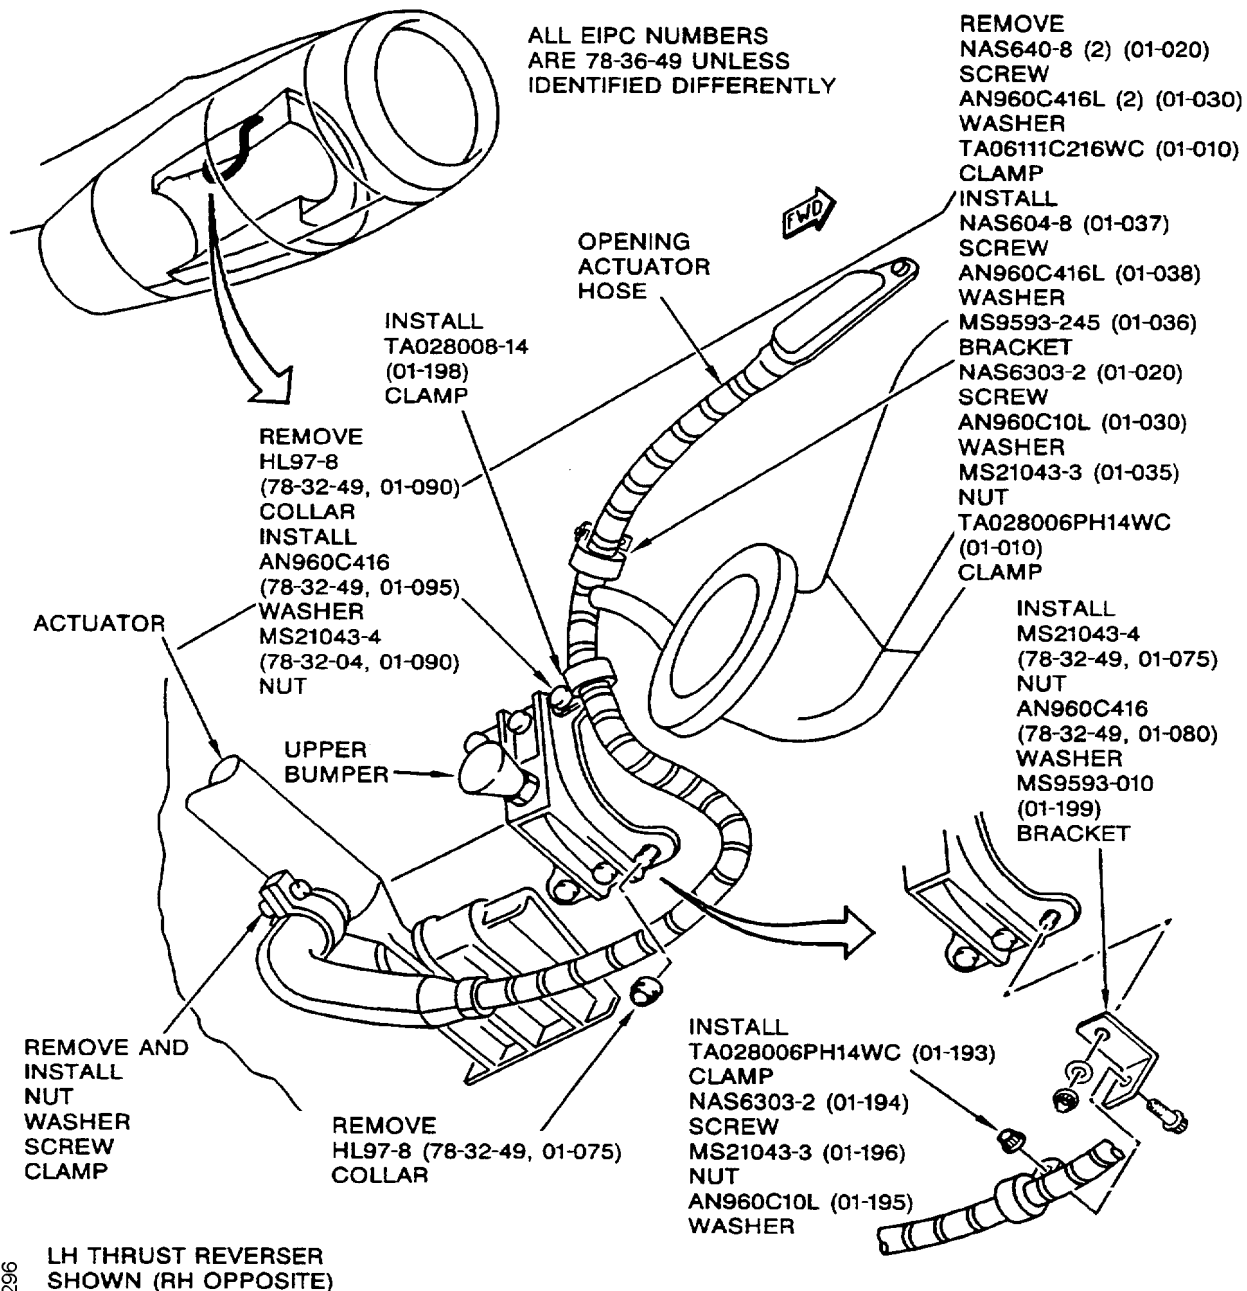
Thrust Reverser Opening Actuator Hose Clamping Modification
Fig.1

The thrust Reverser C-Duct opening actuator hydraulic hose can come into contact with hot engine components under certain operating conditions. This may cause the hose to chafe and age prematurely.

- (a) Remove the screws, washers, and clamps that attach the hose to the heat shield. Keep one NAS604-8 screw, discard the remainder of the remainder of the hardware. Refer to Figure 1.
- (b) Remove the screw, washer, nut and clamp from the hose end cover attached to the actuator. Keep the hardware.
- (c) Remove the collars from the two Hi-Lok pins on the upper bumper.
- (d) Install the MS9593-010 bracket (long side on the bumper) on the lower hi-lok pin on the upper bumper with AN960C416 washer and MS21043-4 nut. Tighten the nut to a torque of 50-70 lb-in (5.6 -7.9 N.m).
- (e) Attach the hose to the bracket with the TA028006PH14WC clamp, NAS6303-2 screw, AN960C10L washer, and MS21043-3 nut. Tighten the nut fingertight.
- (f) Attach the hose to the upper hi-loc pin with the TA028008-14 clamp, AN960C416 washer, and MS21043-4 nut. Tighten the nut fingertight.

- (g) Attach the MS9593-245 bracket to the heat shield with the NAS604-8 screw and AN960C416L washer in the forward hole.
- (h) Attach the hose to the MS9593-245 bracket with the TA028006PH14WC clamp, NAS6303-2 screw, AN960C10L washer, and MS21043-3 nut. Tighten the NAS604-8 screw to a torque of 50-70 lb-in. (5.6-7.9 N.m) and tighten the MS21043-3 nut fingertight.
- (i) Put the hose and the clamps into position to minimize stress and preload on the hose.
- (j) Tighten the nuts that attach the clamp and bracket to the bumper to a torque of 50-70 lb-in. (5.6-7.9 N.m). Tighten the nuts that attach the clamps to the brackets to a torque of 20-25 lb-in. (2.3-2.8 N.m).
- (k) Attach the hose end cover to the hose with the clamp, screw, washer, and nut. Tighten the nut to a torque of 20-25 lb-in (2.3-2.8 N.m).
