International Aero Engines SERVICE BULLETIN

NACELLE - EXHAUST - FLUID DRAINAGE, THRUST REVERSER -MODIFICATION OF

BULLETIN INDEX LOCATOR 78-32-00

October 23, 1996 Revision 2 - January 27, 1998 V2500-NAC-78-0085 Page 1 of 25

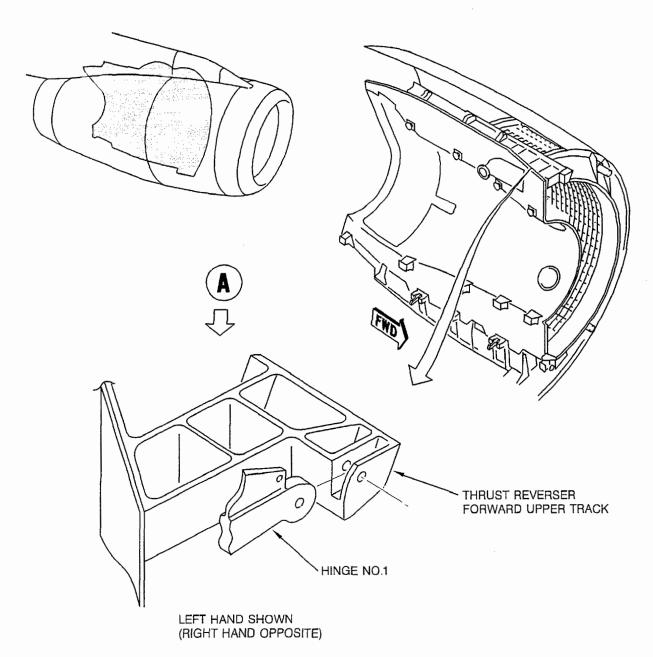
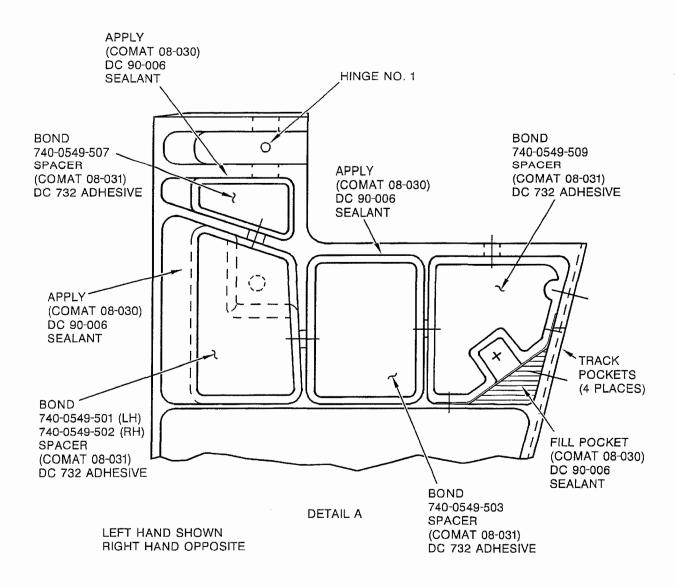
Addition of Spacers to the Track Installation Figure 1 (Sheet 1 of 2)

Fluids, such as hydraulic, fuel, and water, may become trapped in cavities on the upper thrust reverser track fittings and in the lower bifurcation area.

- B. Rework or Modification Instructions
 - (1) Find the machined-out (track) pockets on the left hand thrust reverser forward upper track area aft of hinge number 1. Refer to Figure 1.

- 0.005-0.010 inches (0.127-0.254 mm) thick to the mating surfaces of the four spacers and the track pockets.
- (9) Put each 740-0549 spacer in the position shown in Figure 1. Apply sufficient pressure to keep spacer in touch with mating surface without causing too much adhesive leakage.

- (11) Refer to manufacturer's instructions to mix sealant (CoMat 08-030). Apply sealant around the spacers. Fill all clearances and stop as many air bubbles as possible.
