**International
Aero Engines**

V2500 Propulsion System — Nacelle

**NACELLE — EXHAUST — VENT HOLES,
LEFT THRUST REVERSER DOOR — MODIFICATION AND ADDITION OF**

V2500-NAC-78-0087

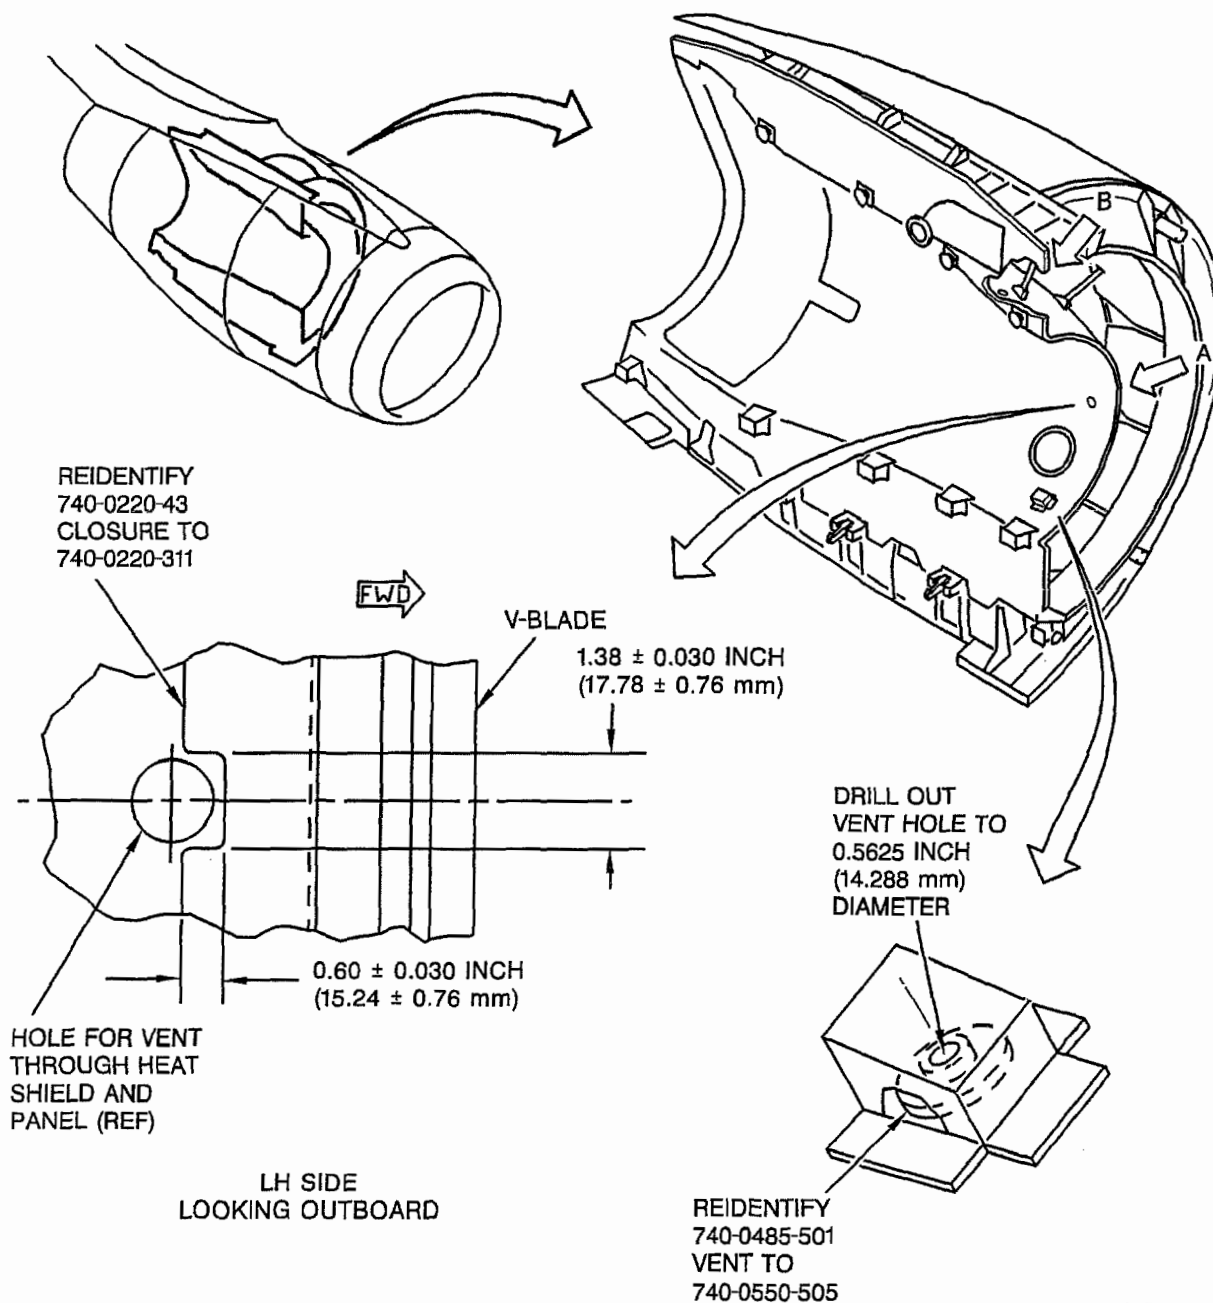
Thrust Reverser Fixed Duct Modification
Figure 1

Potentially inadequate ventilation of engine core compartment.

- (1) Find the 740-0485-501 vent on the left thrust reverser half. Refer to Figure 1.
- (2) Use a drill to make the diameter of the hole in the vent 0.5625 inches (14.288 mm).

- (c) Remove material from the closure as shown in Figure 1. Put a piece of metal between the closure and the heat shield to prevent damage to the heat shield.

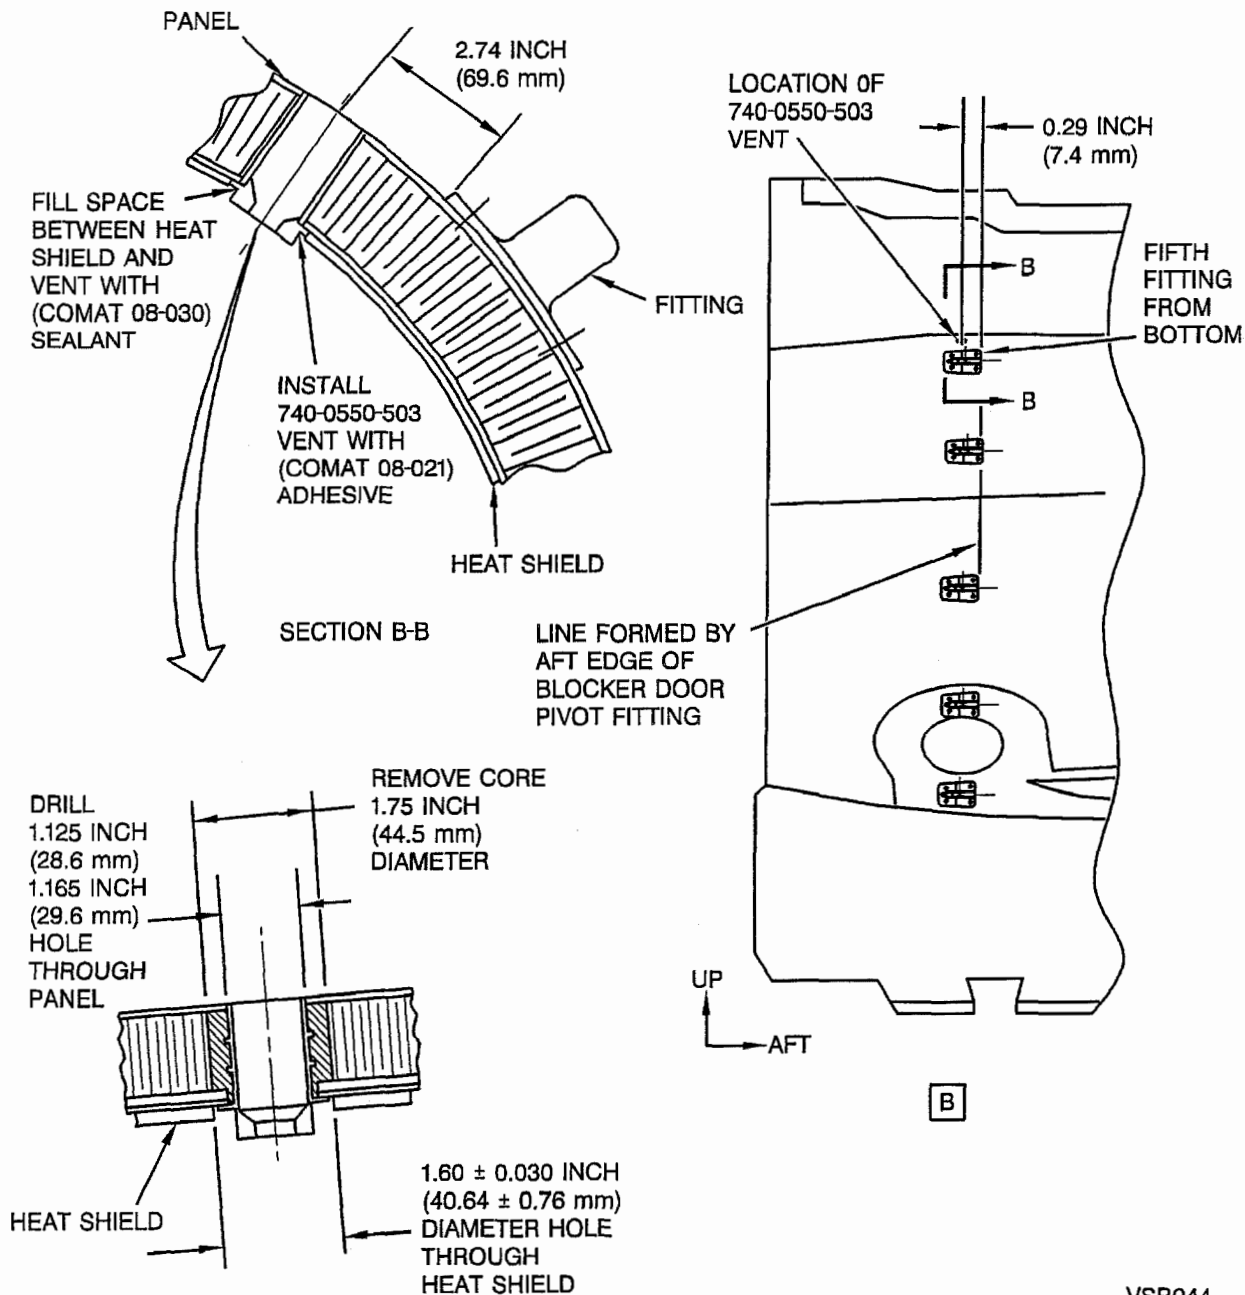
Thrust Reverser Fixed Duct Modification
Figure 3

(1) To revise some text in Figure 3.
