NACELLE - EXHAUST - LUG, THRUST REVERSER LOWER OUTBOARD TRACK ASSEMBLY LANYARD ATTACH - MODIFICATION OF

Turbojet Engine Service Bulletin No. V2500-NAC-78-0097 Revision No. 1 dated May 9, 2017

MODEL APPLICATION V2525-D5, V2528-D5

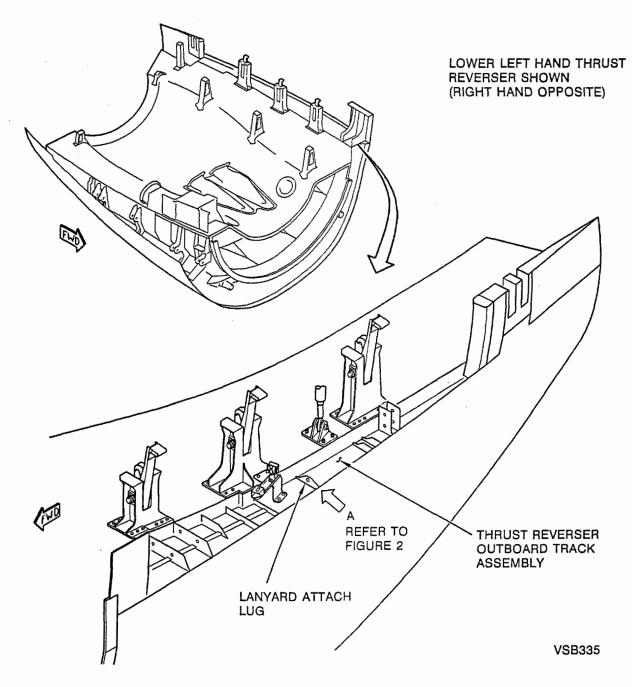
OUTBOARD TRACK ASSEMBLY LANYARD ATTACH LUG FIGURE 1

The lower thrust reverser outboard track assembly lanyard attach lug may exhibit cracking in service.

Inadequate lug thickness of lower thrust reverser outboard track assembly at lanyard attach location.

- B. Rework or Modification Instructions
 - (1) Carefully pull back insulation blanket on outboard track assembly of left hand lower thrust reverser to get access to rework area. Refer to Figure 1.
