International  
Aero Engines

V2500 Propulsion System — Nacelle

**NACELLE - EXHAUST - ACTUATORS AND MANIFOLDS, THRUST REVERSER DOOR  
OPENING - REPLACEMENT OF**

**V2500-NAC-78-0099**

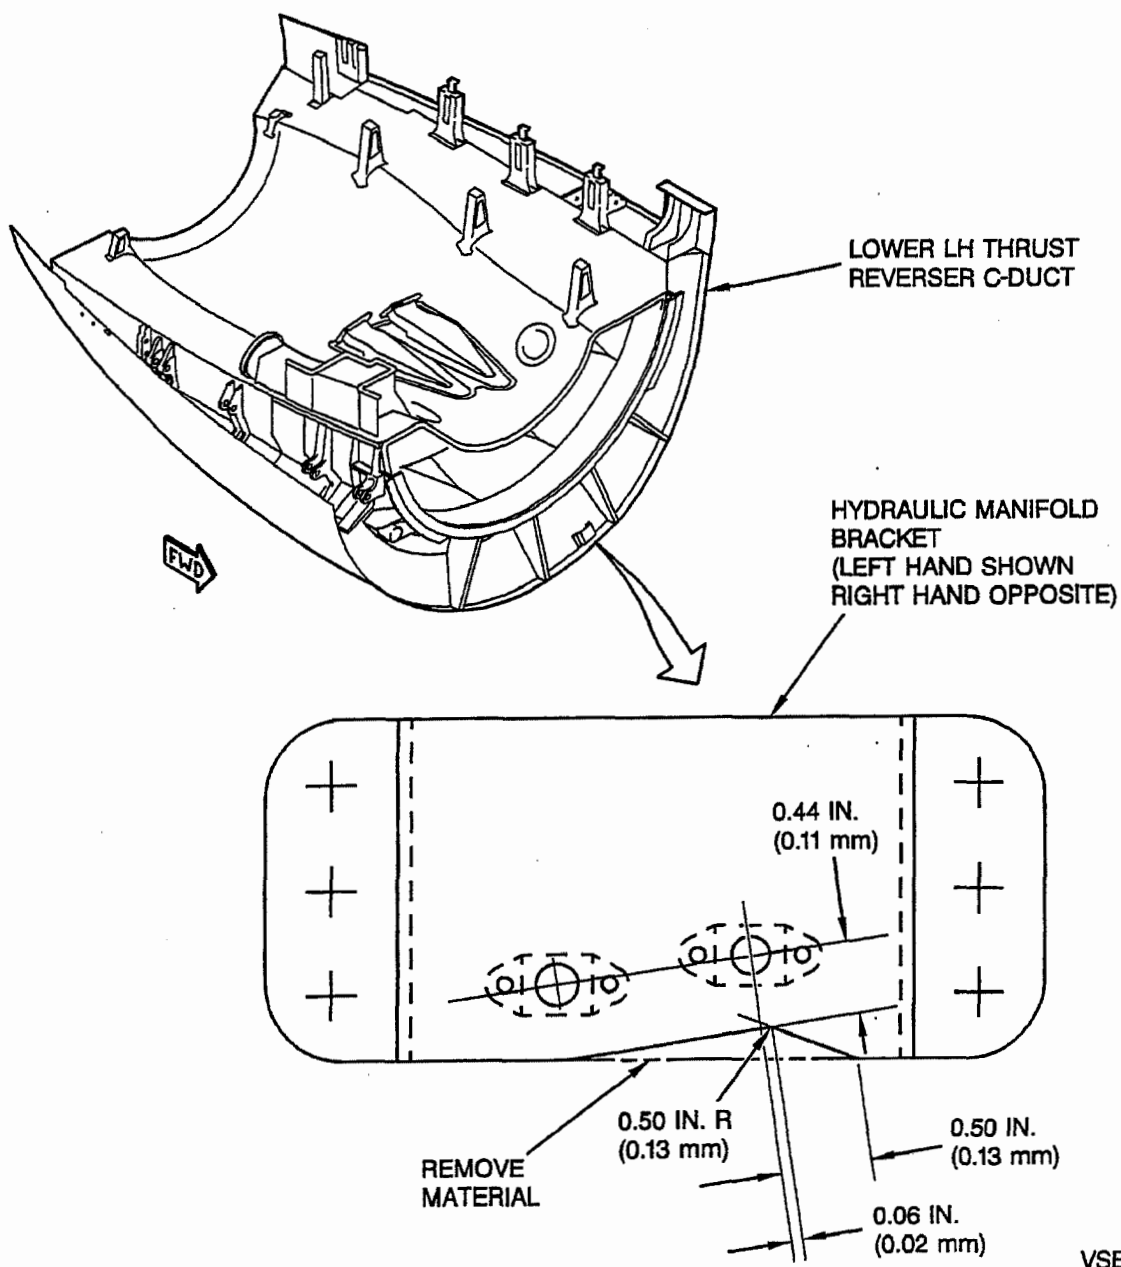
HYDRAULIC MANIFOLD BRACKET REWORK.  
FIGURE 1

Door opening actuators may bottom out in compression during extreme engine mount isolator deflection.

Engine mount isolator deflects more than predicted.

- (2) Install the 1211443-001 and 1211444-001 replacement upper and lower thrust reverser opening actuators. Refer to the Aircraft Maintenance Manual, Chapter 78-35-11.
- (3) Remove two B55818-2 hydraulic manifolds. Refer to the Aircraft Maintenance Manual, Chapter 78-35-12.
- (4) Remove indicated material from hydraulic manifold brackets. See Figure 1.
- (5) Clean the rework surface. Refer to the Standard Practices/Processes Manual, Chapter 70-11-03.

- (6) Prime the rework surface.
