International  
Aero Engines

V2500 Propulsion System — Nacelle

**NACELLE — EXHAUST — BOLT, PRESSURE RELIEF DOOR LANYARD —  
REPLACEMENT OF**

**V2500-NAC-78-0103**

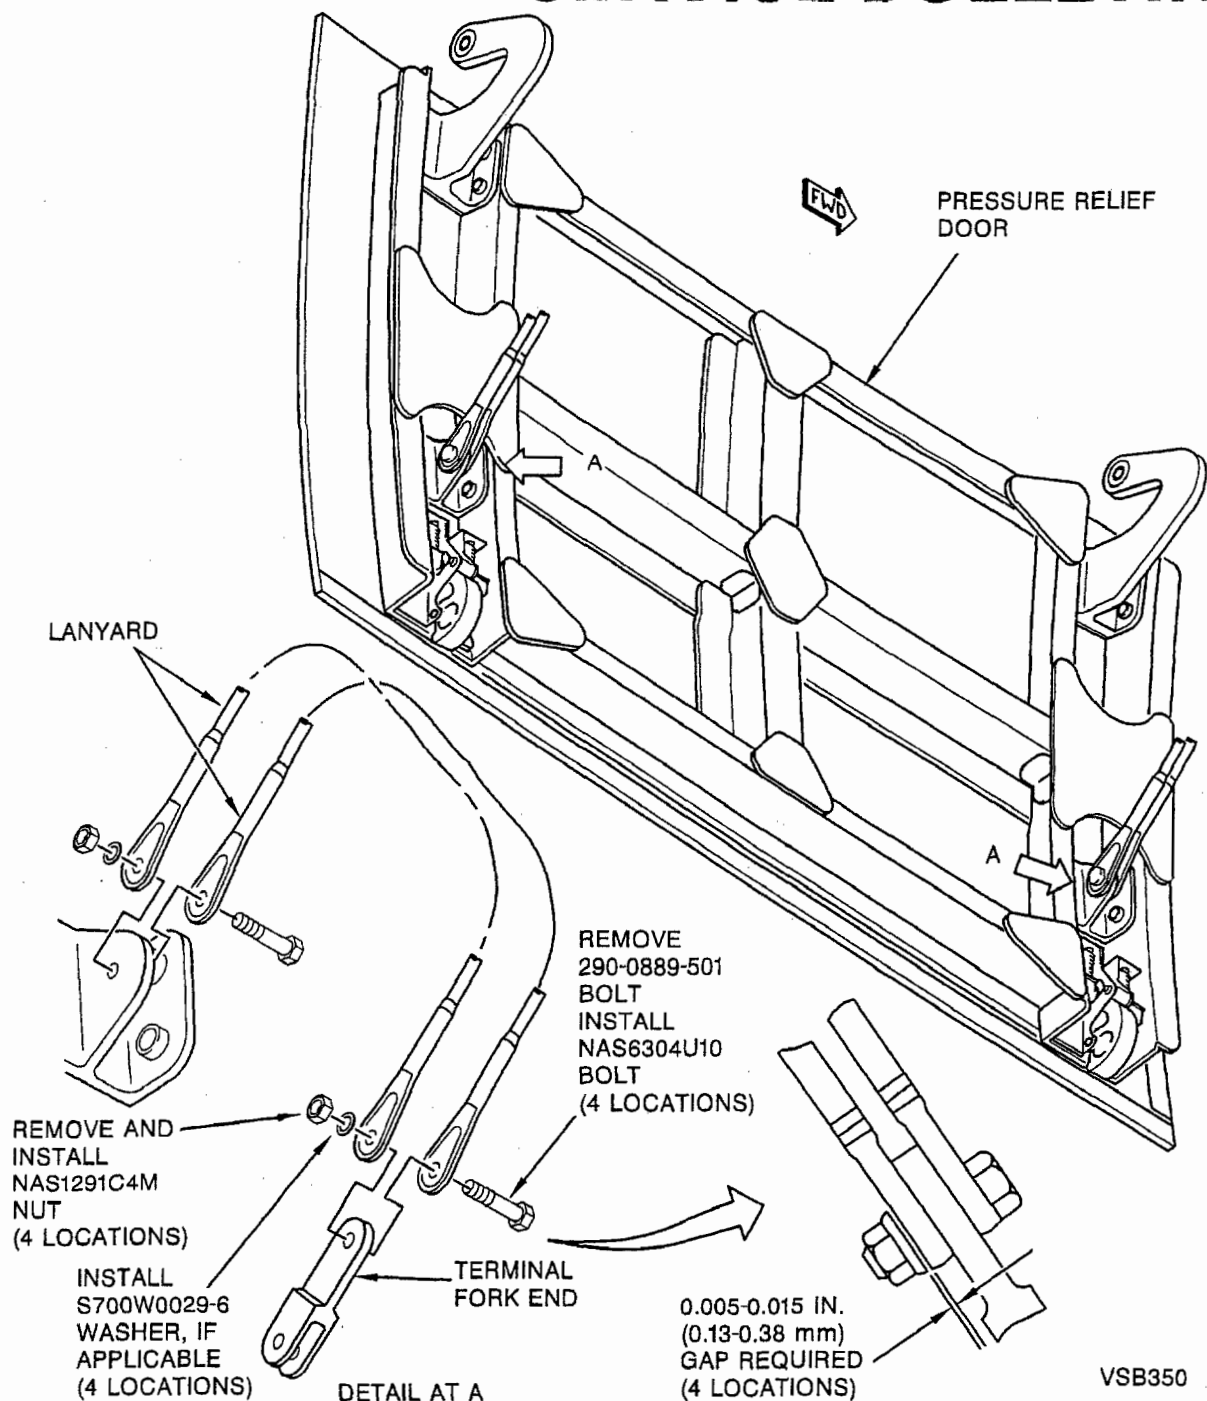
PRESSURE RELIEF DOOR LANYARD BOLT REPLACEMENT  
FIGURE 1

Due to possible clamp up condition of lanyard, it may be difficult to fully open pressure relief door.

Insufficient grip length of bolt.

- (1) Remove four NAS1291C4M nuts and four 290-0889-501 bolts from four lanyards and two terminal fork ends on pressure relief door. Refer to Figure 1. Discard bolts. Keep nuts.
- (2) Install four NAS6304U10 bolts and four NAS1291C4M nuts on four lanyards and two terminal fork ends on thrust reverser pressure relief door. Torque nut to 10-20 lbf-in (1.1-2.4 Nm).
- (3) Measure gaps between nuts and lanyards. Gap should be 0.005-0.015 in (0.13-0.38 mm).
- (4) If any gaps are greater than 0.015 inch (0.38 mm), remove applicable NAS1291C4M nut. Install necessary thickness of S700W0029-6 laminated washer on NAS6304U10 bolt to obtain proper gap. Install NAS1291C4M nut and tighten to a torque of 10-20 lbf-in (1.1-2.4 Nm).
