International
Aero Engines

V2500 Propulsion System — Nacelle

NACELLE - EXHAUST - TAIL CONE -INTRODUCTION OF PERIODIC
INSPECTIONS FOR CRACKING

V2500-NAC-78-0104

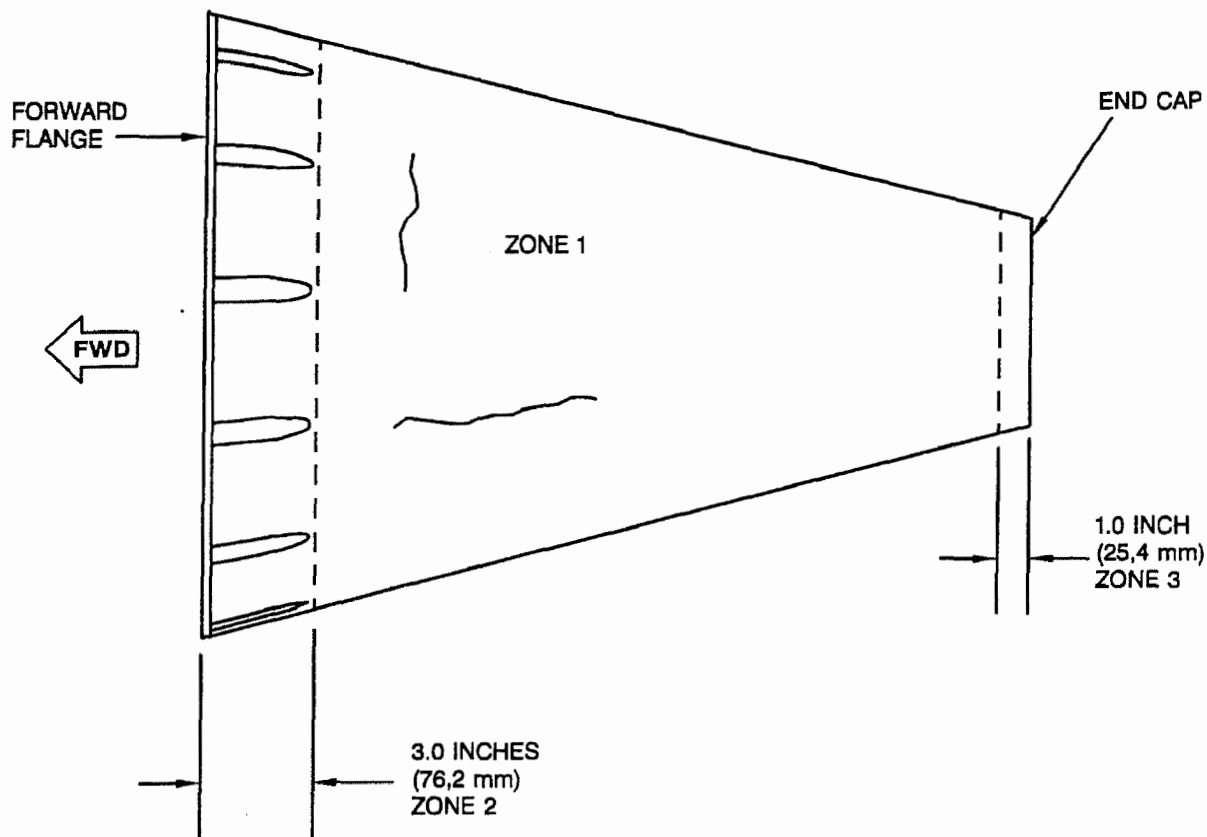
Tail Cone Inspection Criteria
Figure 1

Cracking of the outer skin on the acoustically treated tail cone may have occurred on D5 nacelles.

This anomaly has been attributed to a manufacturing procedure and improvements to the manufacturing process have been incorporated.

- (1) Visually inspect 290-1501-501 tail cone for cracks in zones 1, 2, and 3. Refer to Figure 1.
- (2) If no cracks are found, tail cone is acceptable for further service.
- (3) If cracks are found, use the following criteria for disposition:

<ol style="list-style-type: none">(a) Zone 1 - any length axially or less than 1.00 in. (25,4 mm) long circumferentially	<p>Acceptable. Re-inspect at next A-check and repair at next C-check per VRS2414. Refer to MD90/V2500D5 Exhaust Cone Component Maintenance Manual, CMM-EC-V2500-3IA</p>
--	---

- (b) Zone 1 - Circumferential cracks more than 1.00 in. (25,4 mm)
- Repair tail cone per VRS2414. Refer to MD90 / V2500D5 Exhaust Cone Component Maintenance Manual, CMM-EC-V2500-3IA.

- (c) Zone 2 -less than 0.50 in. (12,7 mm) from forward flange or more than 1.00 in. (25,4 mm) circumferentially
- Repair per VRS2414. Refer to MD90/V2500D5 Exhaust Cone Component Maintenance Manual CMM-EC-V2500-3IA.

- (d) All other cracks in Zone 2.
- Acceptable. Re-inspect at next "A" check and repair at next "C" check per VRS2414. Refer to MD90 / V2500D5 Exhaust Cone Component Maintenance Manual, CMM-EC-V2500-3IA.

- (e) Zone 3 -if crack reaches the end cap.
- Repair per VRS2414. Refer to MD90/V2500D5 Exhaust Cone Component Maintenance Manual, CMM-EC-V2500-3IA.
- (f) All other cracks in zone 3.

- Acceptable. Re-inspect at next "A" check and repair at next "C" check per VRS2414. Refer to MD90 /V2500D5 Exhaust Cone Component Maintenance Manual, CMM-EC-V2500-3IA.
