International
Aero Engines

SERVICE BULLETIN

NACELLE - EXHAUST - LEVER ASSEMBLY, THRUST REVERSER OUTER LOCKING
ACTUATOR - REPLACEMENT OF

V2500-NAC-78-0106

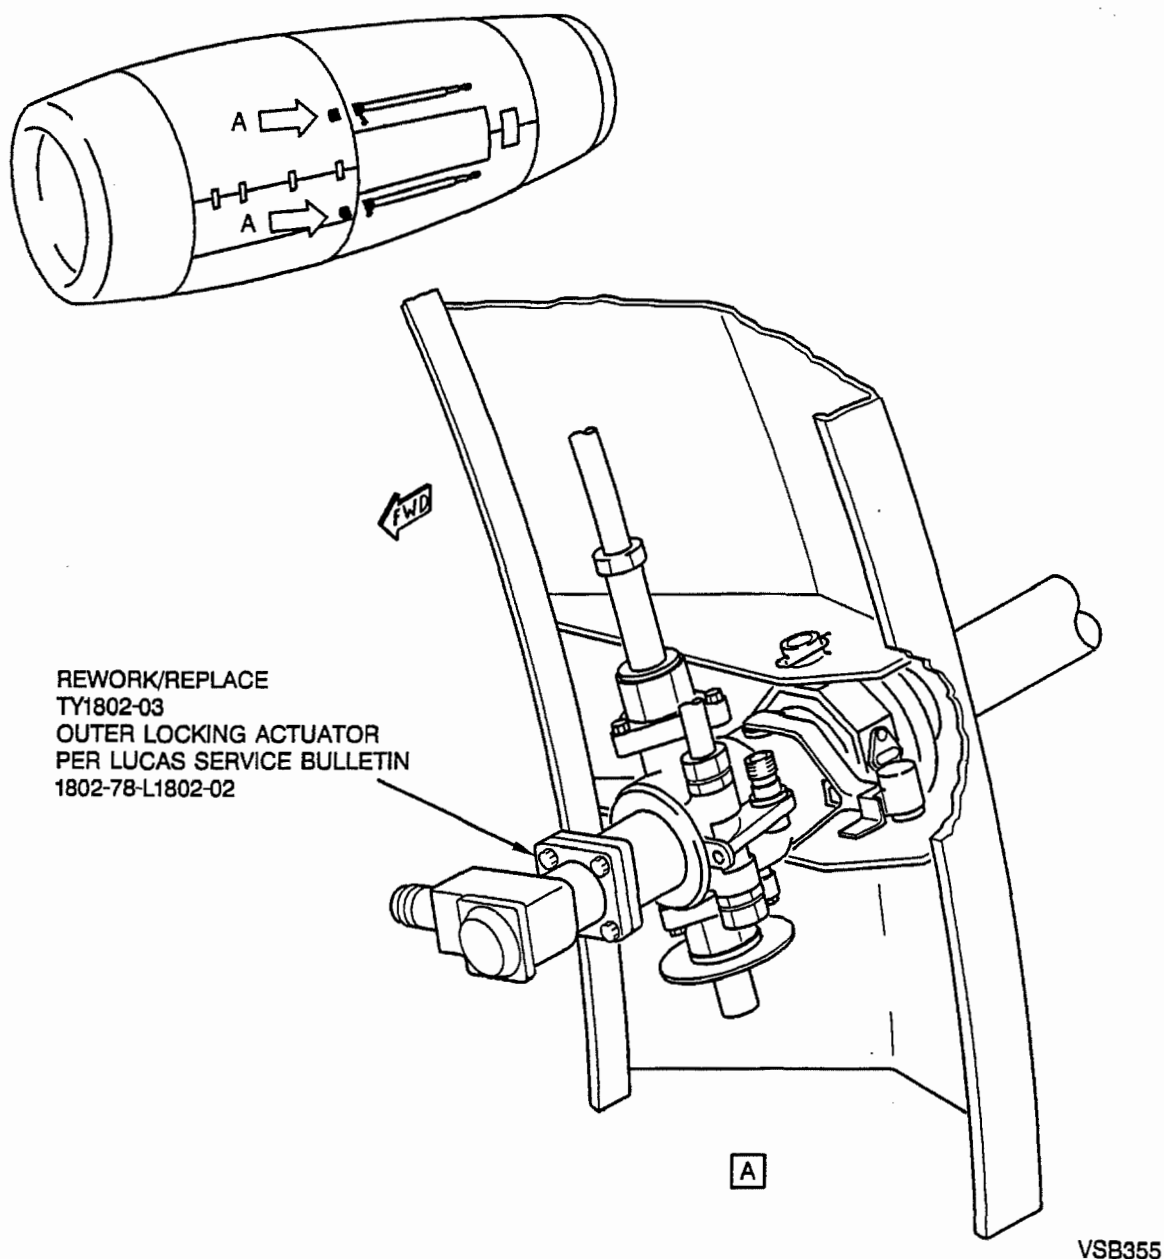
Thrust reverser outer locking actuator
Figure 1

Operators have reported damage to the proximity sensor on thrust reverser outer locking actuator.

Overtravel of outer locking actuator lever assembly during operation.

- (1) Locate TY1802-03 outer locking actuator on left hand upper and lower thrust reverser doors. Refer to Figure 1.
- (2) Visually examine stow pipe on TY1802-03 outer locking actuator for any damage. Refer to Lucas Aerospace Service Bulletin 1802-78-L1802-02 for possible damage area. If there is no damage, continue to paragraph 2.B.(3). If damage is visible, remove damaged outer locking actuator and install replacement TY1802-04 outer locking actuator. Refer to MD90 Aircraft Maintenance Manual, Chapter 78-31-14. Return damaged outer locking actuator to Lucas Aerospace and get replacement TY1802-04 outer locking actuator. Refer to Lucas Aerospace Service Bulletin 1802-78-L1802-02 for address and availability. Continue to paragraph 2.C.

- (3) Replace outer locking actuator lever assembly and proximity sensor, if required, and reidentify TY1802-03 outer locking actuator to TY1802-04 with instructions in Lucas Aerospace Service Bulletin 1802-78-L1802-02.

- (4) Make sure gap is correct between proximity sensor and outer locking actuator lever assembly. Refer to MD90 Aircraft Maintenance Manual, Chapter 78-33-11.

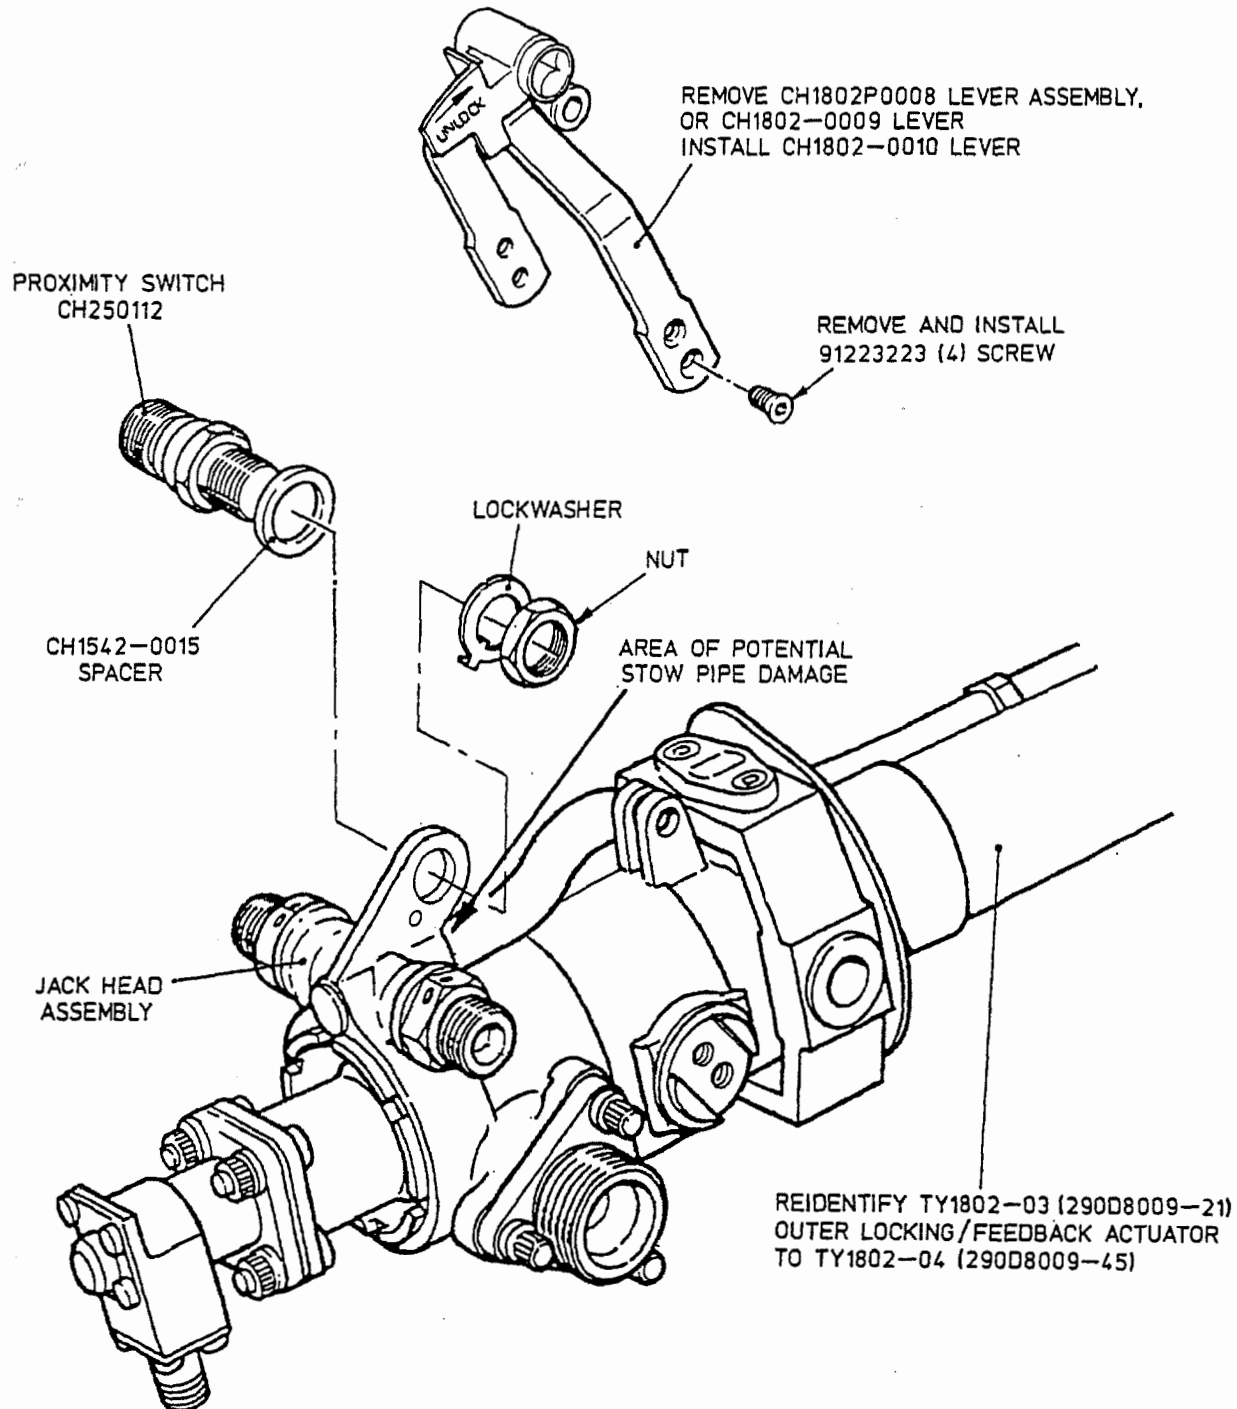
Replacement of Lever Assembly/Proximity Switch
Figure 1

- A. Effectivity – MD90/V2500 Outer Locking/Feedback Actuator TY1802-03
- B. Reason – Operators have reported a foul condition between the lever assembly and proximity switch, resulting in damage to the proximity switch.

- (1) Visually examine the stow pipe attached to the jack head assembly. If there is any damage to the stow pipe (refer to Figure 1), remove the TY1802-03 outer locking/feedback actuator and return to Lucas Aerospace. Replace with TY1802-04 outer locking/feedback actuator and ignore the remainder of this service bulletin.

- (2) Remove the CH1802P0008 lever assembly (TY1802-03 letter A) or the CH1802-0009 lever (TY1802-03 letter B and C) from outer locking/feedback actuator with the four 91223223 screws (refer to Figure 1). Discard the CH1802P0008 lever assembly, return the CH1802-0009 lever to Lucas Aerospace. Retain screws.
- (3) Visually examine the CH250112 proximity switch for any damage which may have occurred from a foul with lever. If there is no damage, return proximity switch from kit to Lucas Aerospace and proceed to paragraph 2.B. (2). If damage has occurred, remove proximity switch as follows:
 - (a) Remove the wirelocking, remove the nut and lockwasher from CH250112 proximity switch. Retain nut and lockwasher.
 - (b) Remove CH1542-0015 spacer and CH250112 proximity switch. Discard proximity switch. Retain spacer.

- (1) If proximity switch required replacement, install new proximity switch as follows:
 - (a) Assemble the original CH1542-0015 spacer on new CH250112 proximity switch.
 - (b) Put CH250112 proximity switch on jack head assembly of outer locking/feedback actuator with lockwasher and nut. Tighten nut to a torque of 12 to 16lbf ft (16,3 to 21,7Nm).
- (2) Apply Hylomar SQ32M or PL32M jointing compound to four 91223223 screws. Put new CH1802-0010 lever on outer locking/feedback actuator with four 91223223 screws. Tighten the screws to a torque of 2.35 to 2.75lbf ft (3,15 to 3,85Nm).

- (3) Using Setting Slip CH1542-0203 or other suitable means, make sure the clearance between the CH250112 proximity switch and the CH1802-0010 lever target face is 0.059 to 0.079 in (1,5 to 2,0 mm). If necessary to obtain the correct clearance select and install a spacer of the correct thickness from the graded range CH1542-0015-1, CH1542-0015-2, CH1542-0015-3 supplied with the mod kit. It may be necessary to use a number of spacers.
- (4) With locking wire, lock the proximity switch nut to the proximity switch.
- (5) Re-identify outer locking/feedback actuator with the vibro-peen method. Refer to paragraph 2.C.
