V2500 Propulsion System — Nacelle

**NACELLE - EXHAUST - TRACK LINERS AND DEPLOY TUBE AND FLEXSHAFT, THRUST  
REVERSER ACTUATION - REPLACEMENT OF**

**V2500-D5**

**V2500-NAC-78-0107**

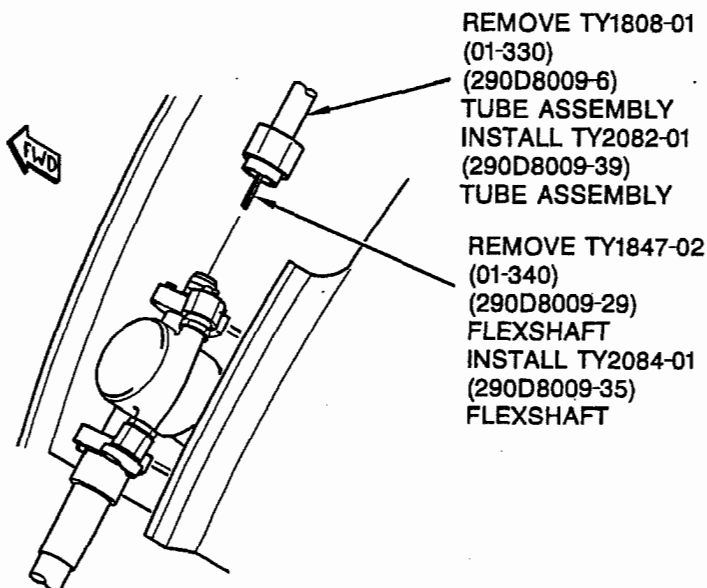
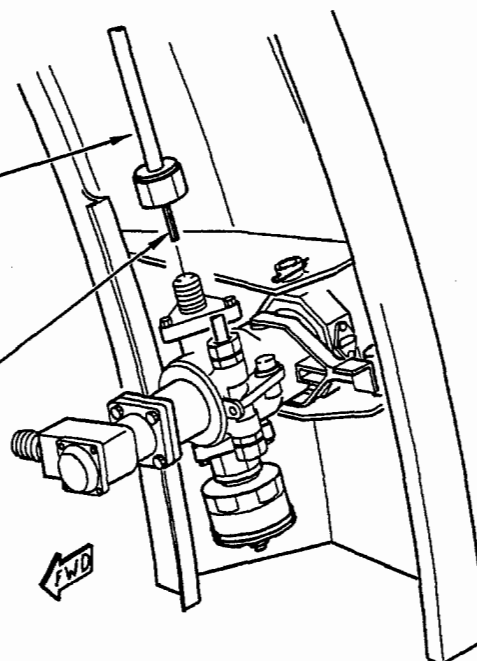
UPPER THRUST REVERSER TUBE AND FLEXSHAFT REMOVAL AND INSTALLATION  
FIGURE 3

REMOVE TY1808-01  
(01-330)  
(290D8009-6)  
TUBE ASSEMBLY  
INSTALL TY2082-01  
(290D8009-39)  
TUBE ASSEMBLY

REMOVE TY1847-02  
(01-340)  
(290D8009-29)  
FLEXSHAFT  
INSTALL TY2084-01  
(290D8009-35)  
FLEXSHAFT

- (a) Remove TY1808-01 (Rohr P/N 290D8009-6) tube assembly and TY1847-02 (Rohr P/N 290D8009-29) flexshaft from the inboard and outboard actuators. Refer to Figures 2 and 3. Refer to MD90 Aircraft Maintenance Manual, Chapter 78-31-16. Discard flexshaft, tube assembly, clamps, and clamp block assemblies. Keep bolts and washers.

- (b) Put TY2084-01 (Rohr P/N 290D8009-35) flexshaft in TY2082-01 (Rohr P/N 290D8009-39) tube assembly. Install tube assembly and flexshaft on inboard and outboard actuators with eight MS9556-06 bolts, eight AN960C10 washers, two TAO27028PH10 clamps, and two 11876 clamp block assemblies. Refer to MD90 Aircraft Maintenance Manual, Chapter 78-31-16. Refer to Figures 2 and 3.
