NACELLE - THRUST REVERSER RIGGING, PRESSURE RELIEF DOOR LATCHES –  
MODIFICATION OF

Turbojet Engine Service Bulletin No. V2500-NAC-78-0110 Revision No. 3 dated May 9, 2017

V2500 Propulsion System — Nacelle

**V2500-NAC-78-0110**

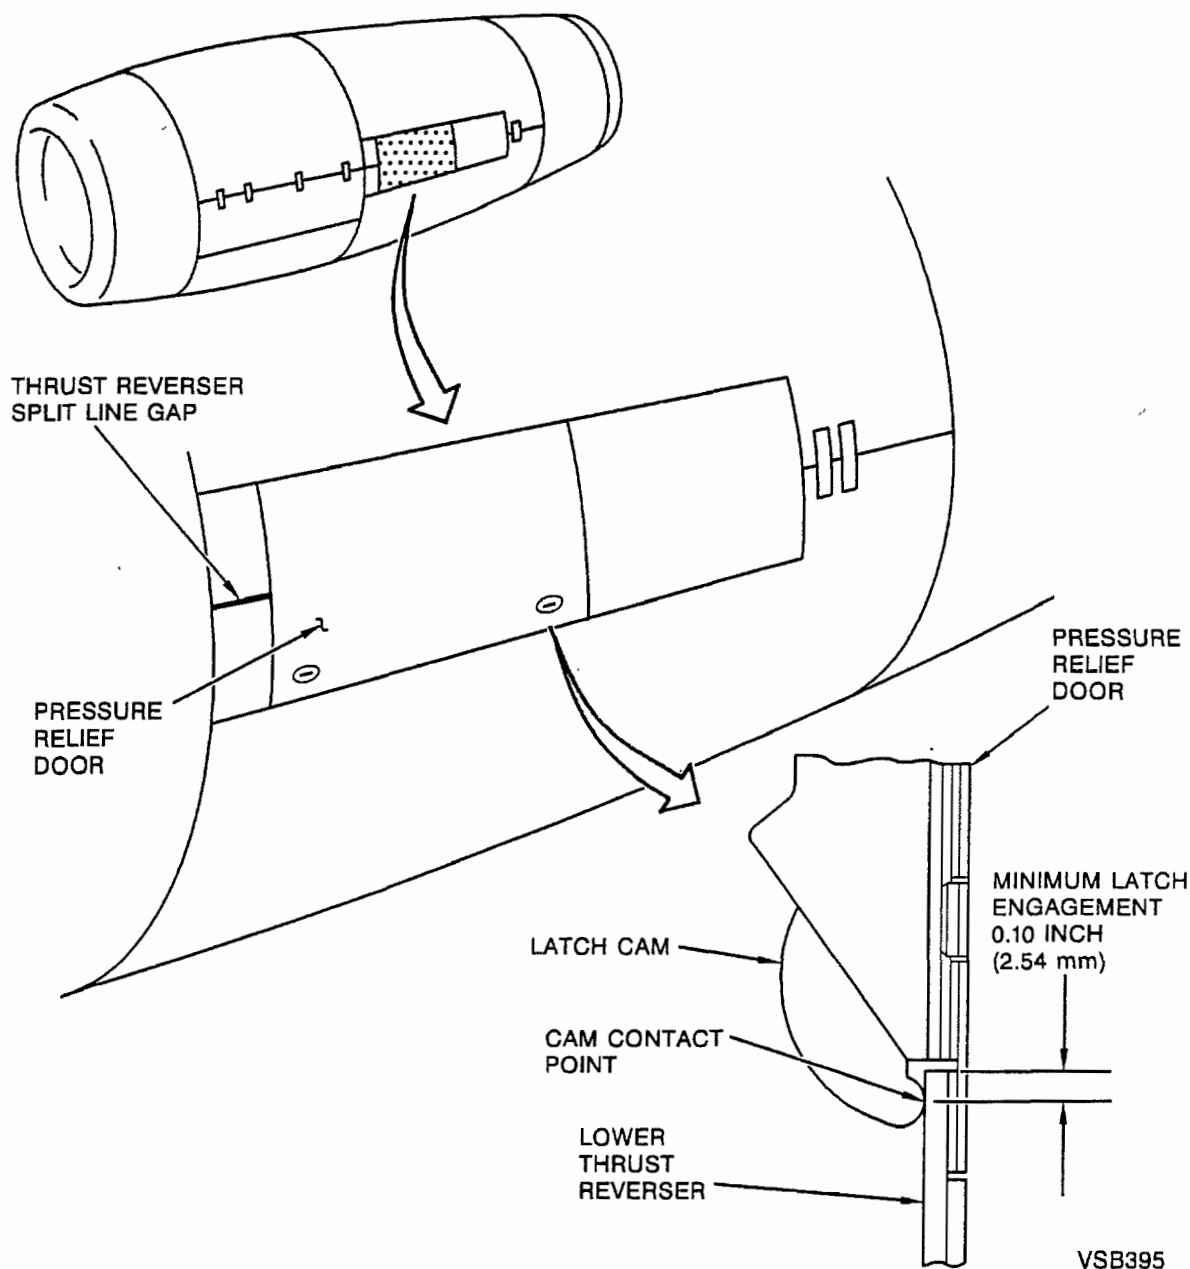
THRUST REVERSER SPLIT LINE GAP AND PRESSURE RELIEF DOOR MEASUREMENT  
FIGURE 1

- (1) Measure the thrust reverser split line gap. The gap should be 0.010-0.160 inch (0.254-4.064 mm). Measure the pressure relief latch engagement. The engagement of both latches should be a minimum of 0.10 inch (2.54mm). Refer to Figure 1. If one or both measurements (thrust reverser split line gap or pressure relief door latch engagement) are not acceptable, perform the following thrust reverser rigging procedure.

- (m) Make sure that the engagement of the pressure relief door latches are a minimum of 0.10 inch (2.54 mm). Refer to Figure 1. If the minimum latch engagement is less than 0.10 inch (2.54 mm), contact your IAE customer support representative.

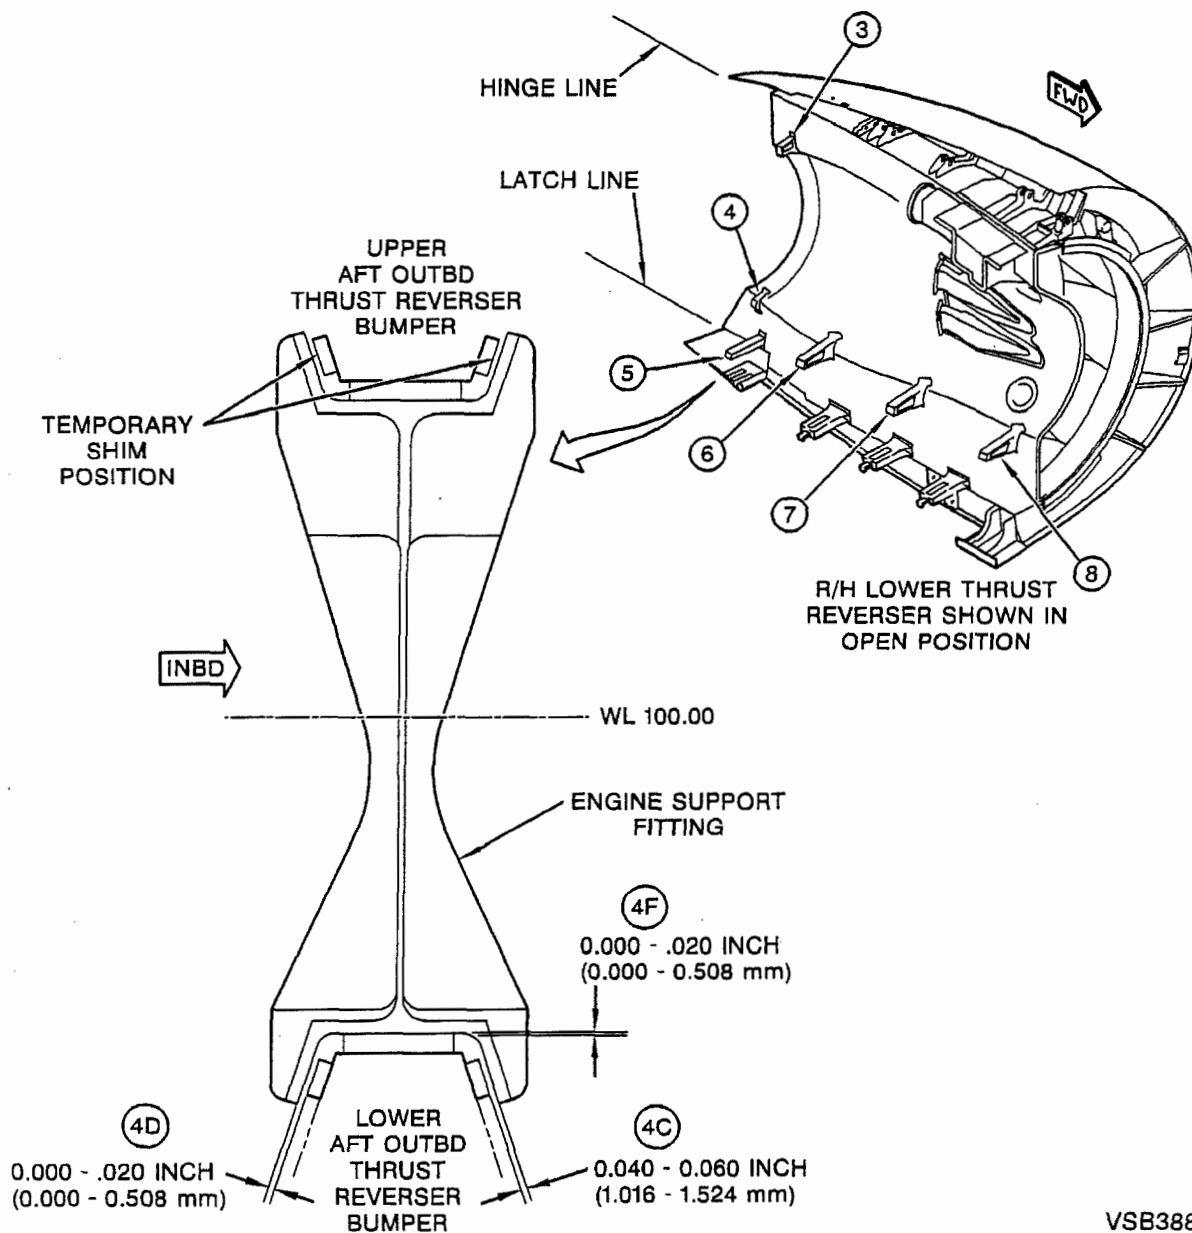
THRUST REVERSER RIGGING ADJUSTMENT  
FIGURE 2

- (i) Open the lower C-duct. Refer to MD-90 Aircraft Maintenance Manual, Chapter 78-32-00, page block 201.
  - (j) Measure gaps between bumpers (thickness of clay) at positions 3, 4, 5, 6, 7, and 8. Refer to Figure 2.

- (k) Add shims to bumpers as required to attain gap of 0.000-0.020 in. (0.000-0.508 mm) at position 3, 0.010-0.050 in. (0.245-1.27 mm) at positions 5, 6, 7, and 8, and gap shown in Figure 2 at position 4.

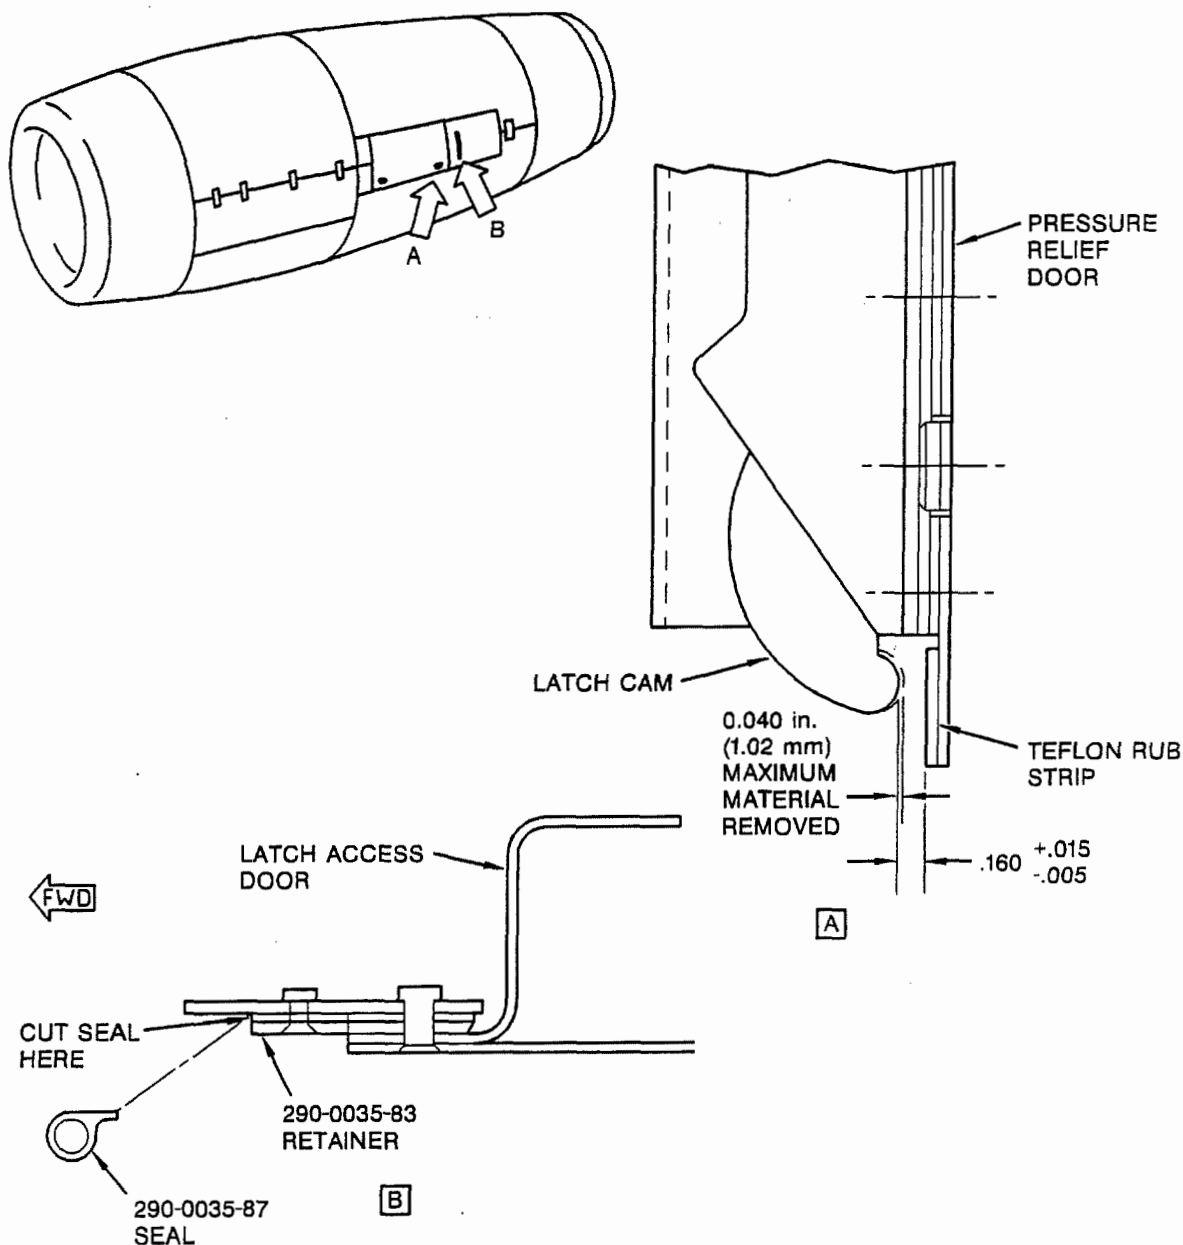
PRESSURE RELIEF DOOR ADJUSTMENT  
FIGURE 3

- (2) Open the thrust reverser pressure relief door.
  - (3) Modify the pressure relief door latches.
    - (a) Measure and record the distance between the latch cam and the teflon rub strip. Refer to Figure 3.

- (b) If the distance is less than the dimension shown, hand grind the latch cam with non-metallic abrasive to achieve the dimension shown in Figure 3. Keep the original radius.

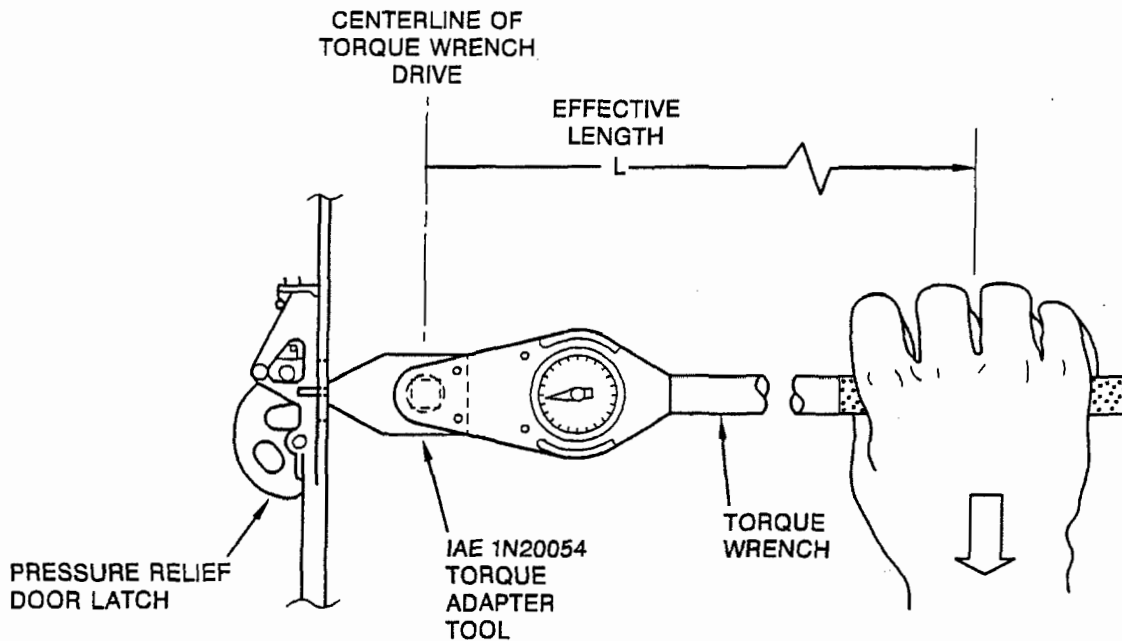
LATCH RELEASE LOAD MEASUREMENT  
FIGURE 5

USAGE: TO ENSURE PRESSURE RELIEF DOOR LATCHES  
ARE NOT SEIZED AND WILL RELEASE AT RATED  
LOADS - USE 1/2" DRIVE TORQUE WRENCH.

L = Distance from the centerline of the torque wrench drive to the center of the operators hand. Refer to Figure 5.

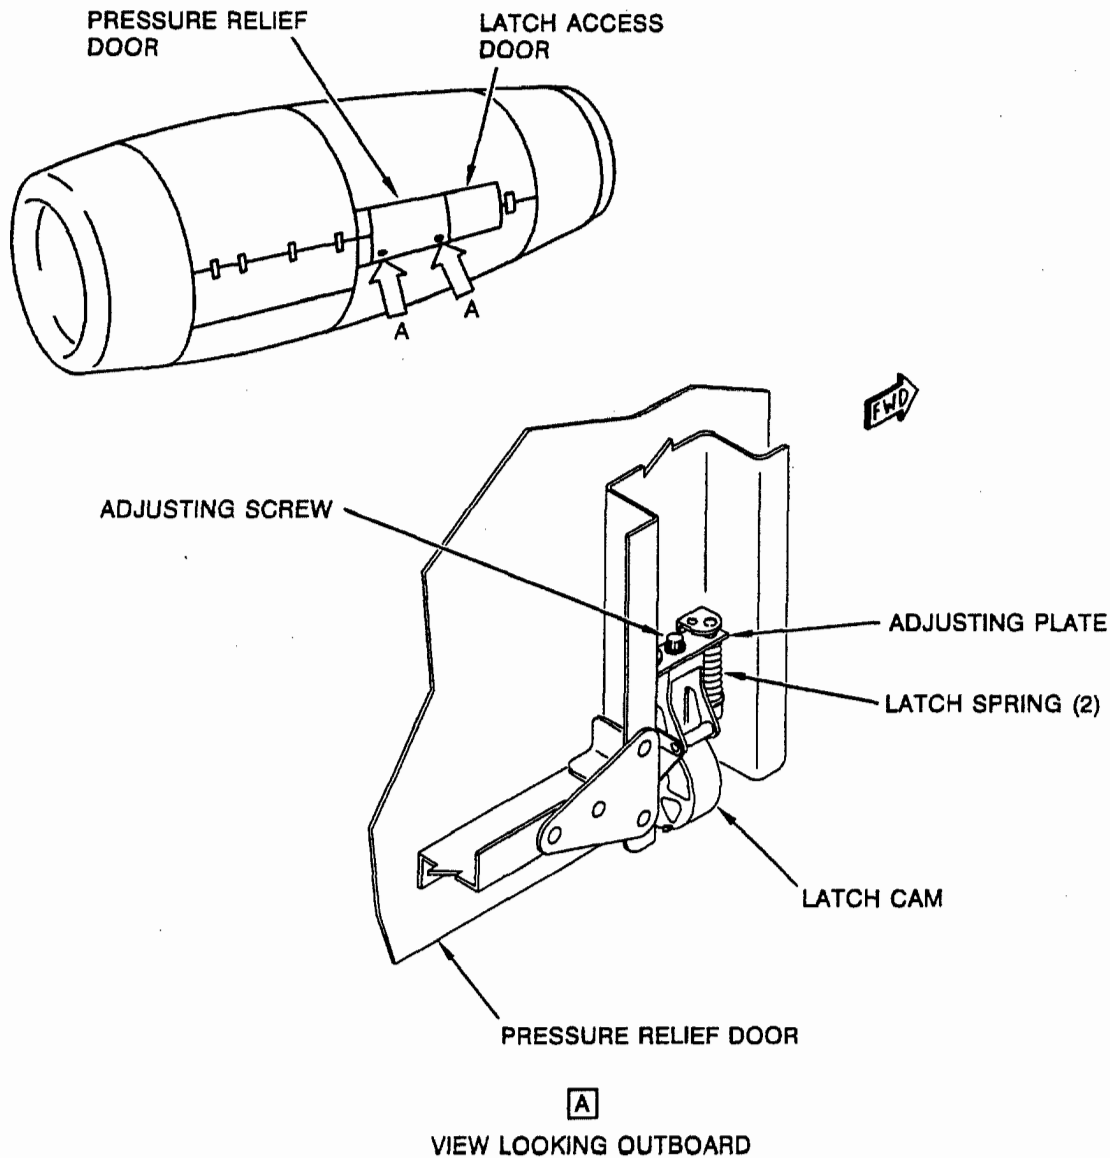
LATCH RELEASE MECHANISM ADJUSTMENT  
FIGURE 6

- (6) If the average closed door, latch release load is more than 329-369 pounds, no further action is required. If the average closed door, latch release load is less than 329 pounds, adjust the latch access door as follow:

- (a) Cut and remove the lockwire from the latch release mechanism adjusting screw. Refer to Figure 6.
  - (b) Tighten the adjusting screw as necessary.

- (e) Safetywire the adjusting screw to the latch release mechanism with 0.032 inch (0.813 mm) diameter lockwire (CoMat 02-147). Refer to IAE V2500 Standard Practices/Processes Manual, Chapter 70-42-05.
