International Aero Engines SERVICE BULLETIN

NACELLE - EXHAUST - COMMON NOZZLE ASSY - BIFURCATION FAIRING -MODIFICATION OF

V2500-D5

V2500-NAC-78-0116 Page 1 of 13

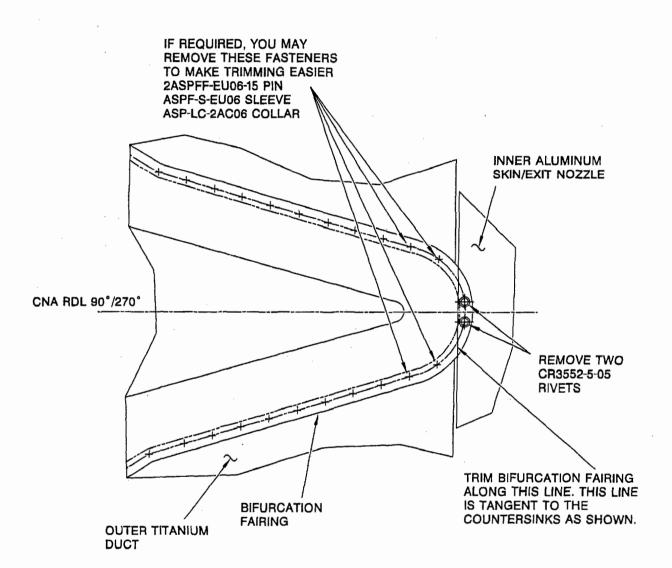
CNA Bifurcation Fairing Trim Figure 1

Cracking may exist at the aft-most fastener hole locations of the CNA Bifurcation Fairing.

- B. Modification Instructions Common Nozzle Assy
 - (1) Find the CNA bifurcation fairing inside the CNA at the 90 degree radial location.
 - (2) Use a (0.156in.) (3,962 mm) diameter drill and remove the two aft-most CR3552-5-05 rivets. Refer to Figure 1.
 - (3) If necessary, you may remove the four adjacent ASPFF-EU06-15 pins, ASPF-S-EU06 sleeves, and ASP-LC-2AC06 collars for access before you trim the fairing. Refer to Figure 1.

(4) Trim the aft portion of the bifurcation fairing as shown in Figure 1.
