**International
Aero Engines**

V2500 Propulsion System — Nacelle

SERVICE BULLETIN

NACELLE - THRUST REVERSER - FAIRING ASSEMBLY, THRUST REVERSER
ACTUATOR - MODIFICATION OF

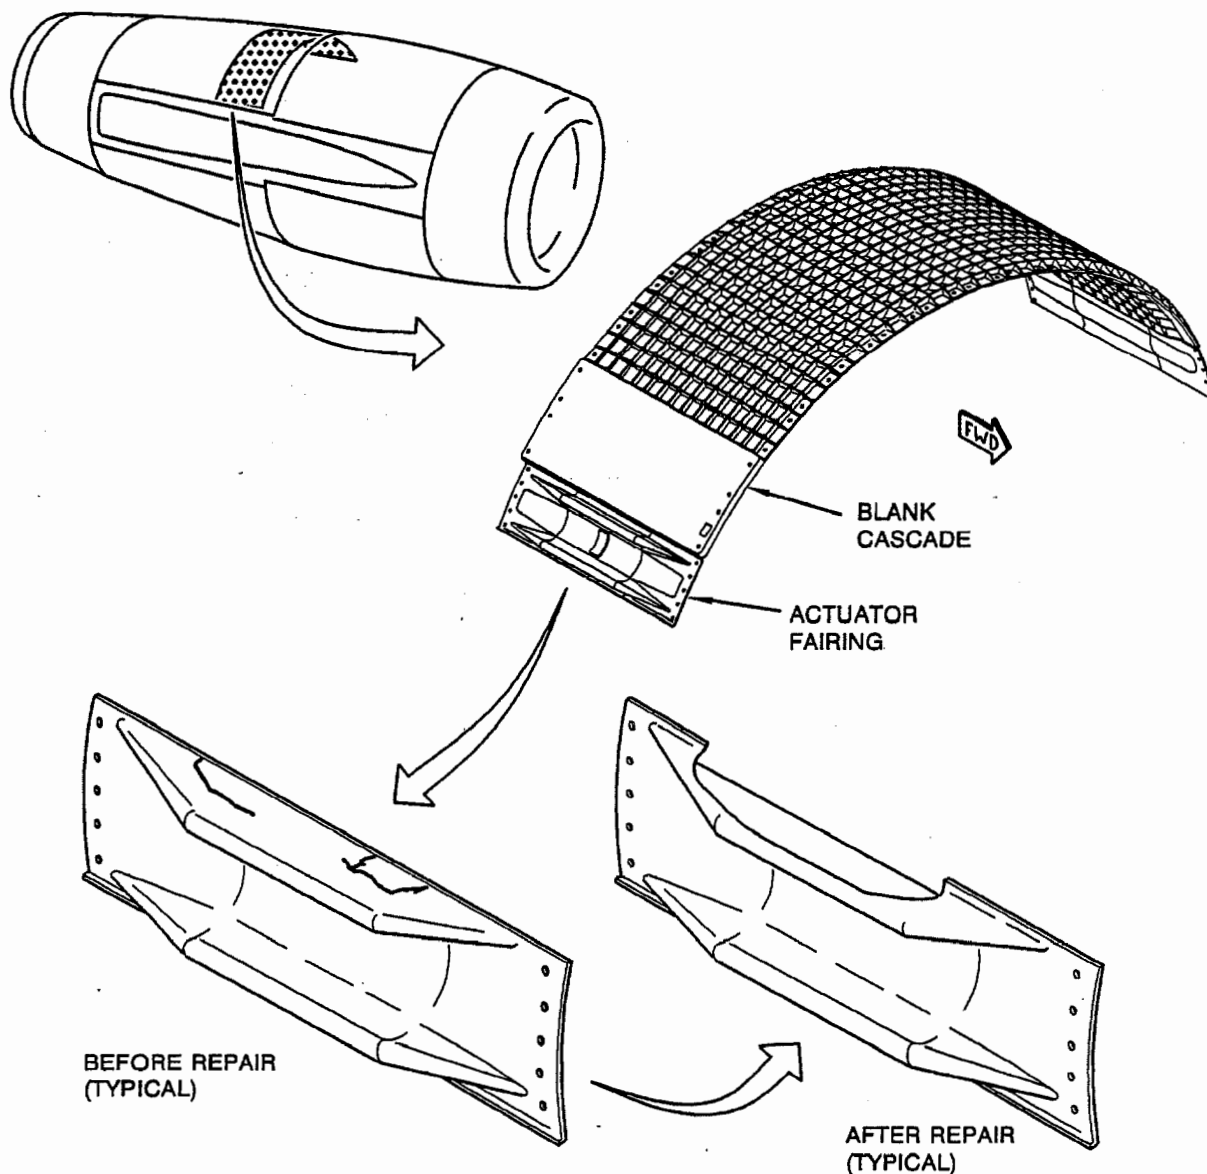
Thrust reverser loading and vibration during thrust reverser deployment may cause an interference between the thrust reverser actuator fairing assemblies and the adjacent thrust reverser blank cascade. This interference may cause the actuator fairing to crack.

Operators have experienced thrust reverser actuator fairing assembly cracks due to interference with the adjacent thrust reverser blank cascade during thrust reverser deployment.

Thrust Reverser Non-locking Actuator Fairing
Trim/Interim Repair - LH Upper Inbd Shown, Lower Inbd Opposite
Figure 1

Part 2 If cracks to the fairing are found, an interim repair can be done after the removal of the adjacent blank cascade for access. The repair will trim and blend the cracked area material as required and remove all sharp corners or edges. After the cracked material is removed, chemical conversion coating will be applied to the exposed edge followed by an application of primer. The blank cascade will then be reinstalled. A 90-day Continue-In-Service period is authorized following this repair, after which time a new fairing must be installed.

- (1) Remove the blank cascade adjacent to the non-locking actuator fairing assembly. Refer to MD-90 Aircraft Maintenance Manual, Chapter 78-32-15, Page Block 401.
- (2) Repair the 290-0031-503 non-locking actuator fairing assembly. Refer to Figure 1.
 - (a) Trim the fairing to remove damaged or cracked material as required and remove all sharp corners and edges.

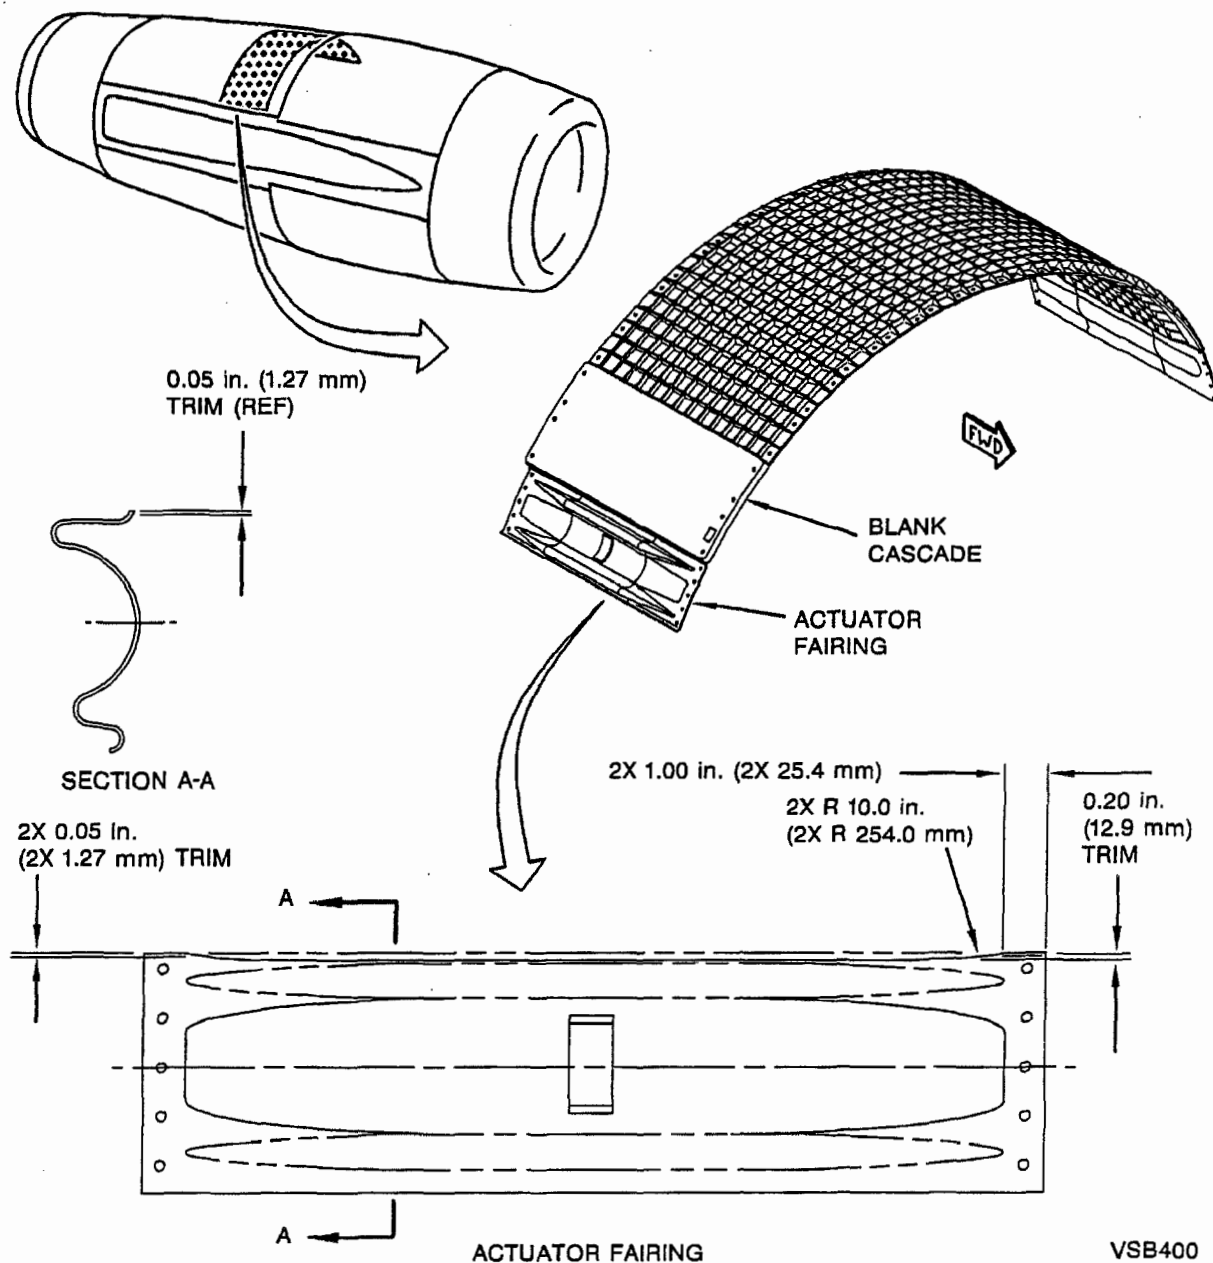
Thrust Reverser Non-locking Actuator Fairing
Trim/Modification - LH Upper Shown, Lower Opposite
Figure 2

Part 3 If no damage is found, the modification can be done after the removal of the adjacent blank cascade for access. The modification will trim away 0.20 inch (5.08 mm) of material along the fairing length and 0.050in. (1.27 mm) from the fairing ends on the fairing/cascade mating edge. After trimming, chemical conversion coating will be applied to the exposed edge followed by an application of primer. The blank cascade will then be reinstalled. Refer to Figure 2, page 12.

- (1) Remove the blank cascade adjacent to the non-locking actuator fairing assembly. Refer to MD-90 Aircraft Maintenance Manual, Chapter 78-32-15, Page Block 401.
- (2) Rework the 290-0031-503 Non-locking Actuator Fairing Assembly.
 - a. Trim the fairing to the dimension shown in Figure 2.
 - b. Break any sharp edges after trim (0.015in. max) (0.381 mm max).
