**International  
Aero Engines**

V2500 Propulsion System — Nacelle

NACELLE - EXHAUST - OUTER SKIN, EXIT NOZZLE, COMMON NOZZLE ASSEMBLY (CNA) -  
MODIFICATION OF

**V2500-NAC-78-0119**

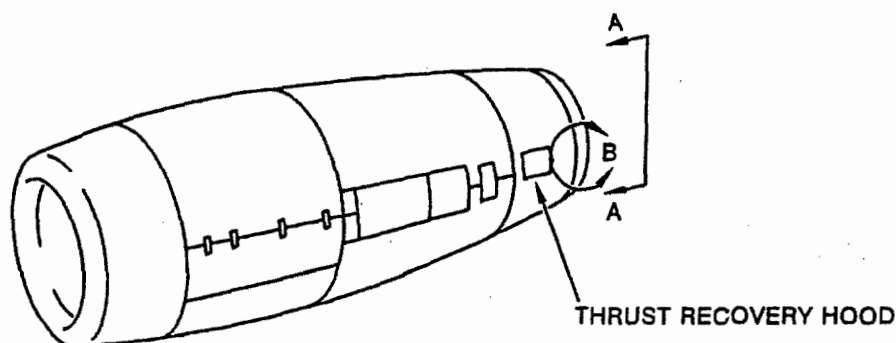
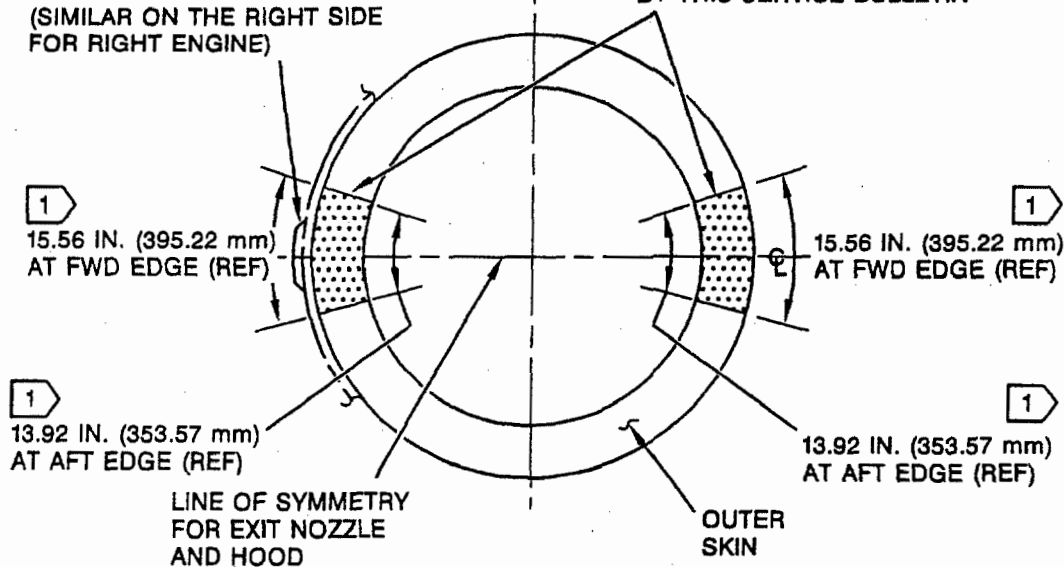
CNA Exit Nozzle Outer Skin Modification  
Figure 1 (sheet 1)

Heat aft of the CNA thrust recovery hood may cause deformation of the CNA exit nozzle skin in that area.

Operators have experienced deformation of the CNA exit nozzle skin aft of the thrust recovery hood.

AREA COVERED  
BY THIS SERVICE BULLETIN

- (1) Clean the damaged area with the solvent (CoMat 01-438) and a lint free cloth (CoMat 02-099). Wipe the surface dry before the solvent evaporates. Refer to Figure 1.

- (2) Find the center line of symmetry. Measure approximately 7.78 inches (197.61 mm) along the circumference on each side of the centerline at the forward edge of the outer skin, and mark the skin. At the aft edge, measure 6.96 inches (176.78 mm) along the circumference on each side of the centerline, and mark the skin. Refer to Figure 1.

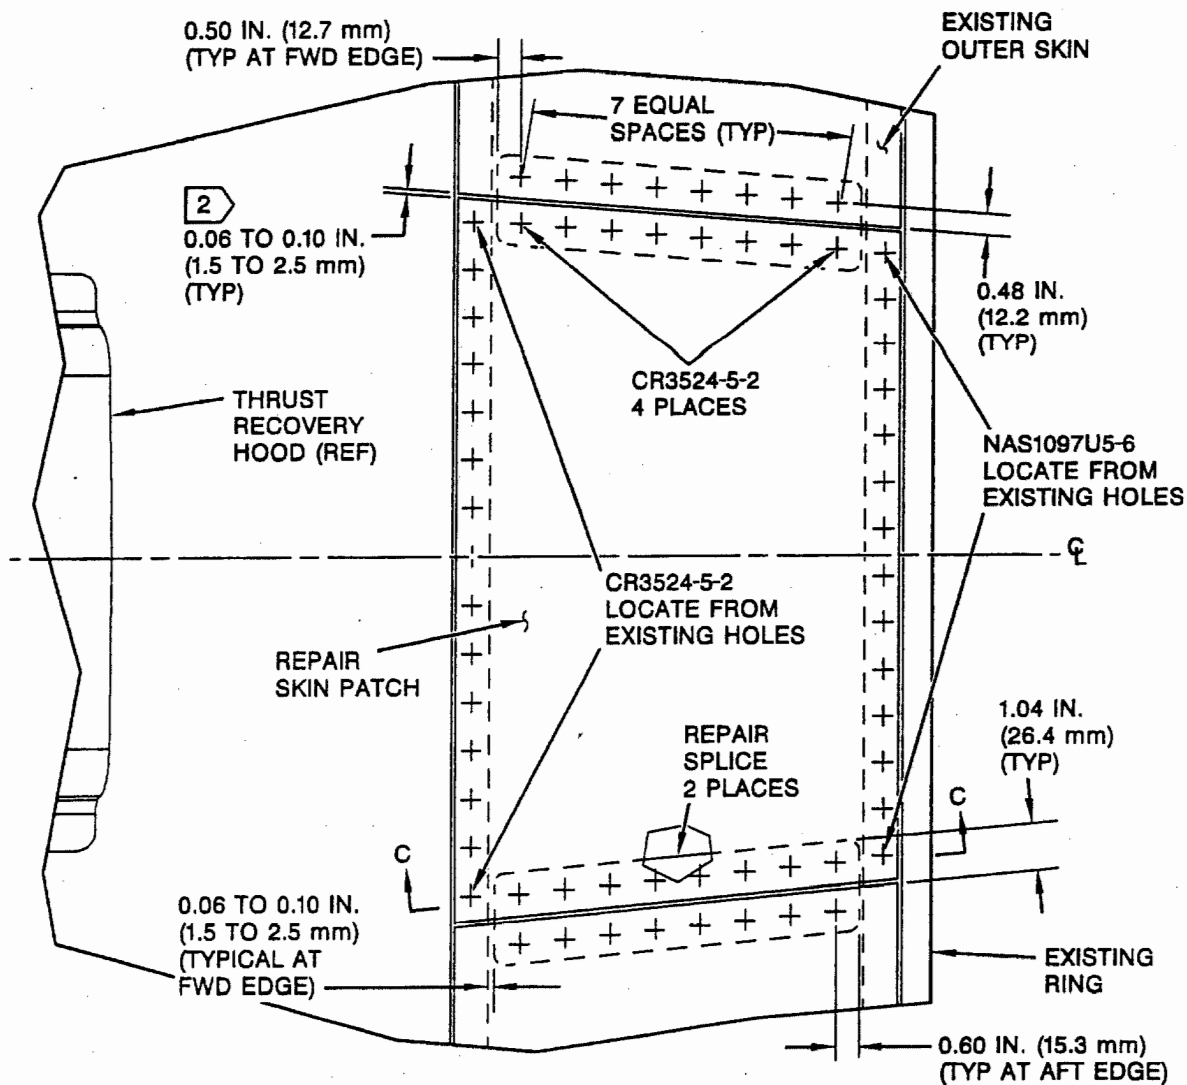
CNA Exit Nozzle Outer Skin Modification  
Figure 1 (sheet 2)

DETAIL B  
VIEW SHOWING THE COMPLETED REPAIR
