**International
Aero Engines**

V2500 Propulsion System — Nacelle

**NACELLE - EXHAUST - THRUST REVERER - PIN, QUICK RELEASE -
HOLD OPEN, PRESSURE RELIEF DOOR - RELOCATION OF**

V2500-NAC-78-0124

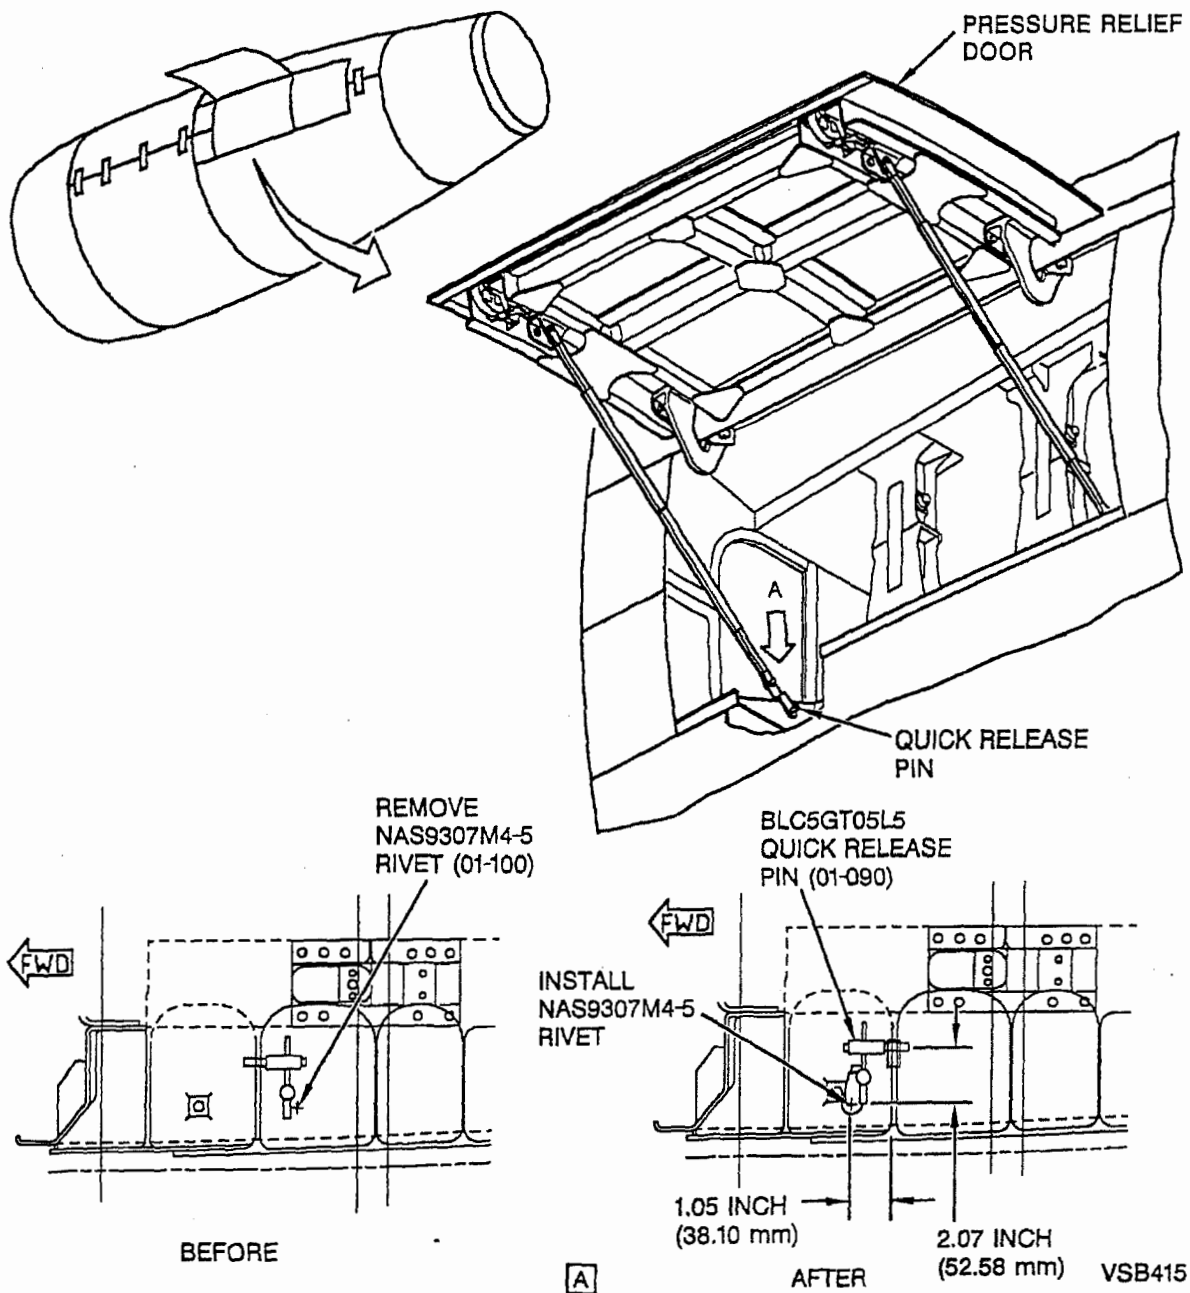
QUICK RELEASE PIN RELOCATION
FIGURE 1

The forward quick release pin used to hold the lanyard on the pressure relief door can be installed in the wrong hole which can cause the pressure relief door to inadvertently open.

- (1) Use a 0.128-0.134 inch (3.251-3.404 mm) diameter drill to remove the NAS9307M-4-5 rivet that attaches the forward BLC5GT05L5 quick release pin lanyard to the track assembly. Remove the quick release pin. Refer to Figure 1.

- (9) Use a 0.128-0.134 inch (3.251 3.404 mm) diameter drill to drill a hole in the track assembly for the NAS9307M-4-5 rivet as shown in Figure 1.
- (10) Attach the quick release pin lanyard to the track assembly with a NAS9307M-4-5 rivet (CR3523P-4-5 or CR3523-4-5 rivets may be substituted for the NAS9307M-4-5 rivet).
