**International
Aero Engines**

SERVICE BULLETIN

**NACELLE - EXHAUST - THRUST REVERSER LOWER CROSS TIE ASSEMBLY -
MODIFICATION OF**

V2500-NAC-78-0125

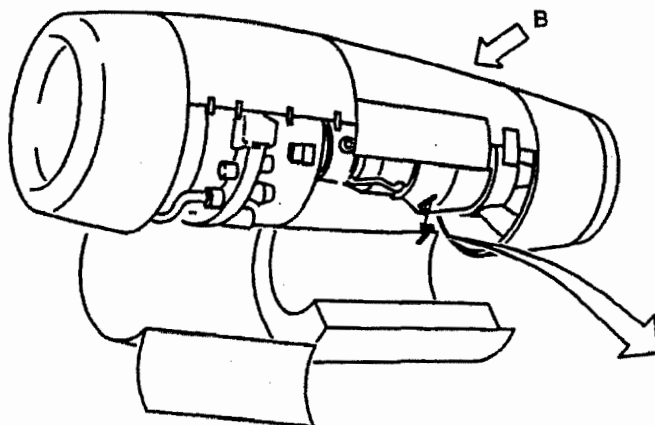
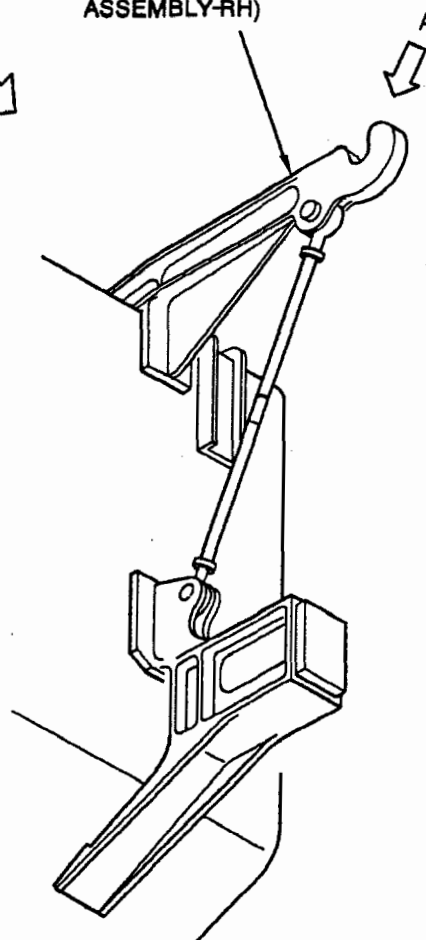
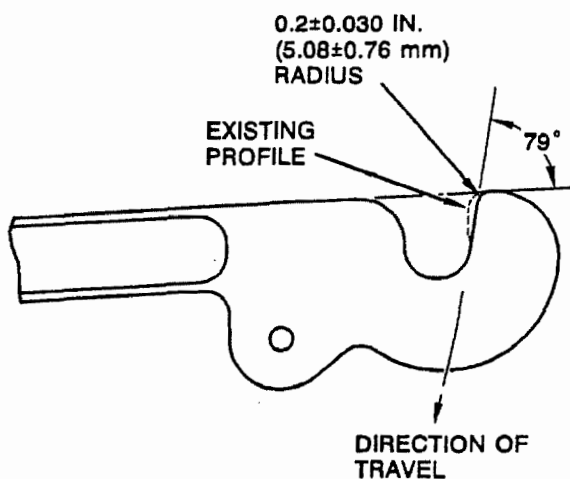
Lower Cross Tie Assembly Modification/Upper Cross Tie Assembly Bushing
Inspection and Damage Removal
Figure 1 (Sheet 1)

Possible interference between the hook portion of the lower cross tie assembly on the lower thrust reverser half and the upper cross tie assembly on the upper thrust reverser half may make it difficult to open the thrust reverser.

Operators have experienced difficulty opening the thrust reverser due to interference between the hook portion of the lower cross tie assembly and the upper cross tie assembly.

- (1) Modify the 290-0277-503 (LH) or 290-0277-504 (RH) lower cross tie assembly. Refer to Figure 1.
 - (a) Machine the indicated material from the hook area of the 290-0277-503 (LH) and 290-0277-504 (RH) lower cross tie assemblies.
- (2) Inspect the 290-0088-501 bushing on the 290-0276-503 (LH) or 290-0276-504 (RH) upper cross tie assembly for surface damage. If damage is found, remove the damage as instructed in paragraph B.(3). If no damage is found, go to paragraph 2.C. Post Requisite Instructions. Refer to Figure 2.
- (3) Remove surface damage from the 290-0088-501 bushing. Refer to Figure 1.
 - (a) Remove the MS21043-6 nut, S700W0131R6H12 washer, NAS 6306U29 bolt, and 290-0088-501 bushing from the upper cross tie assembly.

NOTE: You only need to remove the bushing if necessary for access.
 - (b) Remove any surface damage from the 290-0088-501 bushing with CoMat 05-082 aluminum oxide abrasive paper.
 - (c) Install the MS21043-6 nut, S700W0131R6H12 washer, NAS 6306U29 bolt, and 290-0088-501 bushing on the upper cross tie assembly.
