**International
Aero Engines**

V2500 Propulsion System — Nacelle

**NACELLE — EXHAUST — VENT, COOLING, SLAVE BOOSTER STAGE BLEED VALVE
ACTUATOR (BSBVA) COOLING VENT, RIGHT THRUST REVERSER HALF — ADDITION OF
FOR COOLING AND COMMONALITY ACROSS ALL A320/A321/A319-A5 AIRCRAFT**

V2500-NAC-78-0127

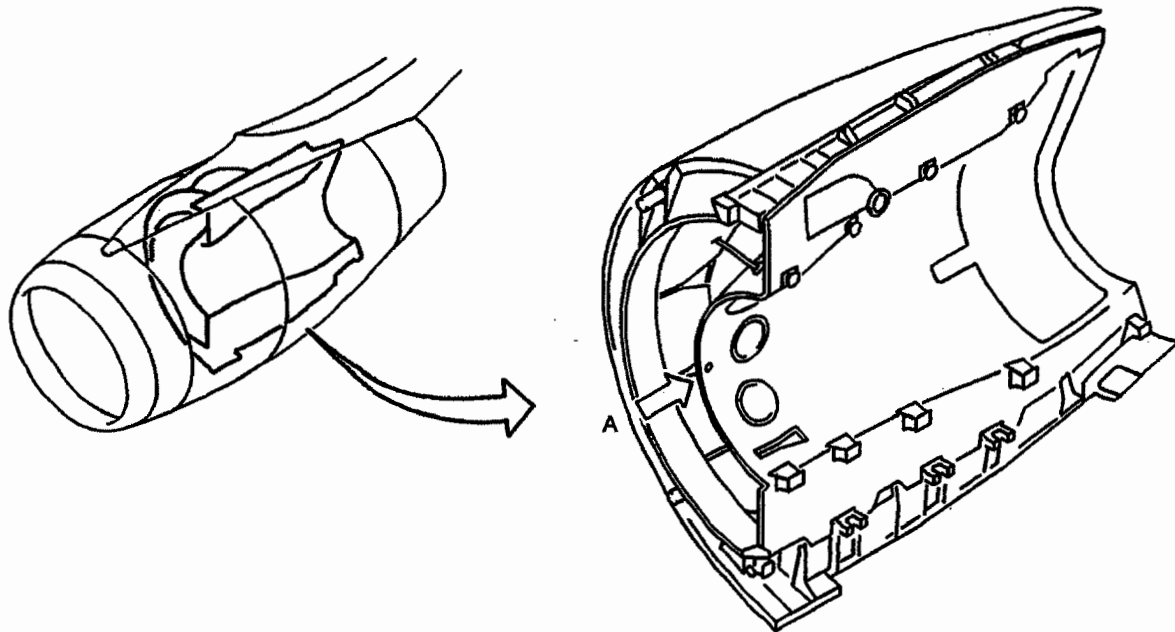
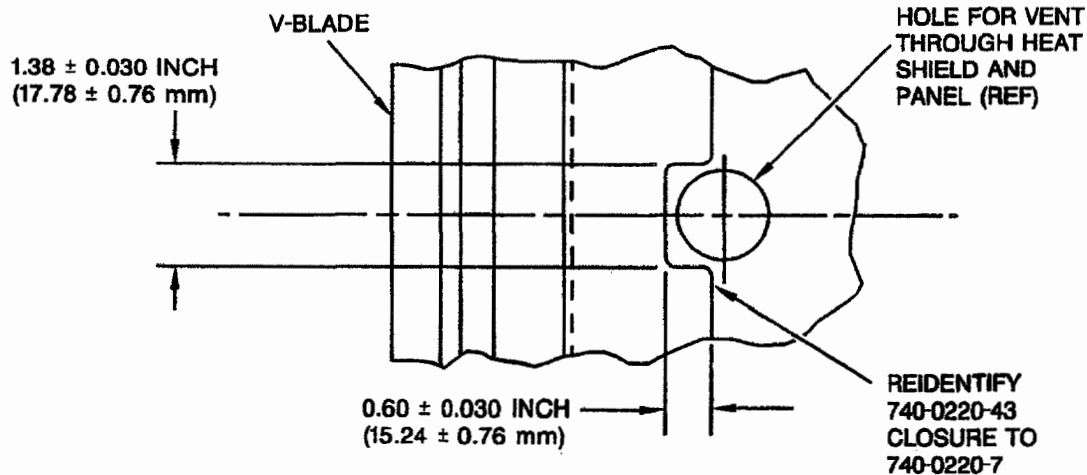
Right Thrust Reverser Half Modification
Figure 1 (Sheet 1)

Due to certification requirements on the A319 and A321-200, the Slave Booster Stage Bleed Valve Actuator (Slave BSBVA) area now requires greater cooling and incorporation is required for commonality across all A320/A321/A319-A5 aircraft.

Certification flight testing for the A319 and the A321-200 has resulted in a requirement for greater cooling air to the Slave BSBVA area.

- (1) Make a mark at the position for the 740-0550-503 vent on the right thrust reverser half as shown in Figure 1.
 - (a) Remove the filler from the lower edge of the blocker door fitting.

- (b) Put a straight against the bottom edge of the blocker door fitting and make a mark where the straight edge meets the forward edge of the v-blade.

- (c) Measure up 2.27 inches (57.66mm) from the mark made in (b) and make a mark on the forward edge of the v-blade.
 - (d) Perpendicular to the forward edge of the v-blade, from the mark made in (c), measure aft 4.10-4.20 inches (104.1-106.7mm) and make a mark on the panel.
