International
Aero Engines

V2500 Propulsion System — Nacelle

NACELLE - EXHAUST - ATTACH HARDWARE, BLOCKER DOOR-TO-LINK ASSEMBLY
REPLACEMENT OF

V2500-NAC-78-0134

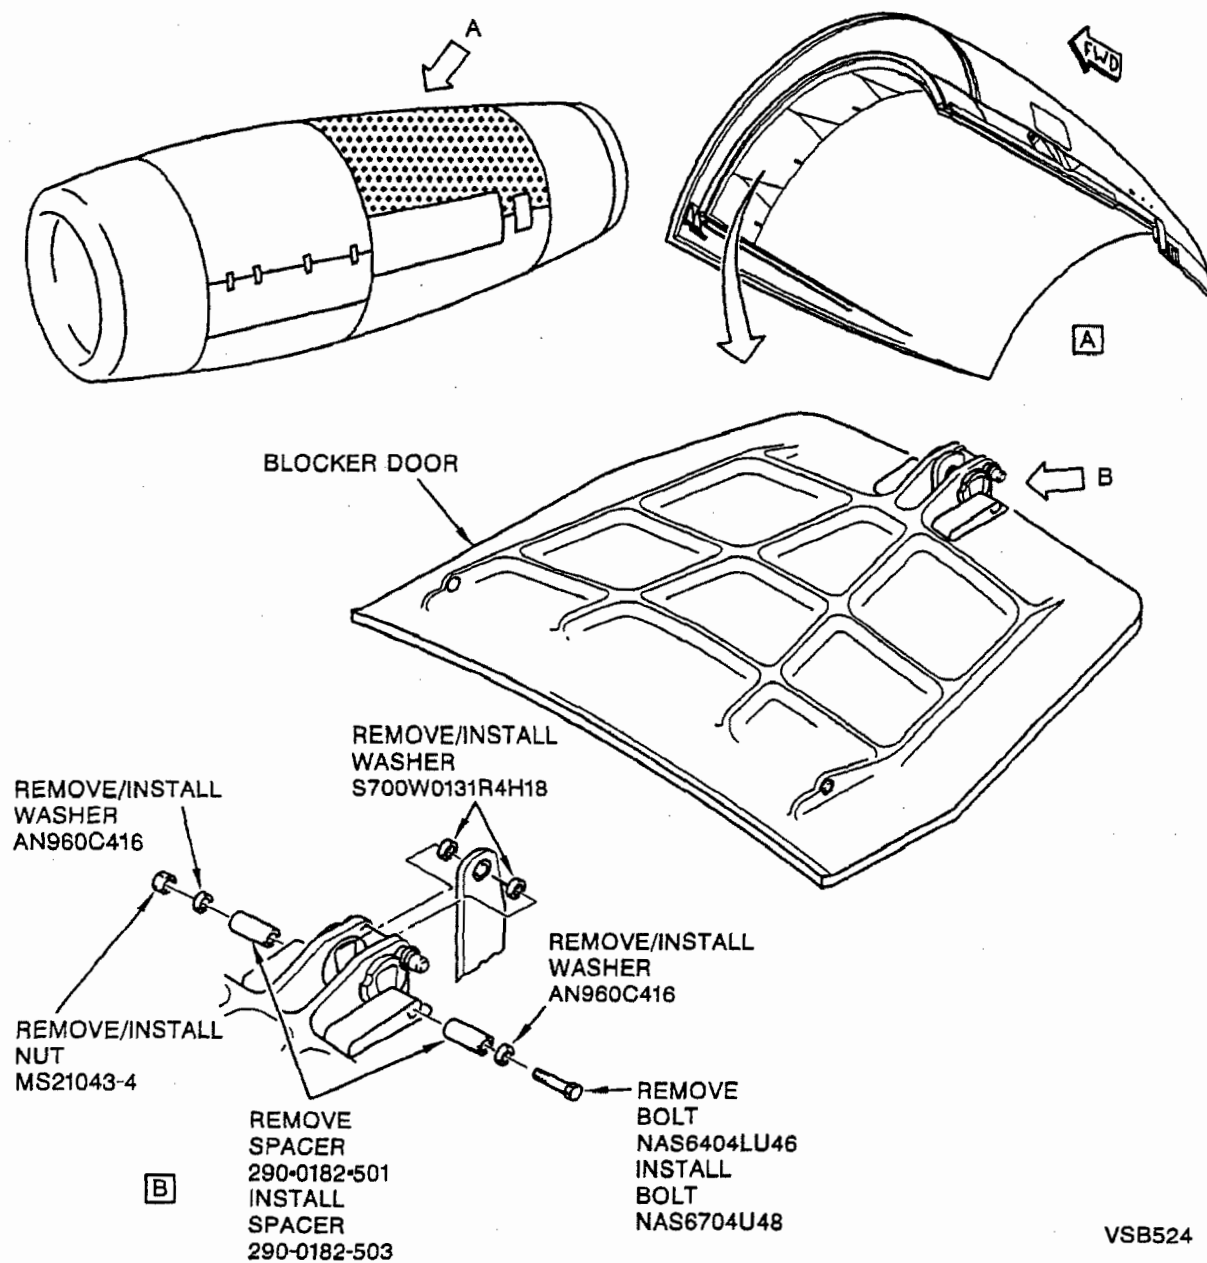
Blocker Door-To-Link Assembly Attach Hardware Replacement
Figure 1

The thrust reverser blocker door-to-link assembly attach bolts have been found to wear prematurely.

- (1) At 10 locations on each thrust reverser, remove the MS21043-4 nut, two AN960C416 washers, two S700W0131R4H18 washers, NAS6404LU46 bolt, and two 290-0182-501 spacers that attach the blocker door to the link assembly.
- (2) At 10 locations on each thrust reverser, install the two 290-0182-503 spacers, NAS6704U48 bolt, two AN960C416 washers, two S700W0131R4H18 washers, and MS21043-4 nut that attach the blocker door to the link assembly. Torque the nuts to 50 to 70 inch-pounds (5.7 to 7.9 Nm).
