V2500 Propulsion System — Nacelle

International  
Aero Engines

NACELLE - EXHAUST - BLOCKER DOOR BUSHING/BUSHING RETAINER PIN  
INSTALLATION - MODIFICATION OF

V2500-NAC-78-0137

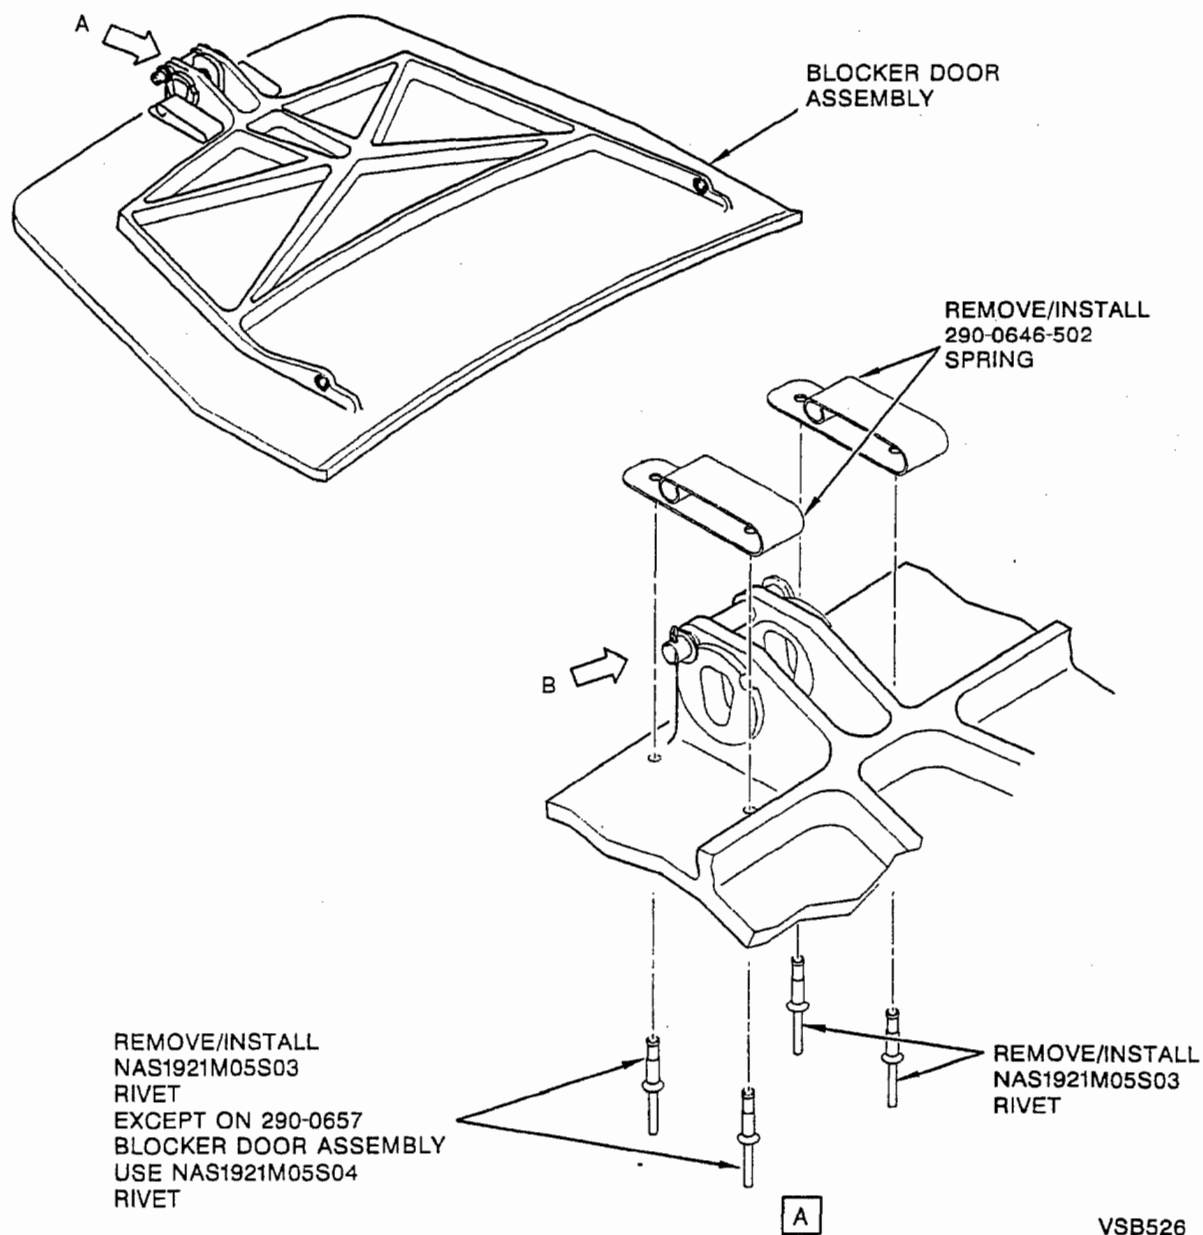
Blocker Door Bushing and Anti-Rotation Pin Installation Modification  
Figure 1 (Sheet 1)

The blocker door bushing can become loose. The blocker door bushing anti-rotation pin can vibrate and cause wear damage to the blocker door.

- (1) Remove the anti-rotation pin from the blocker door.
- (2) Drill out the rivets that attach the spring to the blocker door and remove the spring. Do not make the rivet holes larger.

- (3) Carefully remove the bushings from the blocker door. If the bushings are not loose, heat the bushings to 300 deg F with a heat gun and then remove the bushings.

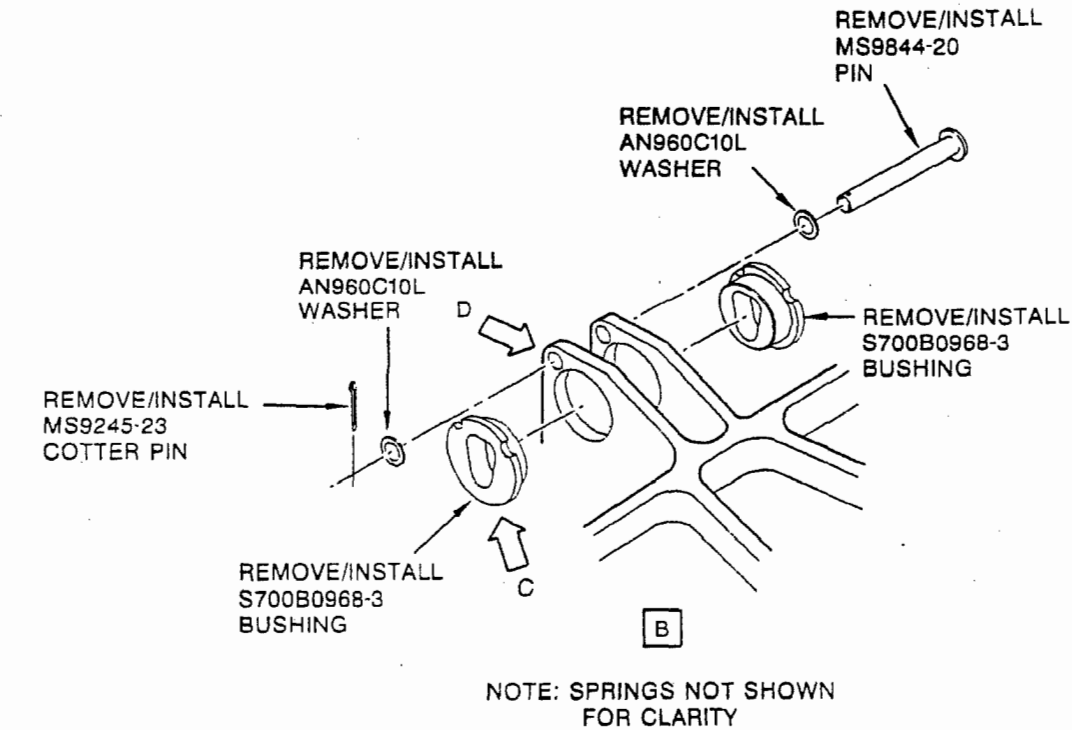
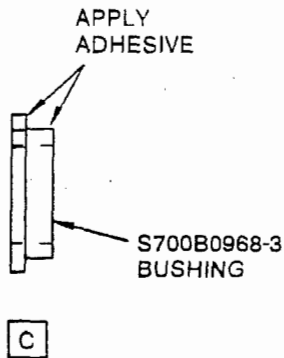
Blocker Door Bushing and Anti-Rotation Pin Installation Modification  
Figure 1 (Sheet 2)

- (a) If the blocker door bushing and anti-rotation pin holes are worn/damaged more than the limits in Figure 1 (Sheet 2), Detail D, you must replace the blocker door.
