**International
Aero Engines**

V2500 Propulsion System — Nacelle

SERVICE BULLETIN

NACELLE - EXHAUST - CASCADE-TO-AFT CASCADE SUPPORT RING ATTACHMENT -
MODIFICATION OF

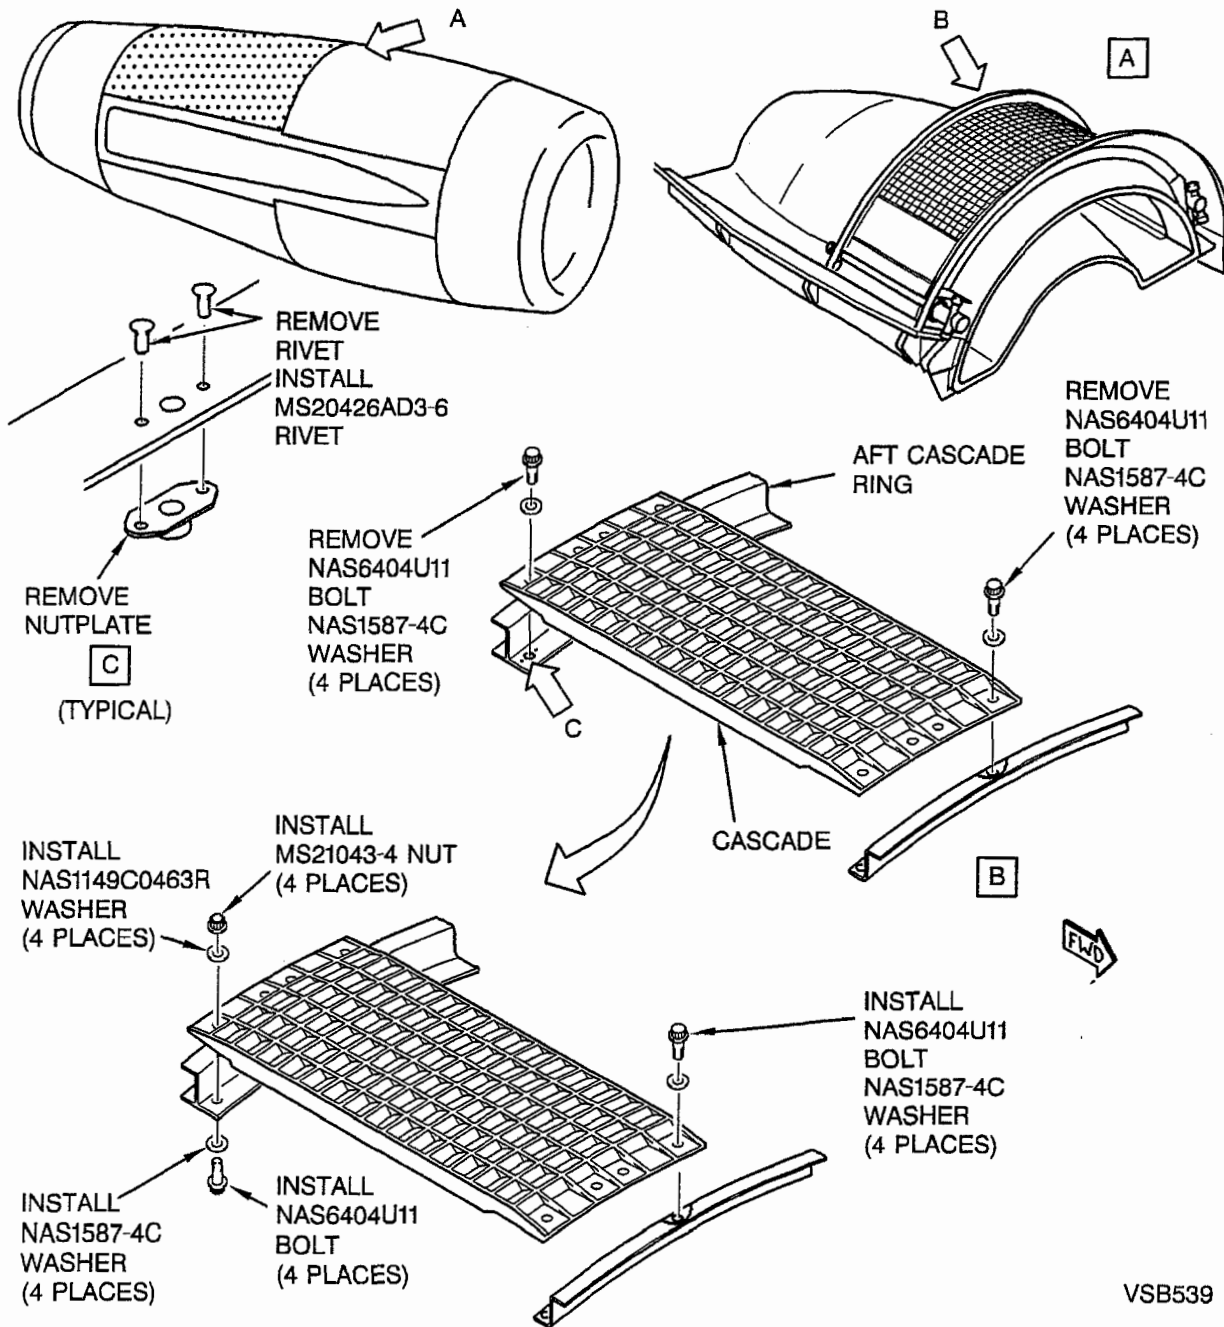
Thrust Reverser Cascade Attachment Modification
Figure 1

The thrust reverser cascade-to-aft cascade ring attach bolts have been found to interfere with the inner surface of the translating sleeve bond panel during certain phases of aircraft operation.

- (1) Inspect the translating sleeve bond panel for damage caused by interference with the cascade attach bolts. Refer to Figure 1.
- (2) If damage is found, repair as follows:

- (7) Install the cascades and blank cascades.
 - a. At the forward end, attach each cascade or blank cascade with four NAS1587-4C washers and four NAS6404U11 bolts. Refer to Figure 1.

- b. At the aft end, attach each cascade or blank cascade to the aft cascade ring with four NAS6404U11 bolts, four NAS1149C0463R washers, four NAS1587-4C washers, and four MS21043-4 nuts. Install the bolts with the heads inboard as shown in Figure 1.
