**International
Aero Engines**

V2500 Propulsion System — Nacelle

**NACELLE — EXHAUST - ACTUATION SYSTEM HARNESS RE-ROUTE AND
CLIPPING POINT HARDWARE REPLACEMENT**

V2500-NAC-78-0141

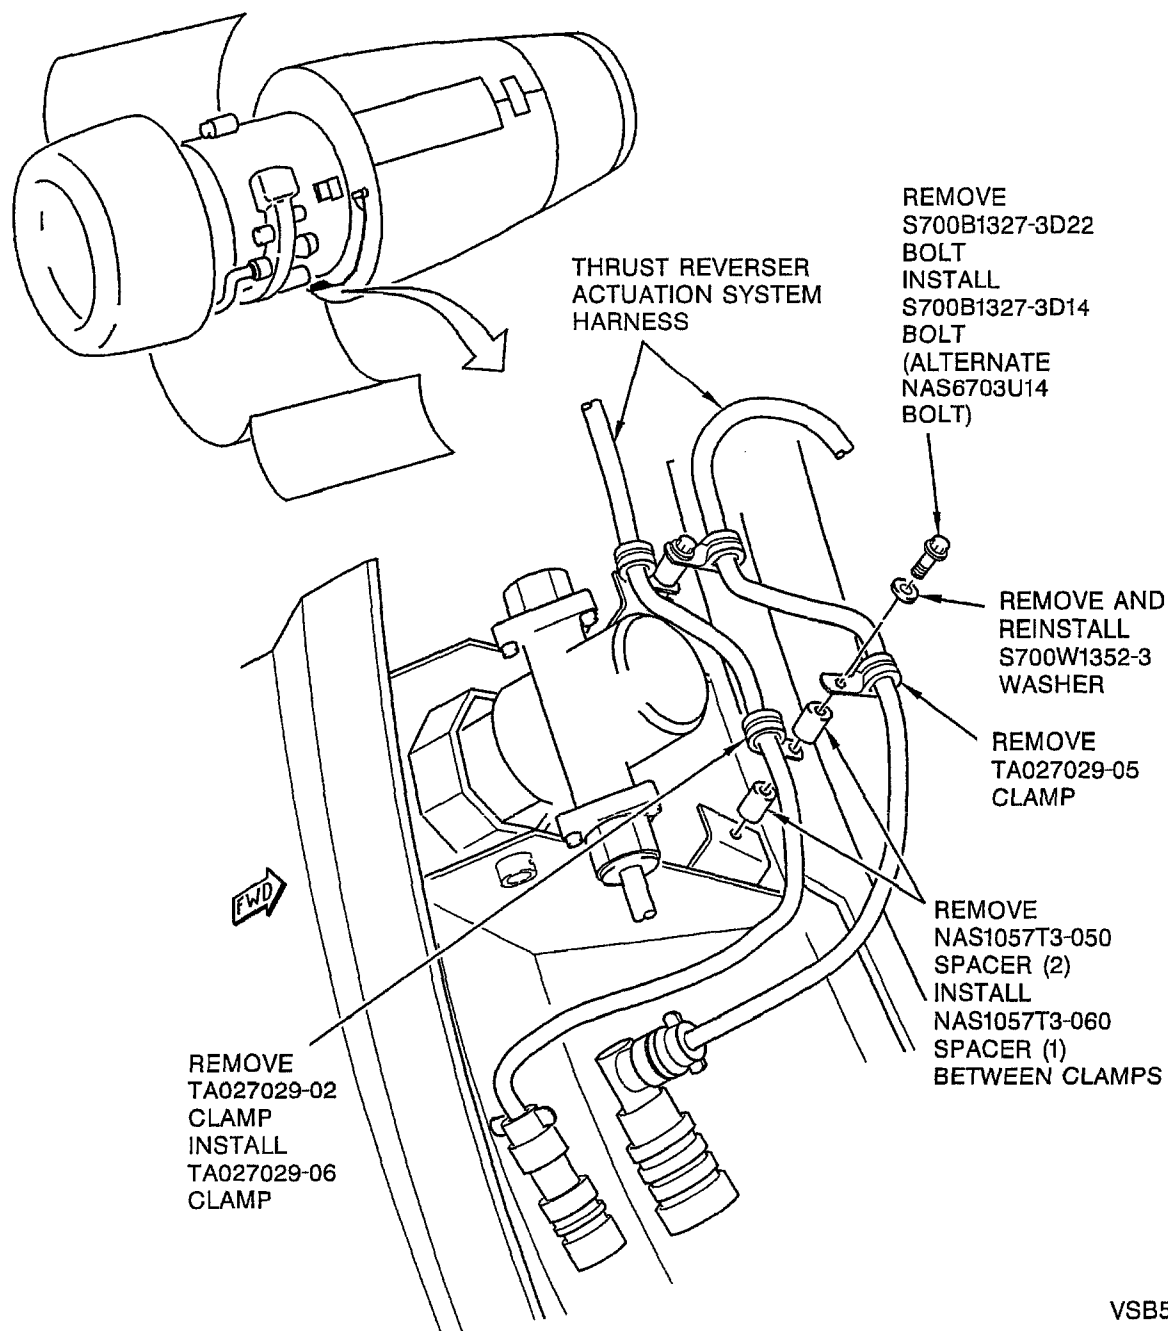
Re-route T/R Actuation Harness & Replace Attach Hardware
Figure 1

Interference may exist between the left hand lower thrust reverser half actuation system harness and the fuel flow meter mounted on the engine fan case.

Operators have experienced wear to the left hand lower thrust reverser half actuation system harness, P/N 6A6460, caused by interference with the engine fuel flow meter.

- (1) If the actuation harness interferes with the fuel flow meter or if there is wear on either the harness or the fuel flow meter, you must inspect for damage/wear and then perform Part 2 of this Service Bulletin. Refer to Figure 1.
- (2) If the harness has damage/wear, contact the local IAE representative for disposition.

- (1) Remove the TA027029-05 clamp, TA027029-02 clamp, two NAS1057T3-050 spacers, and S700B1327-3D22 bolt from the clipping point. Discard the clamps, spacer and bolt. Keep the washers and nuts for installation. Refer to Figure 1.
- (2) Re-route the branch of the harness removed from the lower inboard discarded TA027029-05 clamp and install both branches of the harness into the TA027029-06 clamp (outboard position).
- (3) Install the S700B1327-3D14 bolt, NAS1057T3-060 spacer, and TA027029-06 clamp at the clipping point. Torque the bolt to 50-70 inch-pounds (5.6 -7.9 Nm).
