V2500 Propulsion System — Nacelle

SERVICE BULLETIN

NACELLE - EXHAUST - BLOCKER DOORS, THRUST REVERSER - INSPECTION/REPAIR

V2500-NAC-78-0147

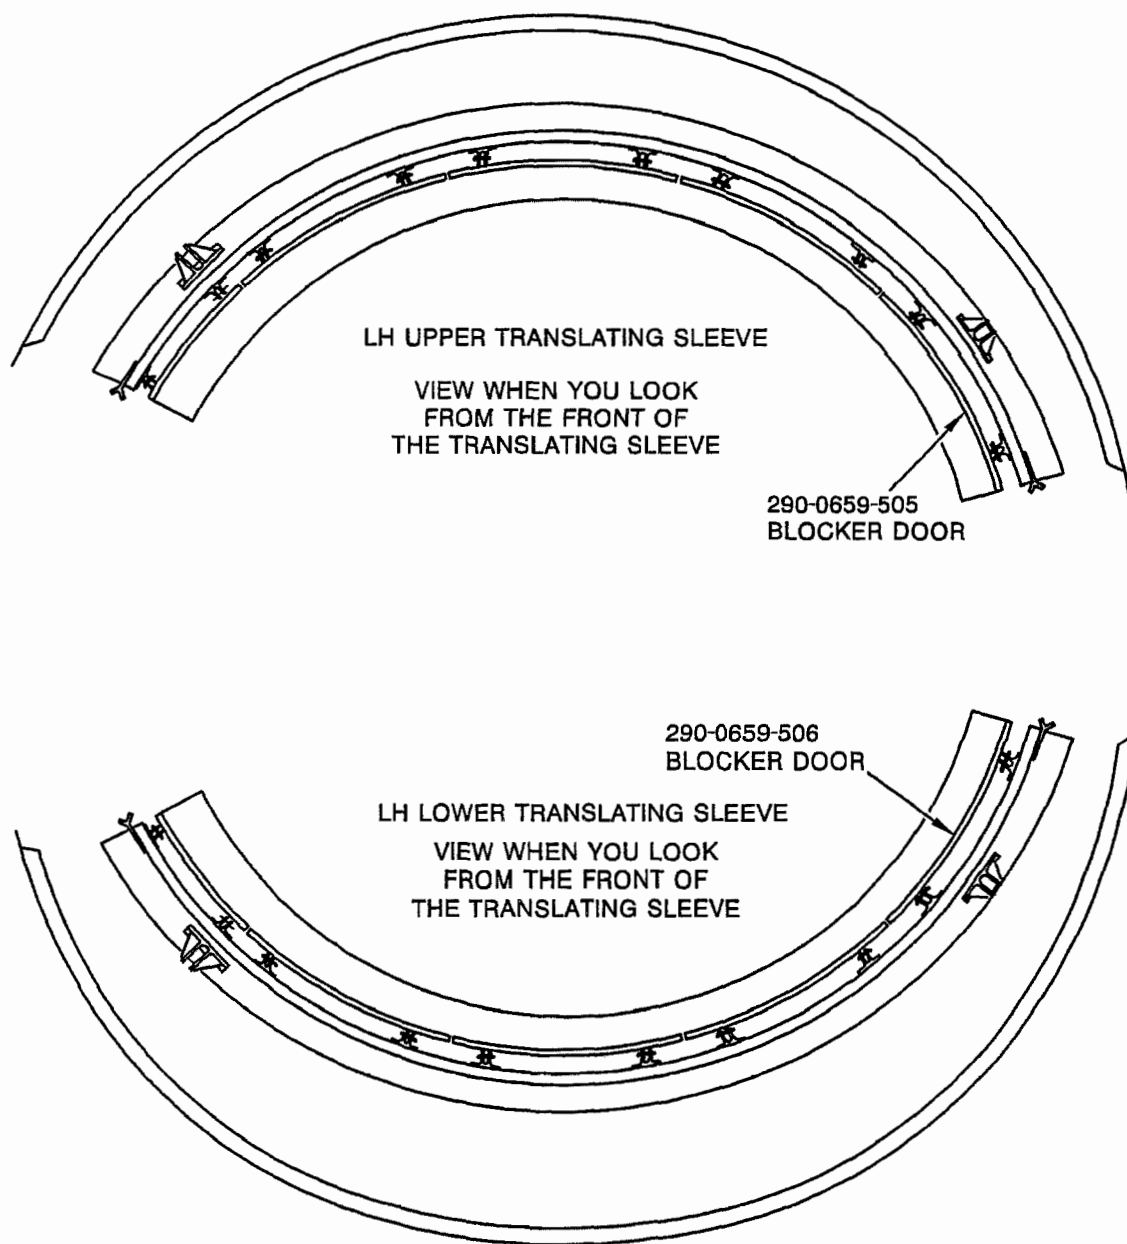
Thrust Reverser Blocker Door Inspection
Figure 1

B. Examine the identification markings on all 290-0659-505 and 290-0659-506 blocker doors (including spare blocker doors). Refer to Figures 1 and 2.

(1) If the blocker door is marked with a date before 11/01/96, and has the name "NC Dynamics" near the assembly part number, you must remove and install the spring as instructed in paragraph C.

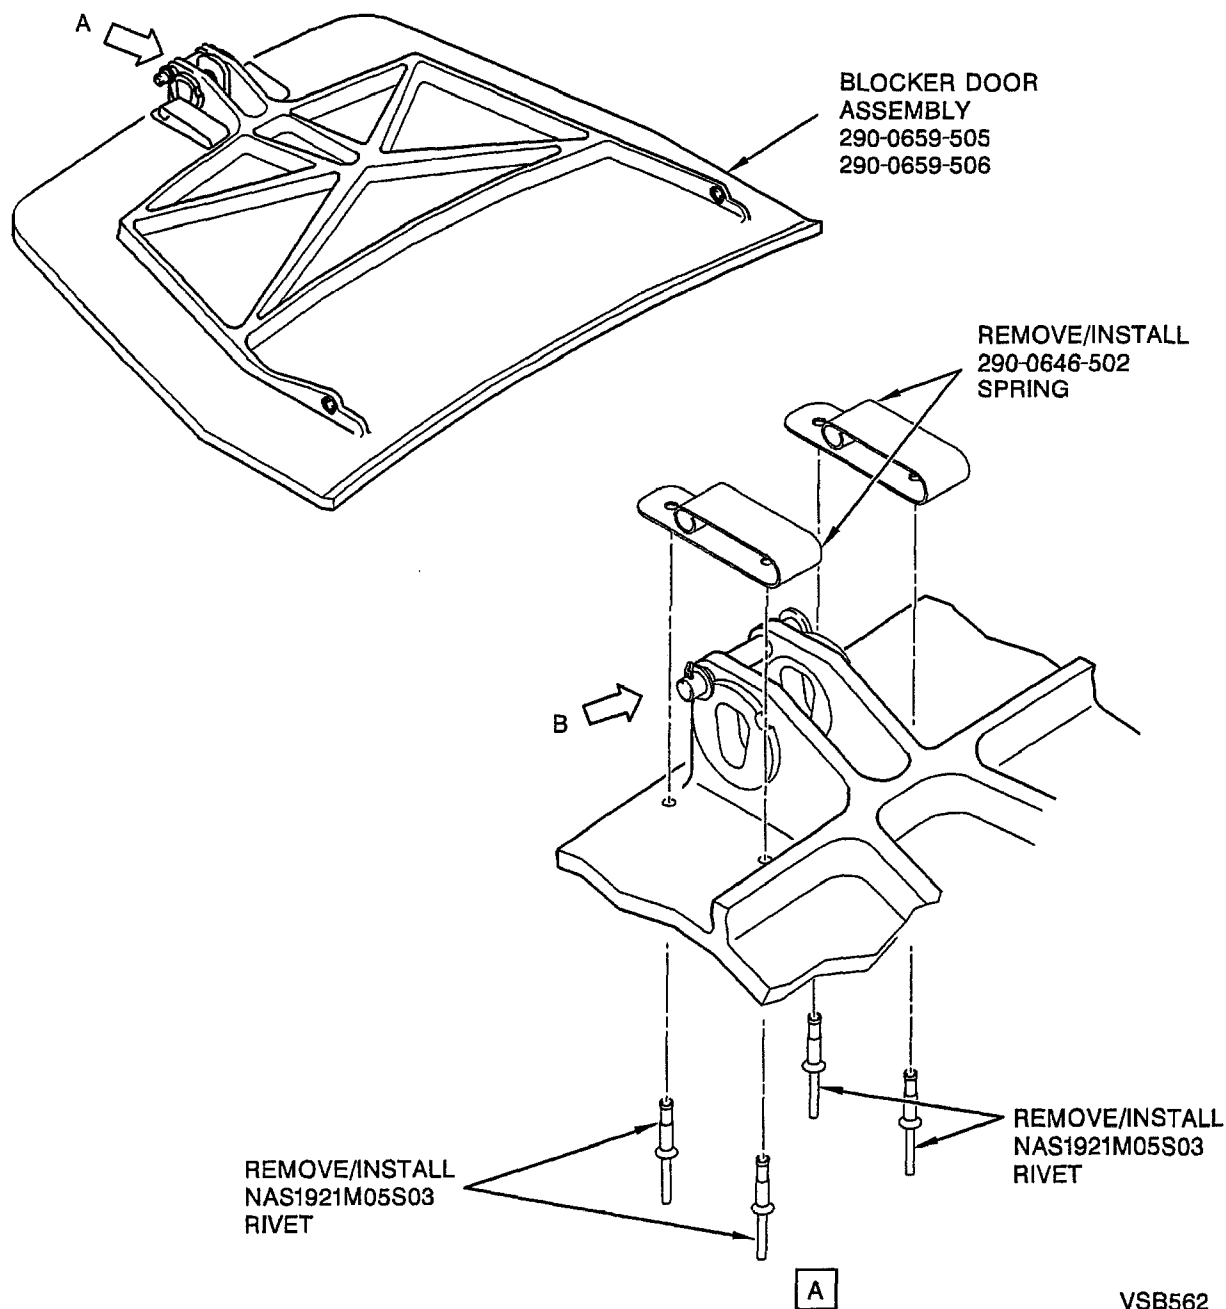
Thrust Reverser Blocker Door Spring Removal/Installation
Figure 3

- (1) The springs of two blocker doors with part numbers 290-0659-505 and 290-0659-506 can come loose from the doors.
- (2) The springs of two blocker doors, with part numbers 290-0659-505 and 290-0659-506, were not installed correctly.
- (3) To find the two doors with the incorrectly installed spring fasteners and remove and correctly install the fasteners.
- (4) Substantiation
Not applicable.

C. Remove and re-install the blocker door springs. Refer to Figure 3.

(2) Remove the rivets and the springs from the blocker door. Do not make the rivet holes larger.

- (3) Mix the primer converter (CoMat 07-115), thinner (CoMat 07-116), and primer base (CoMat 08-039). Refer to the manufacturer's instructions.
- (4) Install the springs on the blocker door with the NAS1921M05S03 rivets. Wet install the rivets with the primer mix. Wipe off any unwanted primer with a lint free cloth (CoMat 02-099) and solvent (01-438).
- (5) If necessary, install the blocker door on the thrust reverser. Refer to the MD-90 Aircraft Maintenance Manual, Chapter 78-32-20, Page block 401.
