**International  
Aero Engines**

# **SERVICE BULLETIN**

**NACELLE — EXHAUST — OVERHEAT DETECTOR HARNESS INSTALLATION, UPPER THRUST  
REVERSER HALF — MODIFICATION OF**

**V2500-NAC-78-0149**

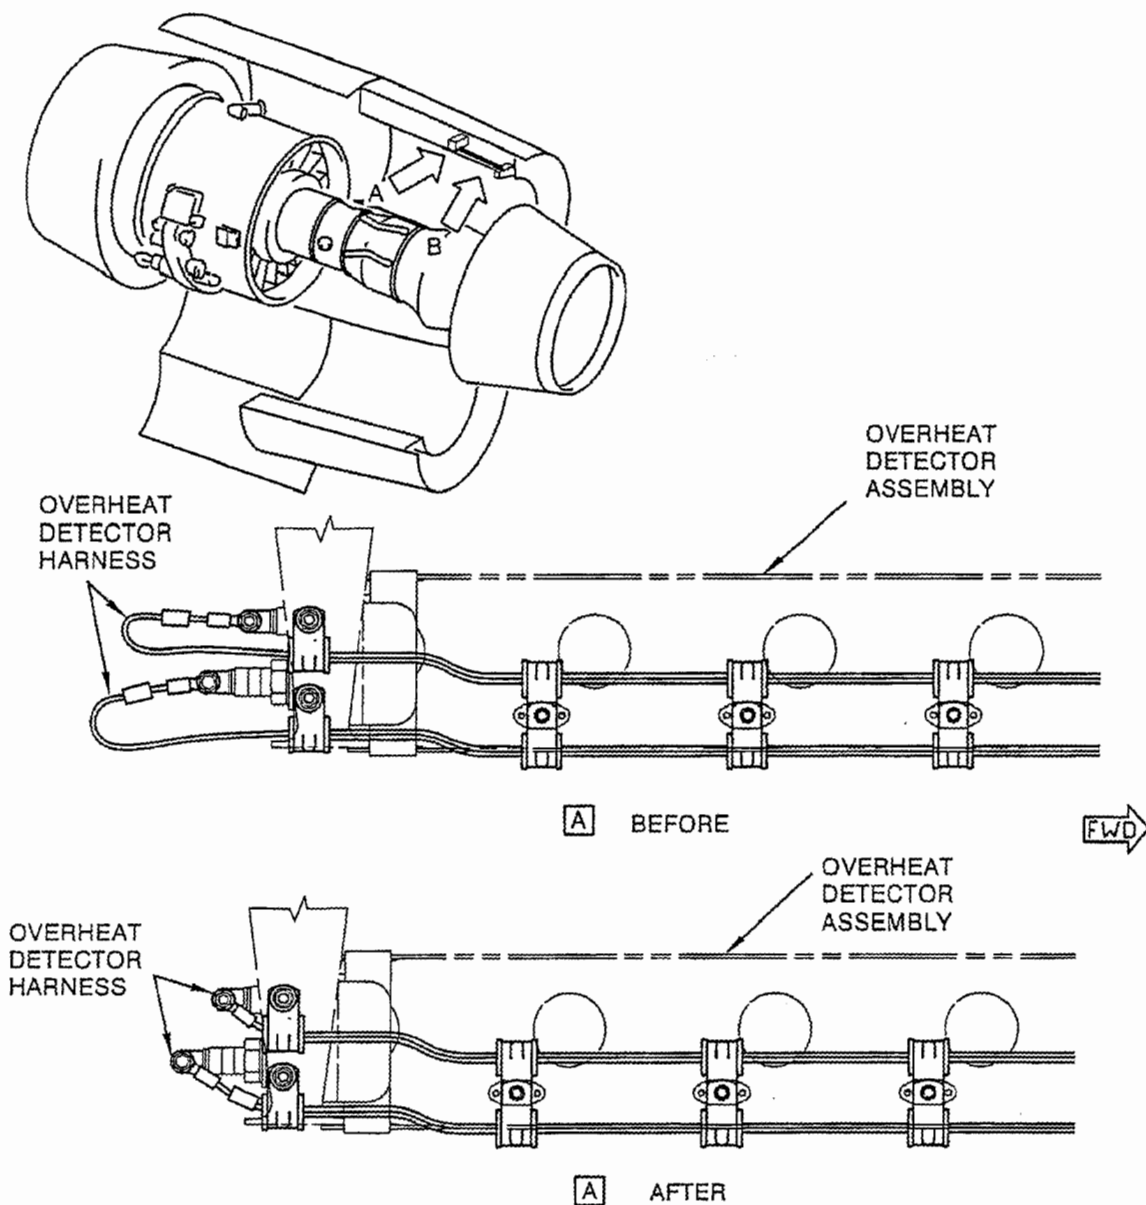
Overheat Detector Harness Installation Modification  
Figure 1 (Sheet 1)

The upper thrust reverser half outboard overheat detector harness can break at the aft terminal lugs. There is also a possibility of interference between the harness and the thrust reverser heat shield at one clipping point.

Operators have experienced broken outboard bifurcation overheat detector harness terminal lugs. The cause has been determined to be stress on the aft terminal lugs which is the result of improper distribution of excess length in the harness. There is a possible interference between the harness and the thrust reverser heat shield at one clipping point.

- (1) Remove the excess length at the aft end of the outboard overheat detector harness. Make the harness installation in this area look the same as shown in Figure 1 (Sheet 1) Detail A.
- (2) Distribute the remaining excess length of the overheat detector harness forward. Be careful not to cause interference with other components.
