V2500 Propulsion System — Nacelle

Subject: Transmittal of Revision 5 to Service Bulletin Number V2500-NAC-78-0150

NACELLE — POWERPLANT — TRANSLATING SLEEVE, THRUST REVERSER —  
MODIFICATION OF

V2500-NAC-78-0150

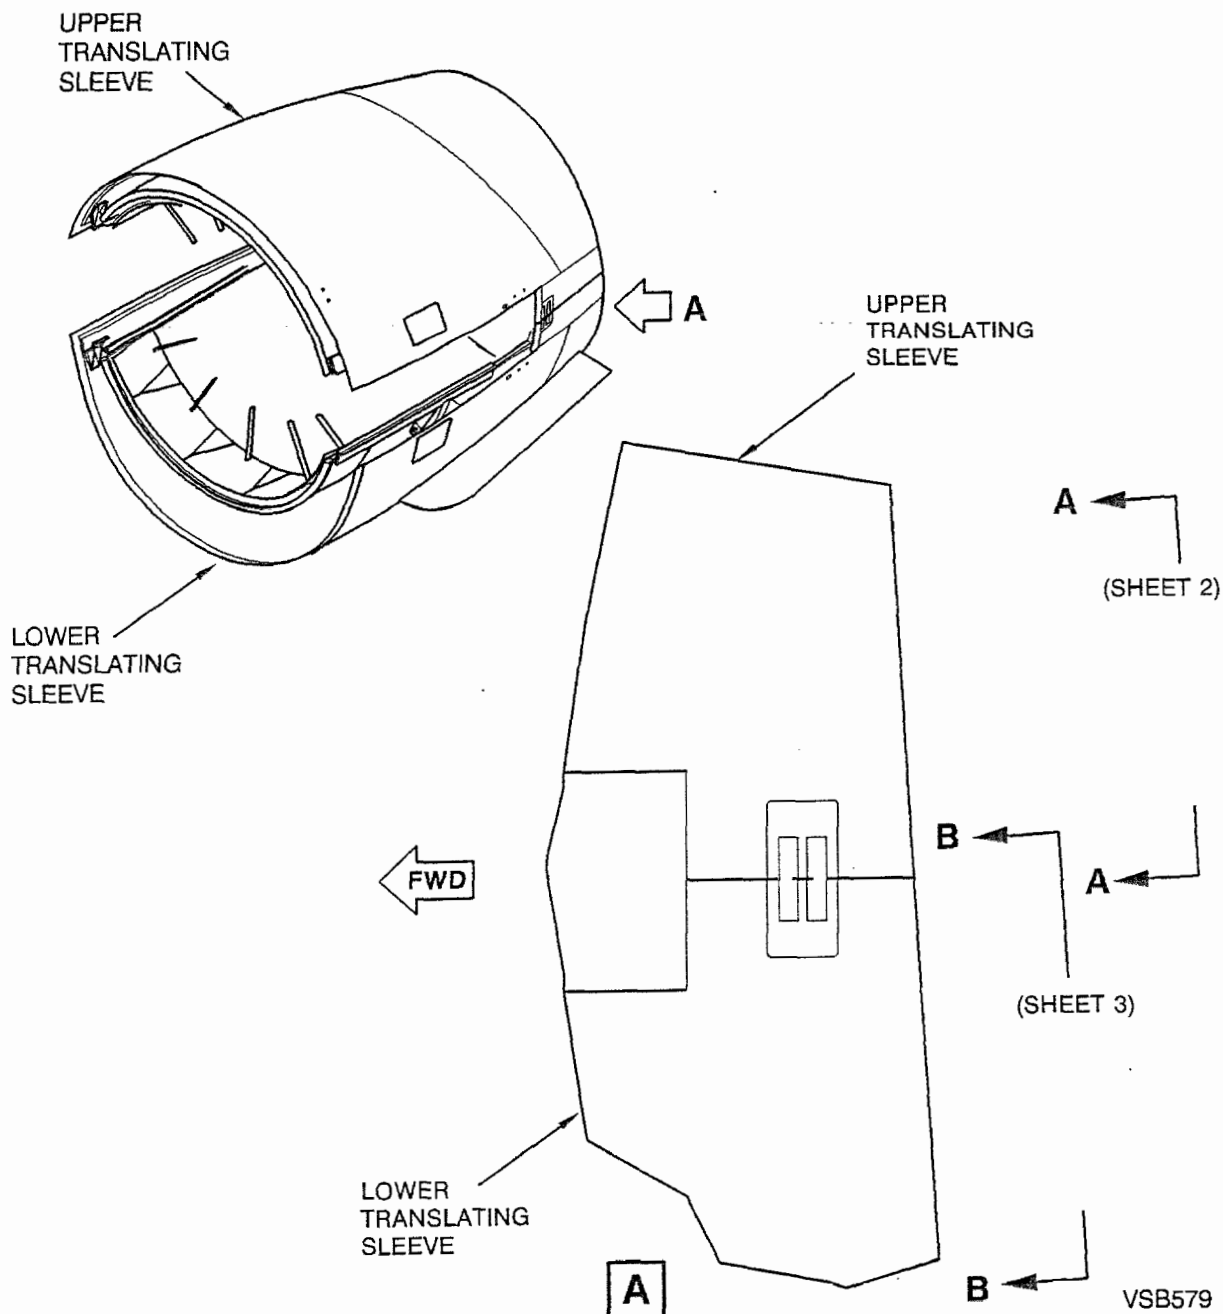
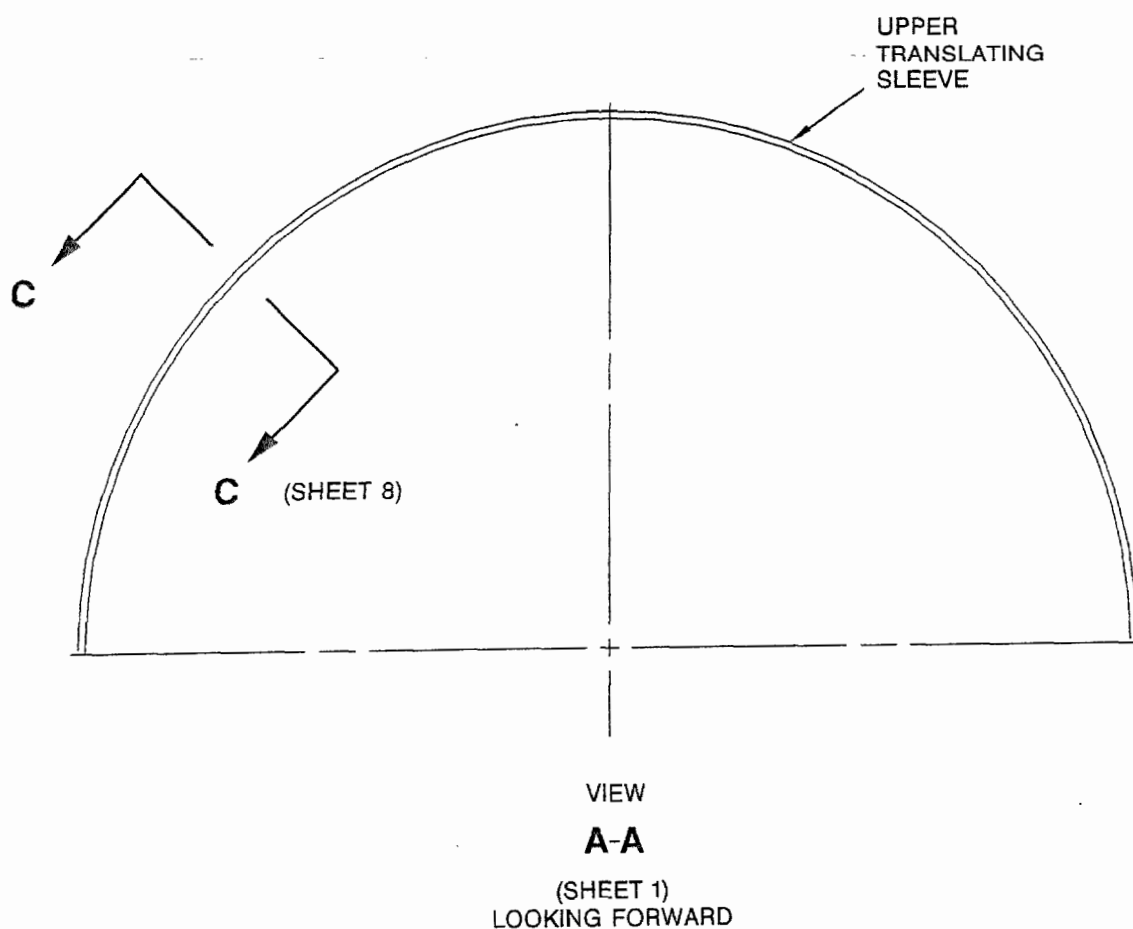
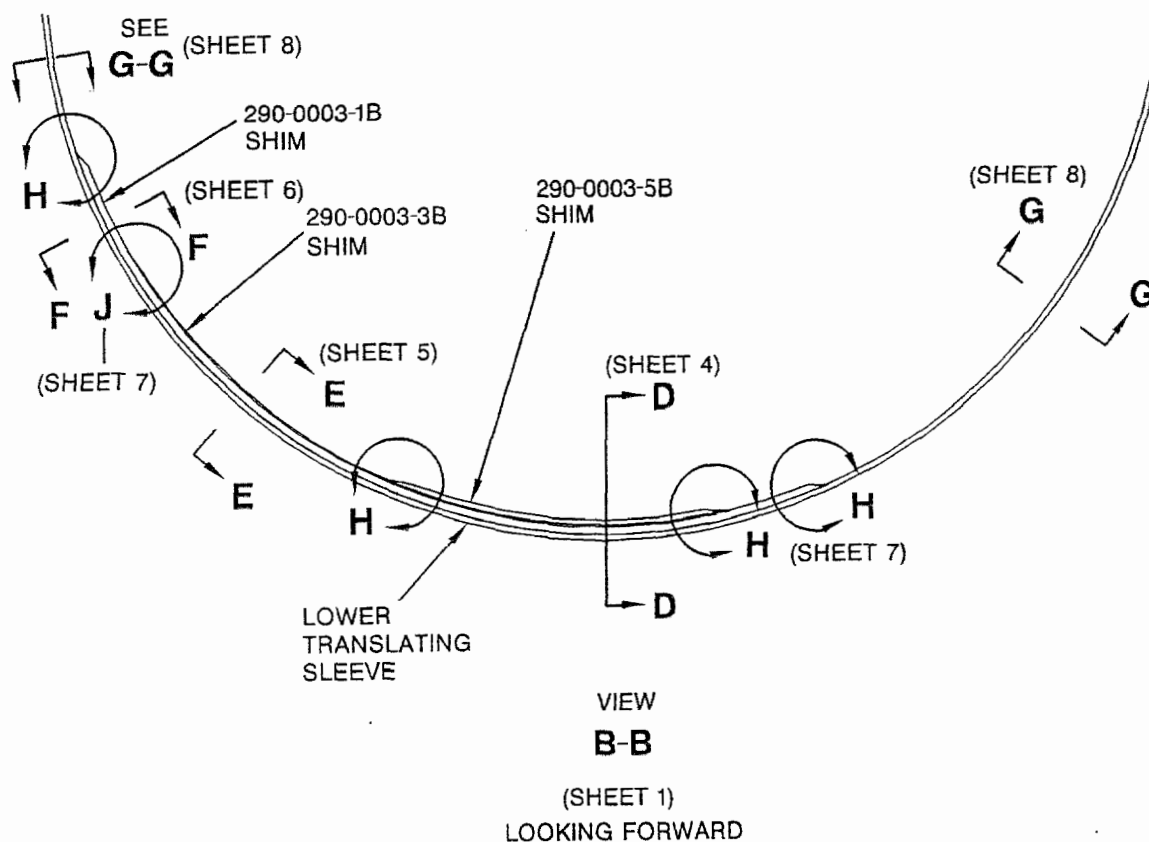
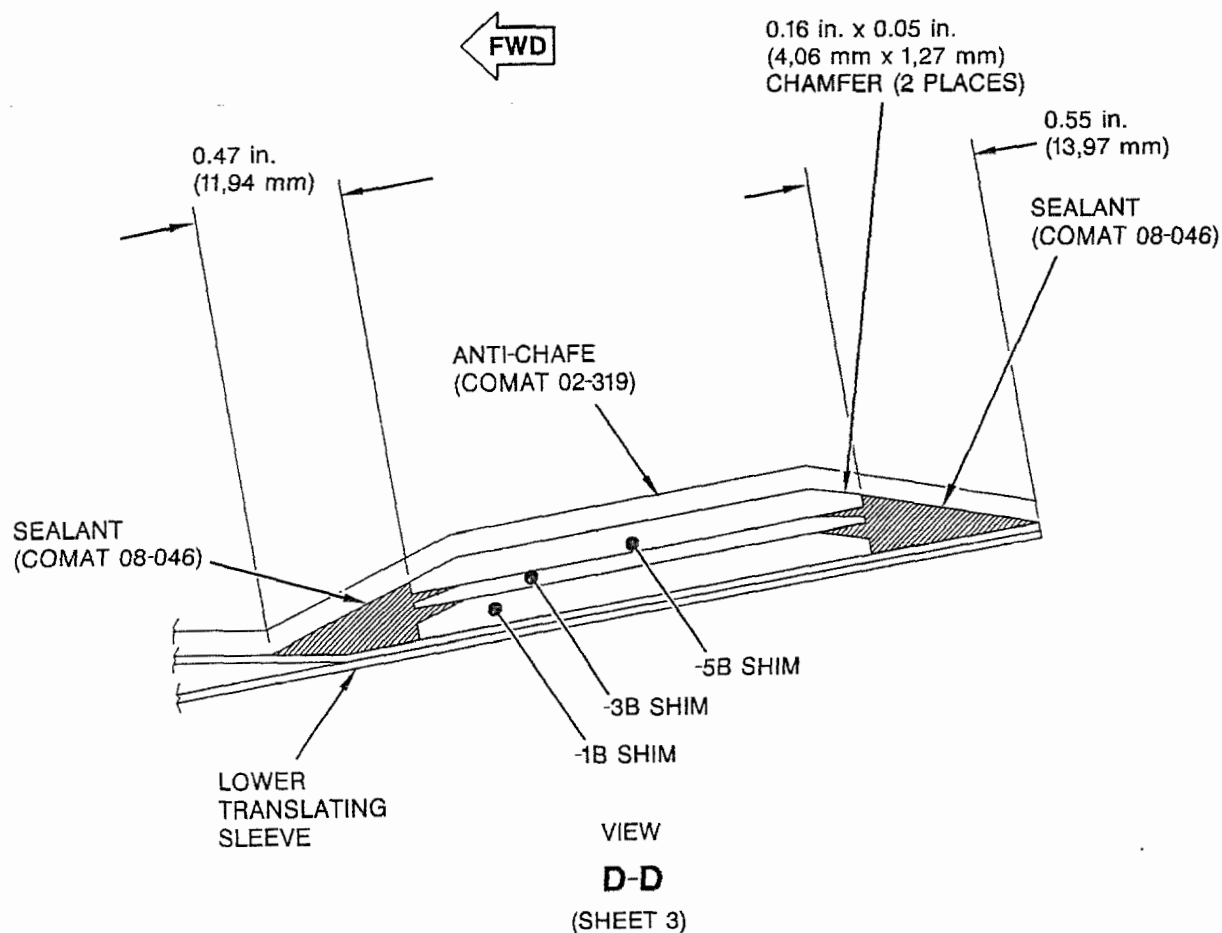
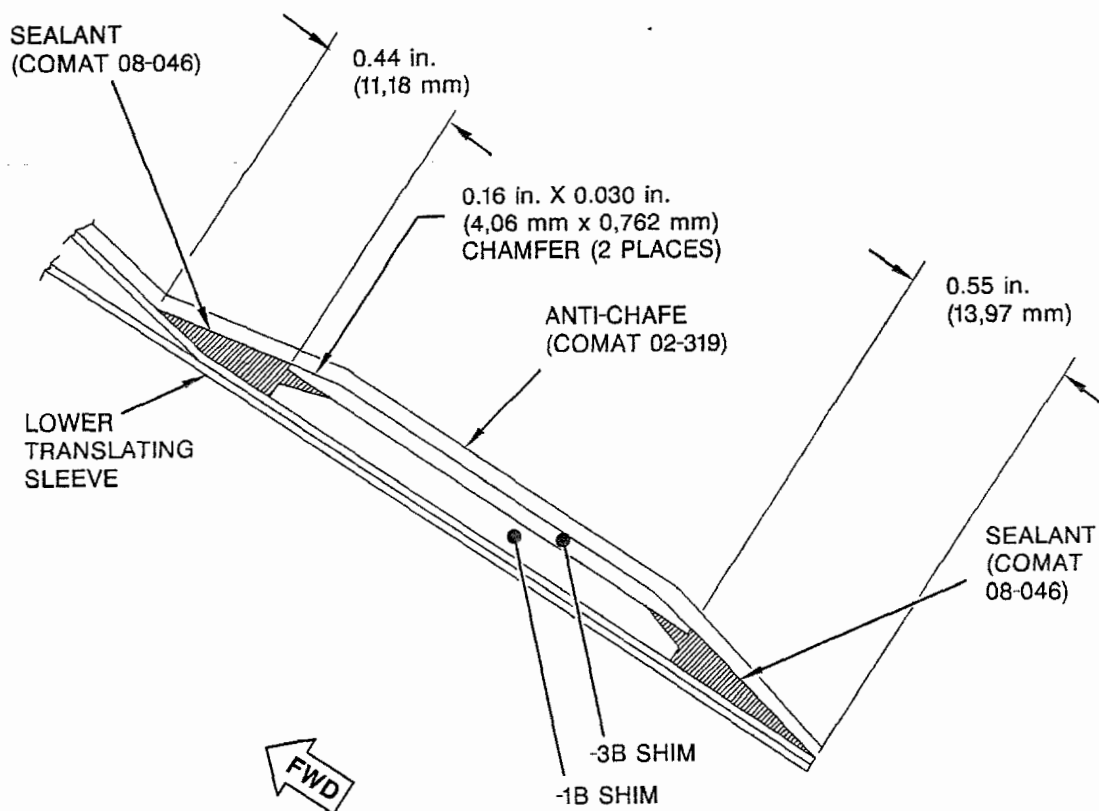
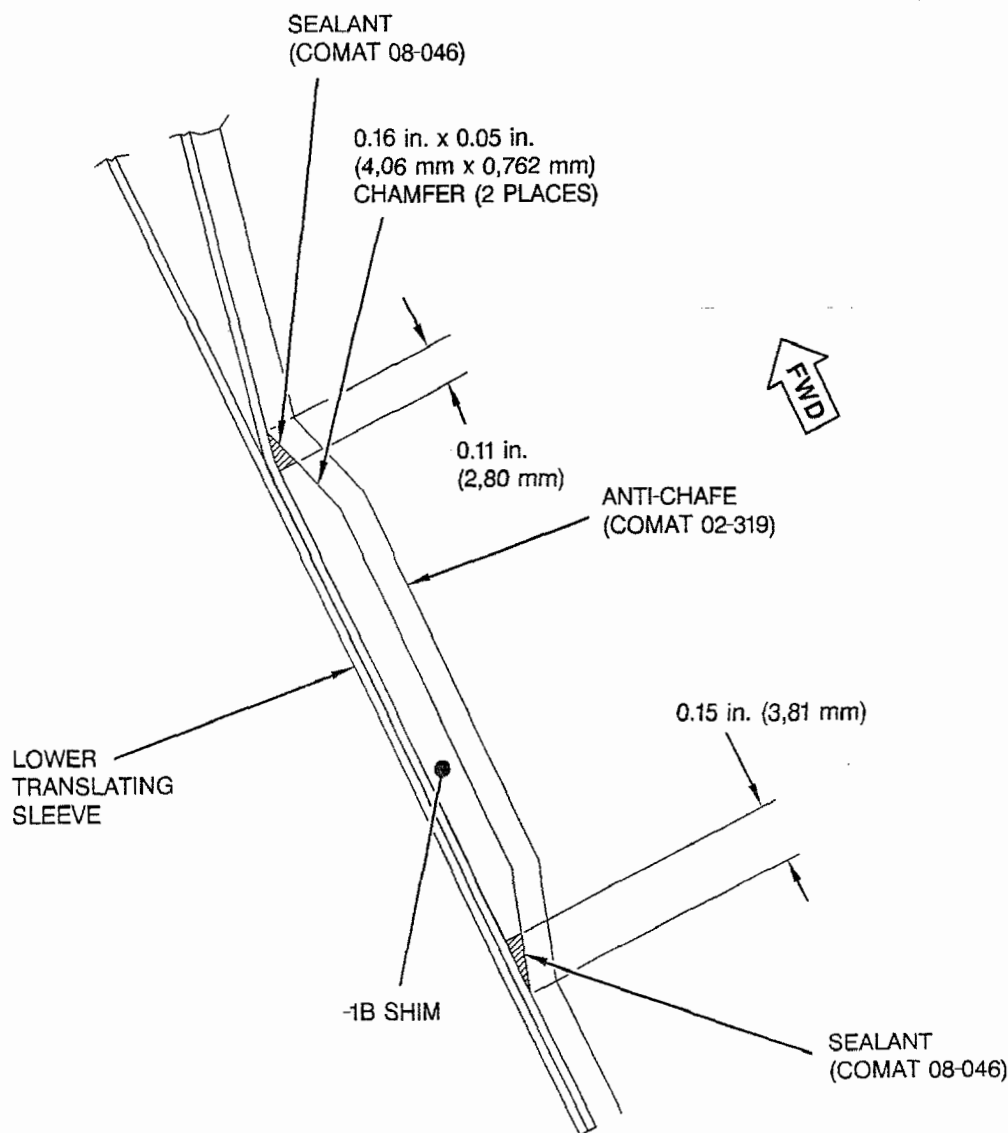
Translating Sleeve Modification  
Figure 1 (Sheet 1)

R The common nozzle assembly (CNA) seals can be damaged by the shims at the aft end of the lower translating sleeve.

R In-service Damage to the CNA seals has been found to be caused by the shims at the aft end of the lower translating sleeve.  
R

### C. Chamfer the shims on the lower translating sleeve to the dimensions shown in Figure 1.

- (1) Make the indicated areas of the upper and lower translating sleeve indicated in Figure 1 lightly rough with nylon scouring pads.

- (7) Apply aero-sealant (CoMat 08-046) around the shims on the lower translating sleeve as shown in Figure 1.
- (8) Cure the aero-sealant. Refer to the manufacturer's instructions.

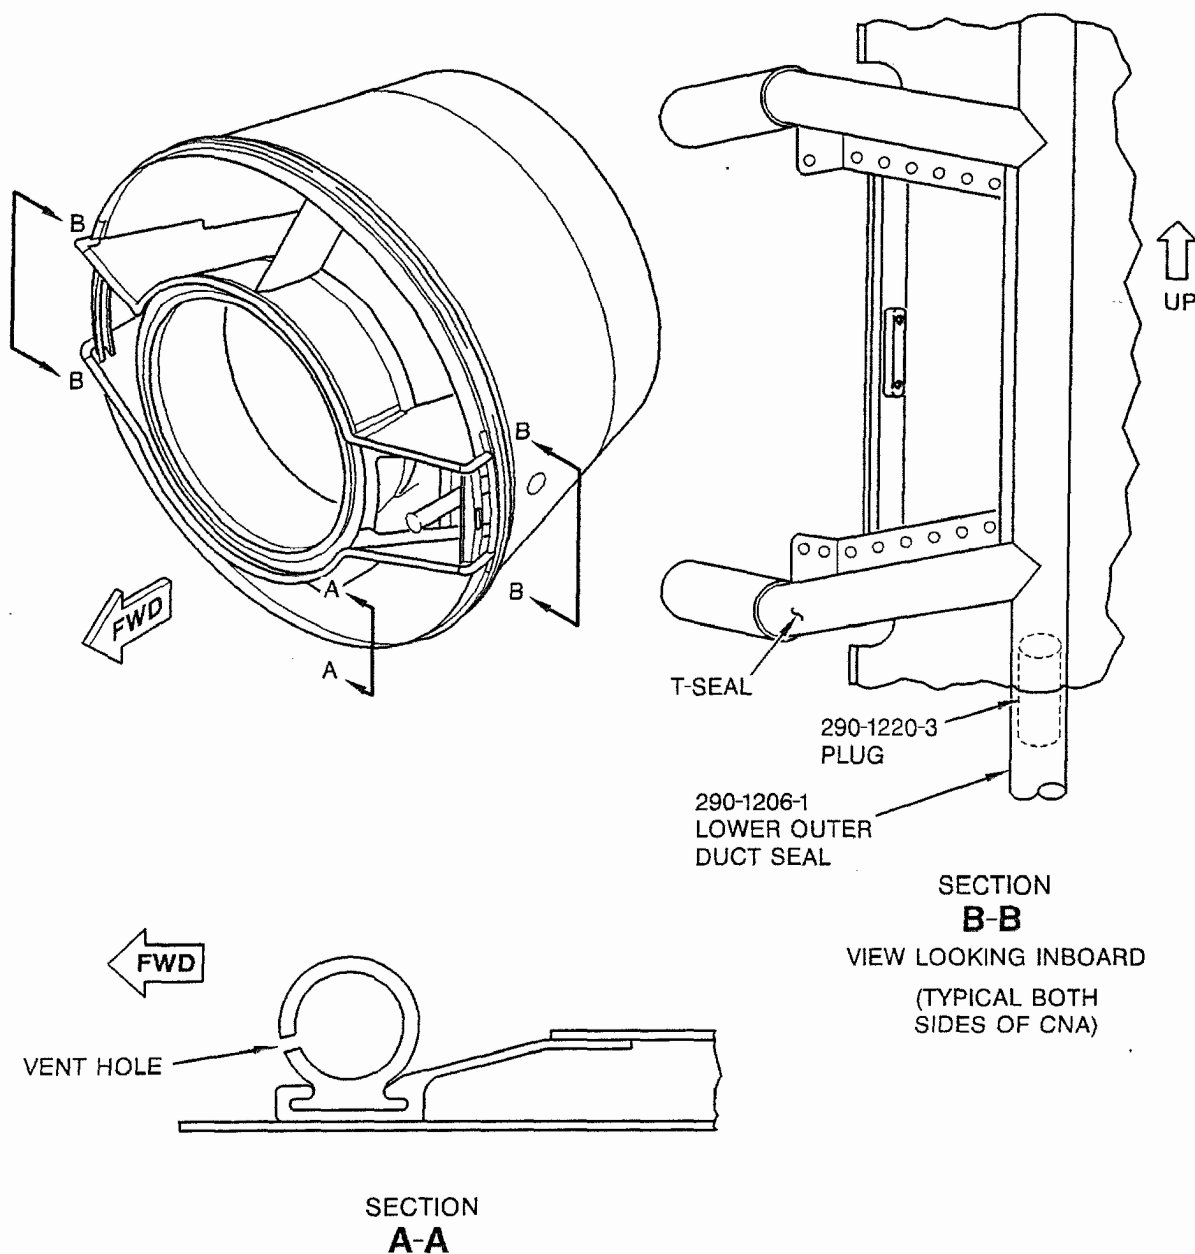
Common Nozzle Assembly Lower Outer Duct Seal Inspection/Replacement  
Figure 2

- (1) Examine the 290-1206-1 lower outer duct seal for damage.  
Refer to Figure 2.

- 1 If the abrasion does not penetrate the cover of the seal, accept the seal.
- 2 If the abrasion does penetrate the cover of the seal, replace the seal.

- 1 If no gouges, rips, or tears, accept the seal.
- 2 If any gouges, rips, or tears, replace the seal.

- (2) Replace the 290-1206-1 lower outer duct seal, if required.  
Refer to Figure 2.

- (a) Remove the damaged outer duct seal and old sealant from the seal carrier and adjacent T-seals.
