SERVICE BULLETIN

NACELLE — EXHAUST — RUB BLOCKS, COMMON NOZZLE ASSEMBLY — MODIFICATION OF

V2500-D5

V2500-NAC-78-0155

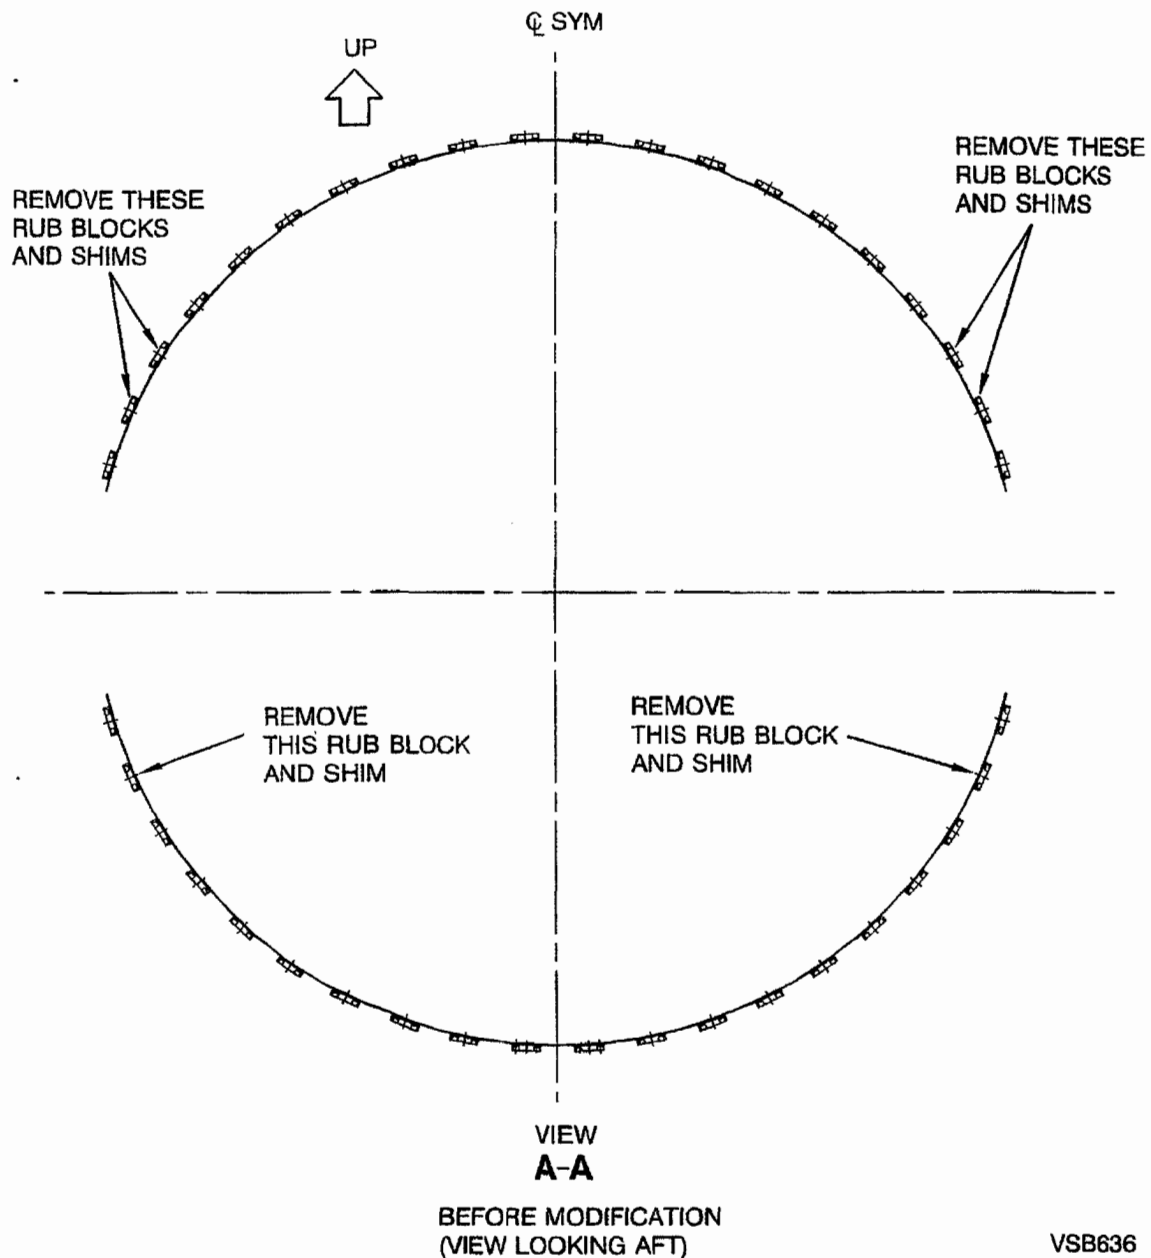
CNA Rub Block Installation
Figure 1 (Sheet 2)

Interference between the new configuration translating sleeve and the common nozzle assembly rub blocks can occur.

- (1) Remove the fasteners, three rub blocks, and associated shims from each side of the CNA. Refer to Figure 1 (sheet 2).
